TECHNICAL EXAMINATION REPORT

Landscape with Hermit

Circle of Jan Wellens de Cock

2017.84

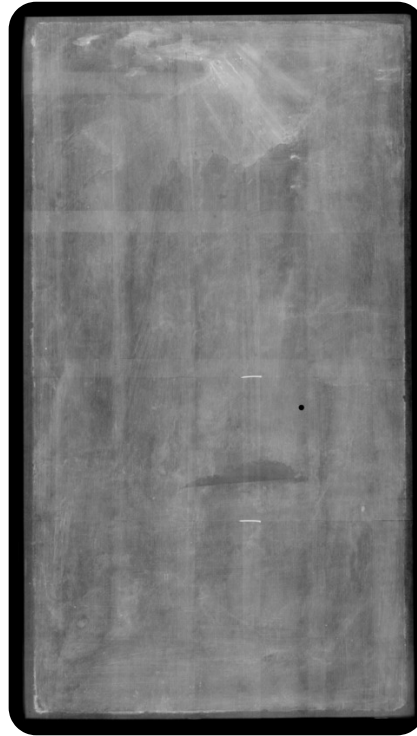
Technical Figure 1: X-radiograph. Circle of Jan Wellens de Cock, *Landscape with Hermit*, early 1500s, Indianapolis Museum of Art at Newfields, The Clowes Collection, 2017.84.

In the X-radiograph, two horizontally positioned nails are visible toward the center of the panel in the lower half of the composition (tech. fig. 1). Given that the nails appear relatively modern, and the original support is only 1 mm thick, it is quite certain that they do not relate to the original construction of the panel. Close examination suggests these nails are not present in the cradle. It is therefore likely that the nails are present in the 5-mm-thick panel to which the original support was marouflaged.

The ground is in generally good condition. The adhesion is strong between the panel and the ground despite previous interventions to the structure of the painting. There is a triangular area in the center of the painting that is less dense in the X-radiograph and may correspond to a loss in the ground and paint layers.

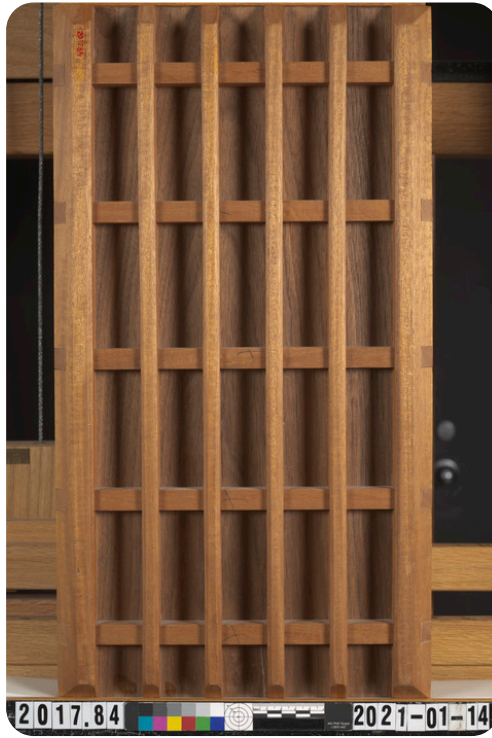
Technical Figure 2: Back. Circle of Jan Wellens de Cock, *Landscape with Hermit*, early 1500s, Indianapolis Museum of Art at Newfields, The Clowes Collection, 2017.84.

The auxiliary support consists of a secondary panel into which the original panel was marouflaged. This panel has been backed with a wood veneer to which a cradle has been glued.

The cradle is robust and well-constructed (tech. fig. 2). It is composed of six vertical members. The central four members are 1 cm wide and have rounded edges. The two outer members are 3 cm wide with beveled and rounded edges. There are five horizontal members that were designed to be movable but all of which have seized. The horizontal bars have squared corners and are 1.5 cm wide.

Glue residues are present along the bottom edge of the back.

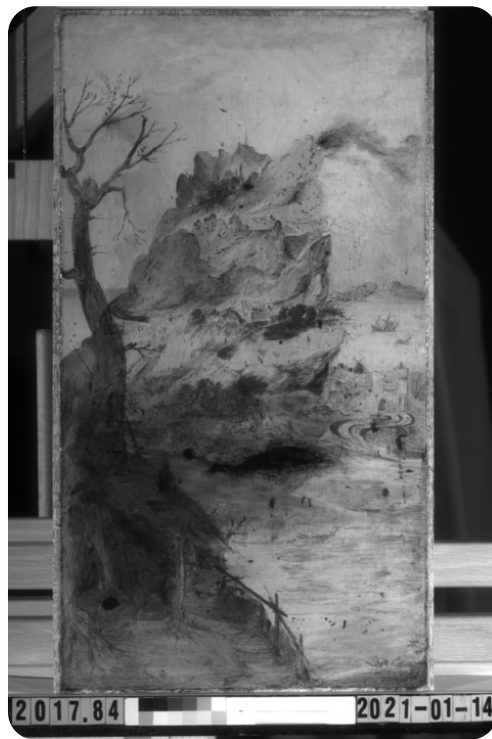
Technical Figure 3: Infrared reflectogram. Circle of Jan Wellens de Cock, *Landscape with Hermit*, early 1500s, Indianapolis Museum of Art at Newfields, The Clowes Collection, 2017.84.

There is no evidence of underdrawing visible in infrared reflectography (tech. fig. 3). The quick, brushy application of a wash layer (see **Description of Paint**) may suggest that the composition was not carefully planned before the painting stage but rather was blocked out in paint. It is also possible that the composition was outlined using a medium that does not strongly absorb in infrared.

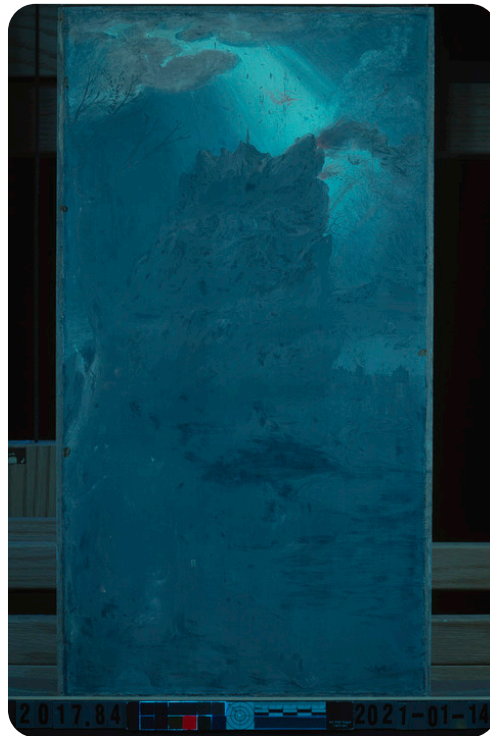
Technical Figure 10: Ultraviolet-induced visible fluorescence. Circle of Jan Wellens de Cock, *Landscape with Hermit*, early 1500s, Indianapolis Museum of Art at Newfields, The Clowes Collection, 2017.84.

There is a thick, evenly applied layer of varnish that luminesces in ultraviolet-induced visible fluorescence (tech. fig. 10). The fluorescence is greenish-blue, suggesting it may be a natural resin varnish.

The varnish coating has darkened, obscuring the surface detail in the painting. Further, the coating has become desaturated making it difficult to appreciate details in the dark areas. Areas of retouching are visible in the ultraviolet-induced visible fluorescence image. Because the painting is very dark, it is, in some cases, difficult to spot these areas on the painting even when using microscopy.

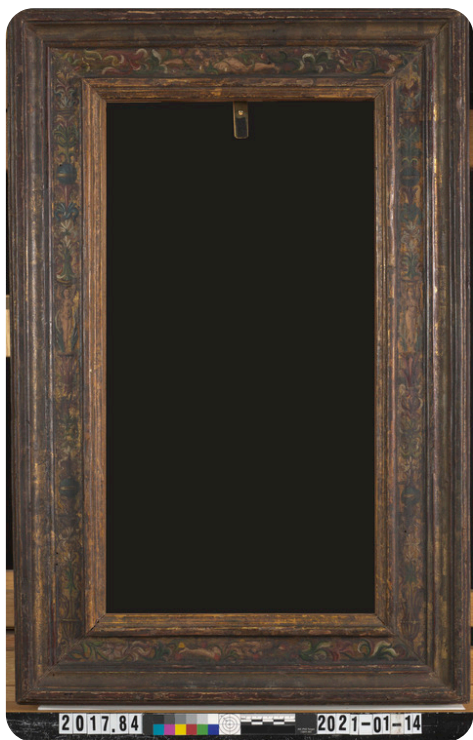
Technical Figure 11: Frame, front. Circle of Jan Wellens de Cock, *Landscape with Hermit*, early 1500s, Indianapolis Museum of Art at Newfields, The Clowes Collection, 2017.84.

The frame is a cassetta-style frame (tech. fig. 11) that is constructed from wood with mitered corner joins (tech. fig. 12). The molding profile is carved from wood and covered with a dark red bole and a water-gilt surface. Over the gilding, a floral motif is painted on the flat central frieze. Nude figures holding up vases are present in the center of the right and left sides.

The frame is in acceptable condition. The structure is sound, but there are some losses to the gilding and abrasion to the painted surface.

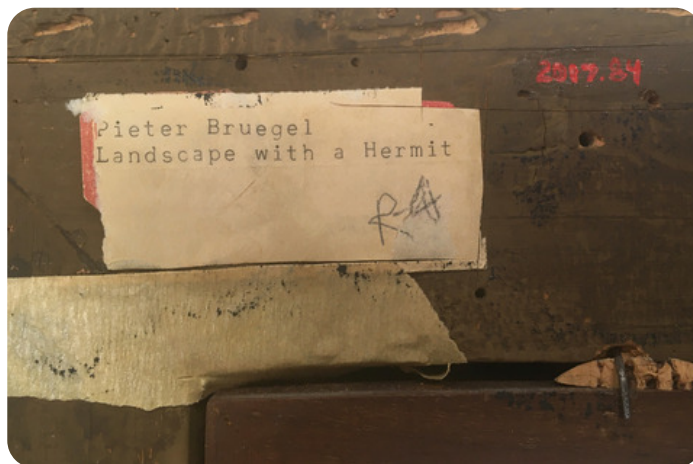
Technical Figure 13: Details of label and inscription on frame. Circle of Jan Wellens de Cock, *Landscape with Hermit*, early 1500s, Indianapolis Museum of Art at Newfields, The Clowes Collection, 2017.84.

Item 1. Paper label, upper-left corner of frame, typed "Pieter Bruegel/ Landscape with a Hermit," handwritten "R4" (tech. fig. 13).

Item 2. Painted inscription, upper-left corner of frame, red paint "2017.84" (tech. fig. 13).
