TECHNICAL EXAMINATION REPORT

Madonna and Child

Badia a Isola Master

2009.52

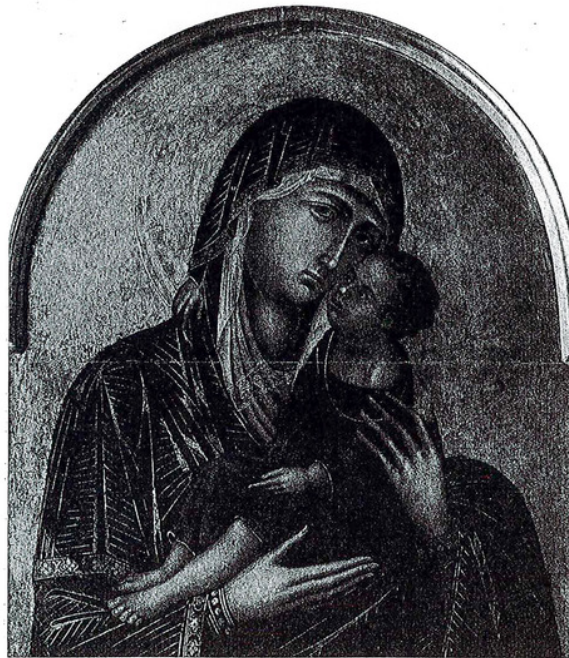
Technical Figure 1: Image of the Clowes painting scanned from a 1936 article by Hilde Weigelt, "Madonna mit Kind von Segna di Buonaventura," *Pantheon* (1936): 17. Note the frame does not extend to the bottom on either side. Badia a Isola Master, *Madonna and Child*, about 1300–1310, Indianapolis Museum of Art at Newfields, The Clowes Collection, 2009.52.

The original shape of the engaged frame, which only existed as an arch at the top of the panel, is visible in an archival image of the painting (see tech. fig. 1). This was a common design for polyptychs. The arched frame and the *Madonna and Child* subject matter are typical in central panels of thirteenth-century Italian altarpieces. For example, the Duccio di Buoninsegna altarpiece at the Pinoteca Nazionale in Siena depicts a similar *Madonna and Child* in the central panel (tech. fig. 5).

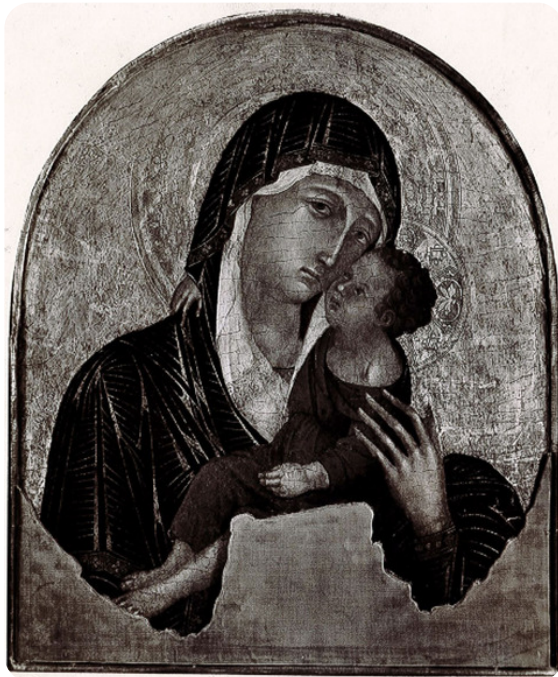
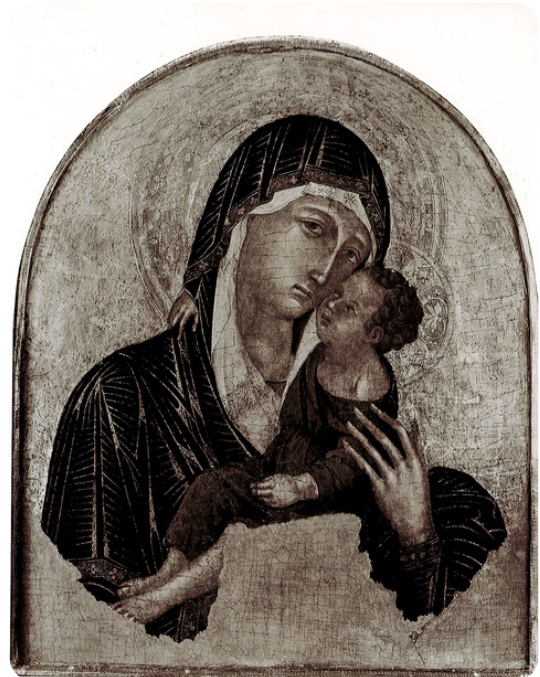
During a treatment that appears to have been carried out in 1935, canvas and [fill](#) were added to extend the paint layer on the front of the panel, perhaps in an attempt to mimic the techniques of early Italian painting. Technical figures 2 and 3 are both dated 1935 and appear to show this process under way. Technical figure 2 shows the panel with the canvas applied but without fill or [retouching](#). Technical figure 3 shows the painting, much in its current state, with fill and neutral retouching. This approach was likely taken

Technical Figures 2, 3: Master of Badia a Isola, *Madonna and Child*, with the exposed canvas addition before (left) and after (right) the application of the ground. Badia a Isola Master, *Madonna and Child*, about 1300–1310, Indianapolis Museum of Art at Newfields, The Clowes Collection, 2009.52.

Technical figure 1 shows a photograph of the painting with the lower section fully reconstructed.⁷ Photos taken during treatment in 1935 (see tech. figs. 2, 3) show the current intervention under way and the previously reconstructed lower section (see tech. fig. 1) replaced with the current neutral retouching. There are no records of treatment to the object after this 1935 intervention.

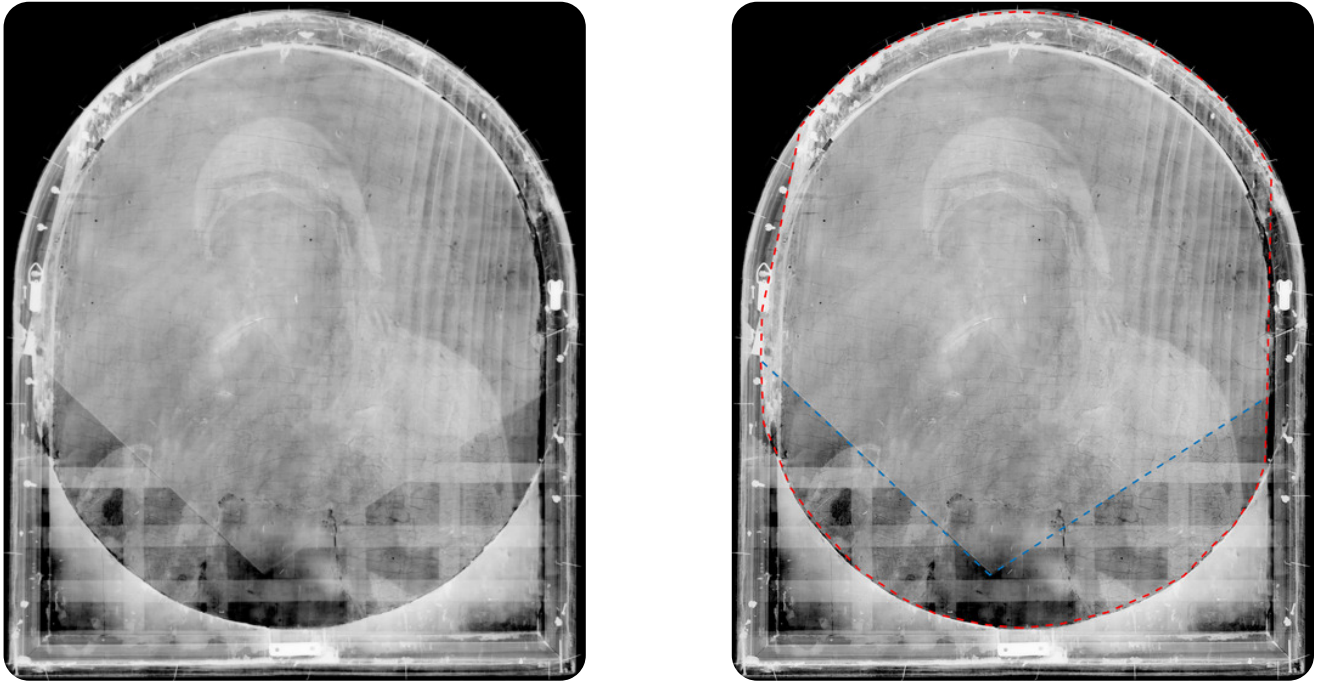
Technical Figure 4: X-radiograph showing wood grain, addition, and cradle. The red dashed line outlines the original wooden support and frame, and the blue dashed line denotes the area below which the panel was thinned in preparation for the addition of the cradle and lower support segment. Badia a Isola Master, *Madonna and Child*, about 1300–1310, Indianapolis Museum of Art at Newfields, The Clowes Collection, 2009.52.

The X-radiograph reveals continuous wood grain through the original panel to the top of the frame (tech. fig. 4). However, a gap along the top edge of the panel is visible where it meets the frame, and the canvas that was applied to the front of the panel appears to wrap around the edge under the engaged frame. This suggests that the extant segments of the original frame were carved separately from the panel and attached to it after the addition of the canvas, but before the application of *gesso* and gilding. The bottom member of the current frame, and the lower components on either side, appear to be nonoriginal (tech. figs. 4, 9). The lower portions are entirely reconstructed, as evident from the back and the X-radiograph. Canvas has also been applied to the lower portion of the panel, including over nonoriginal wood. Although it is difficult to determine with certainty, it appears that this canvas was added later to match that of the original portion of the panel.

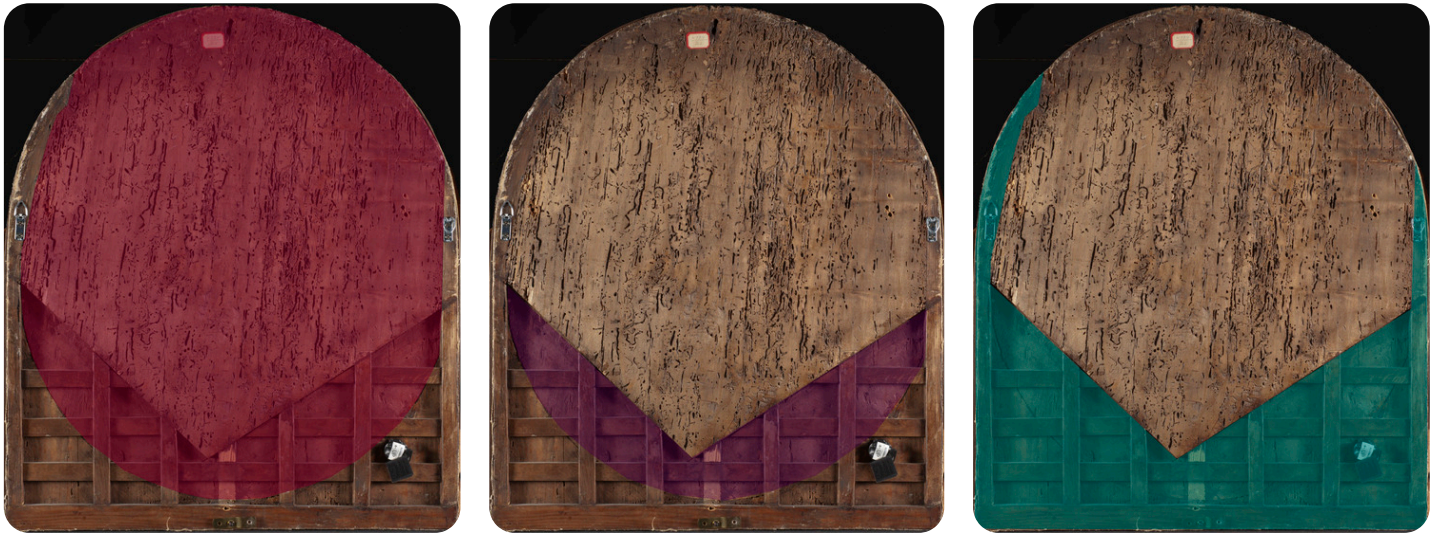
The auxiliary support is not original to the painting and consists of a partial cradle that is attached to the thinned section of the back as well as the added support (tech. figs. 7, 8, 9). The cradle consists of seven vertical members fixed in place and three horizontal members, also fixed. The cradle is cut to fit the diagonal thinning of the panel and create support for the added lower reconstruction. The central vertical member has been partially removed.

Technical Figures 7, 8, 9: Back of the painting showing the original support (red), the thinned area of the support (purple), and later additions to the support (green). Badia a Isola Master, *Madonna and Child*, about 1300–1310, Indianapolis Museum of Art at Newfields, The Clowes Collection, 2009.52.

The support is in stable condition, although it has suffered significant damages in the past. The back shows extensive tunneling from wood-boring insects. Prior to the addition of the partial cradle, the thickness of the original panel was thinned, revealing the insect tunnels in [cross section](#). The panel was deliberately cut into an oval (tech. fig. 7) and then thinned into a “v” shape on the back (tech. fig. 8), likely to accommodate the addition of the cradle or possibly to remove a particularly damaged area of the support. The thinned area where the cradle is attached (see purple in diagram) does not appear to have as much woodworm damage as the upper section of the panel, which may suggest the cradle was added to this area because it was the most stable. Losses are present along the outer edges of the original panel due to the woodworm infestation and damages inflicted over time and through natural aging.

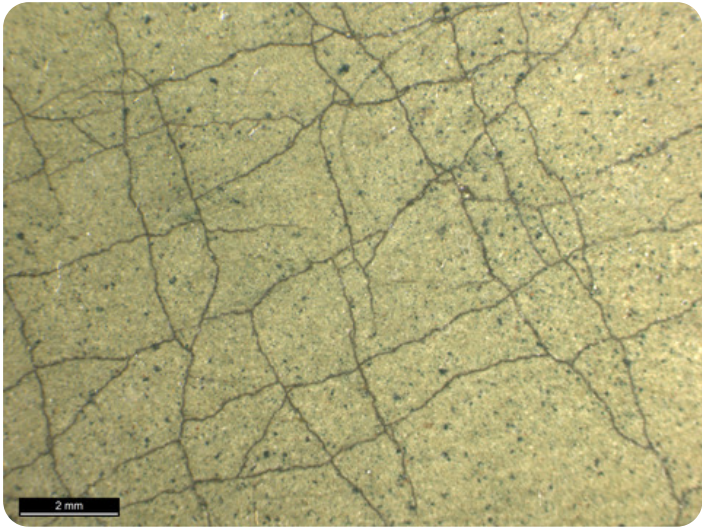
The ground layer is in stable condition but has suffered numerous losses. A natural craquelure pattern, due to aging, can be seen over the surface of the painting in a slightly horizontal pattern, even though the panel grain runs vertically. This may be a result of the canvas layer offsetting the stresses caused by movement in the panel. Where the bottom of the panel was removed, the added panel has been covered with a canvas layer and coated with a thick layer of fill to imitate the ground layer (tech. fig. 11). Neutral retouching in green paint was applied to imitate the verdaccio layer. The choice of green is somewhat unusual for such a large section, as that color was primarily used underneath skin tones.

Technical Figure 11: Photomicrograph of green fill in lower section of the panel. Badia a Isola Master, *Madonna and Child*, about 1300–1310, Indianapolis Museum of Art at Newfields, The Clowes Collection, 2009.52.

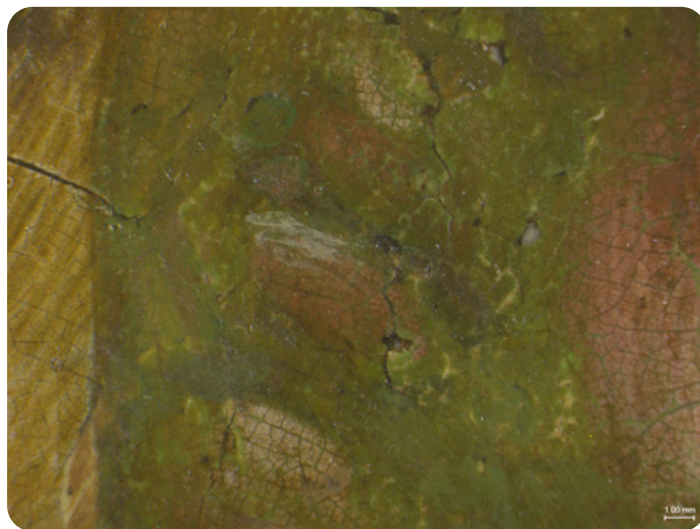
The paint layer is in stable condition but suffers from significant past damage as well as natural aging. A distinct craquelure network is present throughout the painting. Retouching is present in copious amounts across the surface the painting, including in the areas of gilding, which have been restored using gold paint. Much of the retouching is poorly matched and hastily applied (tech. fig. 22).

Technical Figure 22: Photomicrograph of abraded area of the Christ child's face with poorly matched retouching. Badia a Isola Master, *Madonna and Child*, about 1300–1310, Indianapolis Museum of Art at Newfields, The Clowes Collection, 2009.52.

The varnish appears to adequately saturate the painting, although the gold *fondo oro* would typically look much more vibrant and reflective than it currently does. The skin tones have increased transparency over time, contributing to the greenish hue in their appearance as they allow more of the underlying verdaccio to become visible. They have also been severely abraded, which has compromised the masterful quality of the original work. This damage is particularly apparent in the Christ child's face, where few remnants of his proper right eye and mouth remain intact (tech. figs. 22, 23).

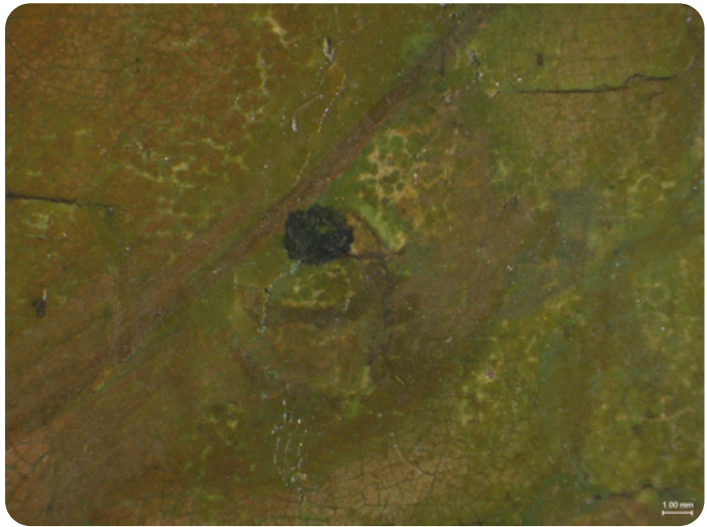
Technical Figure 23: Photomicrograph of the Christ child's proper right eye showing extensive damage and abrasion. Badia a Isola Master, *Madonna and Child*, about 1300–1310, Indianapolis Museum of Art at Newfields, The Clowes Collection, 2009.52.

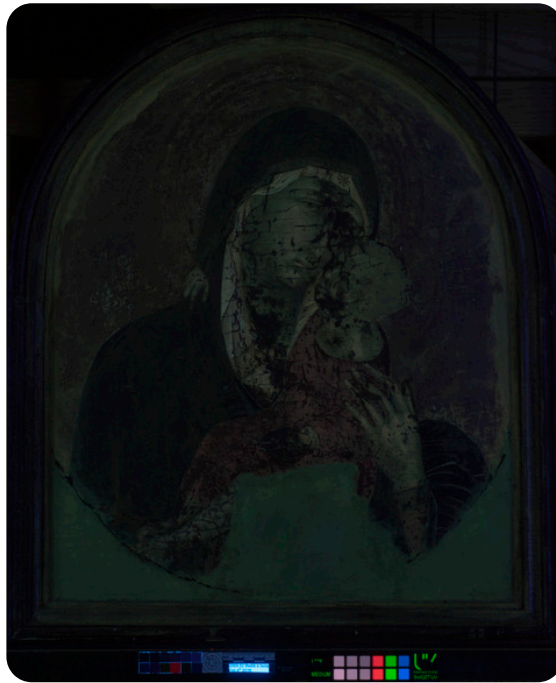
Technical Figure 24: Painting under ultraviolet-induced visible fluorescence showing a green fluorescence characteristic of an aged natural resin varnish. Image brightened to enhance fluorescence. Badia a Isola Master, *Madonna and Child*, about 1300–1310, Indianapolis Museum of Art at Newfields, The Clowes Collection, 2009.52.

The painting appears to have a coat of synthetic varnish on its surface with residues of an older natural resin varnish, identifiable by a greenish fluorescence when viewed with ultraviolet radiation (tech. fig. 24). The subject of varnishing early tempera paintings remains debatable, and while references to it exist, such as in translations of Cennino Cennini's *Il Libro dell'Arte*,⁶ others indicate it was not a contemporary practice. In either case, it would be difficult to ascertain the original state of the work, as any remnants of an original varnish would have likely been cleaned away during later varnish removal campaigns. Subsequent restorations have resulted in the applications of layers of varnish, overpaint, and retouching. The most recent restoration campaign likely added a varnish layer to create a barrier between original material and retouching.
