TECHNICAL EXAMINATION REPORT

Portrait of a Man

Attributed to Leandro Bassano

2016.163

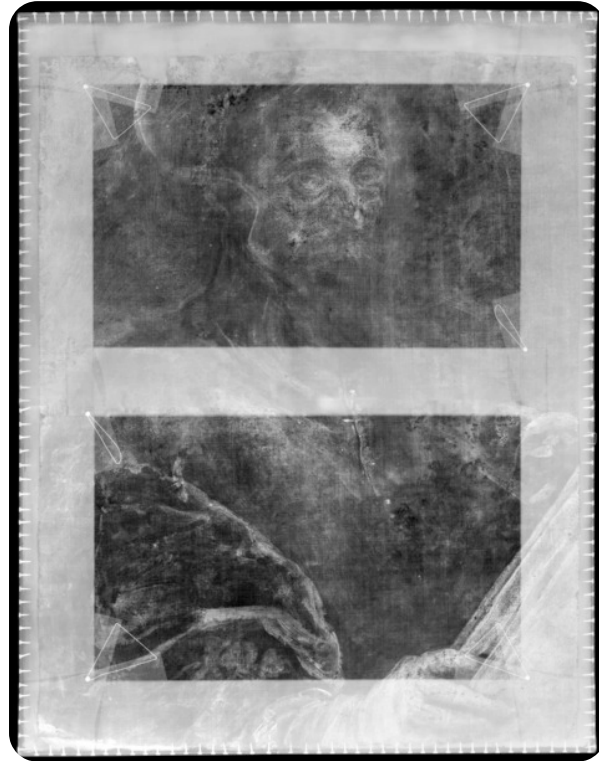
Technical Figure 1: X-radiograph. Attributed to Leandro Bassano, *Portrait of a Man*, about 1590–1600, Indianapolis Museum of Art at Newfields, The Clowes Collection, 2016.163.

The original canvas was trimmed and no longer exhibits any tacking margins. There is no sign of cussing (tech. fig. 1), suggesting that the painting was significantly cut along all edges. It was likely cut by hand at the time the lining was applied.

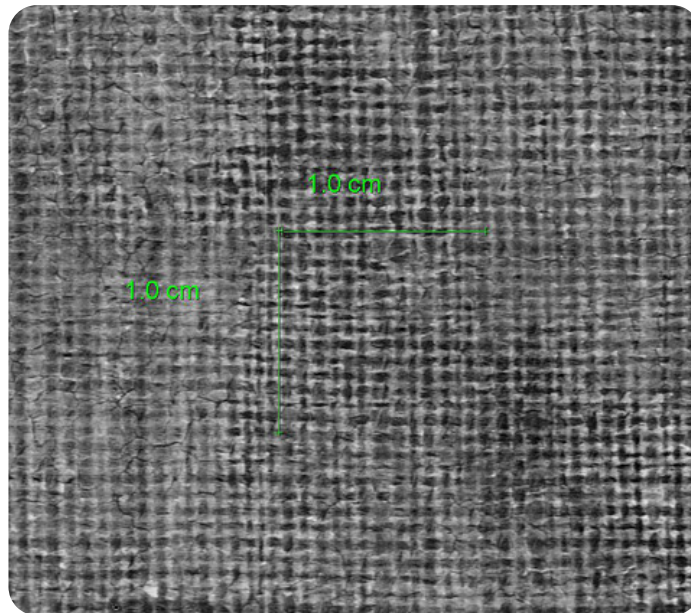
The original canvas exhibits a plain weave with a thread count of 15×14 threads/cm (tech. fig. 2). The canvas has relatively coarse weave with evenly spaced thread and a few slubs appearing occasionally.

Technical Figure 2: X-radiograph detail, thread count of 15×14 threads/cm. Attributed to Leandro Bassano, *Portrait of a Man*, about 1590–1600, Indianapolis Museum of Art at Newfields, The Clowes Collection, 2016.163.

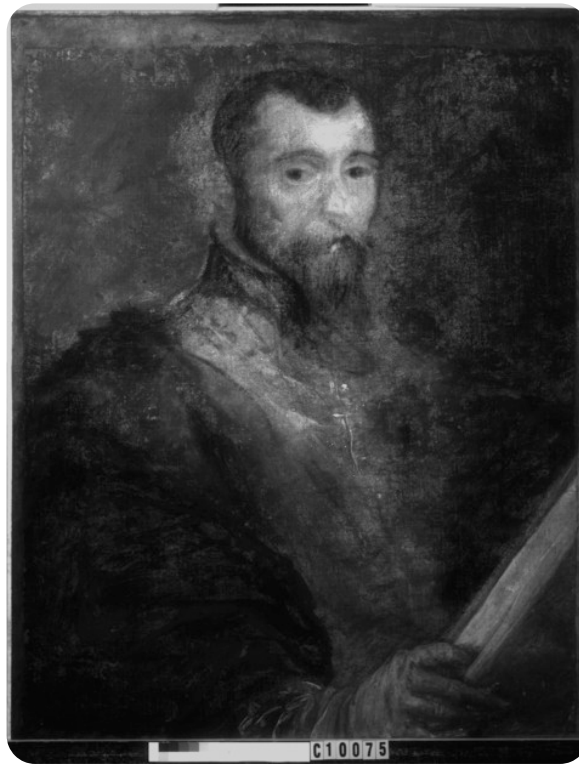
Technical Figure 3: Infrared reflectogram showing adjustments of the figure and damages in the background. Attributed to Leandro Bassano, *Portrait of a Man*, about 1590–1600, Indianapolis Museum of Art at Newfields, The Clowes Collection, 2016.163.

No pentimenti are discernible (tech. fig. 3). Some slight adjustments and reinforcements of the figure using paint are present, for example in the folds of the coat around the neck and in the facial hair. Numerous damages are also visible in the infrared reflectogram, particularly in the background and around the head of the figure. Additionally, there are some wavy lines visible in the X-radiograph that appear to be painted with lead white on the proper right near the figure's head. These do not correspond to the composition, and the reason for their presence is unclear. The original edge of the canvas is visible in the reflected infrared image, and it is apparent that the canvas was quite damaged, especially at the top edge where holes and tears are present.

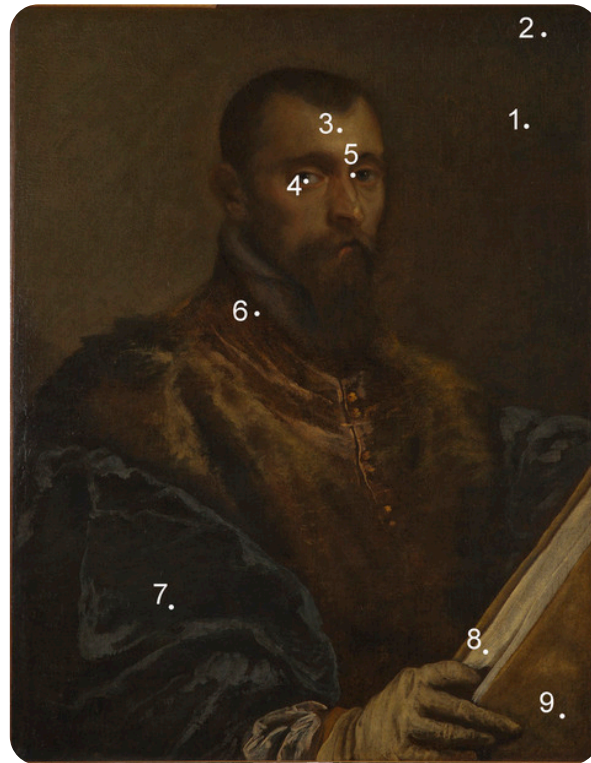
XRF analysis (tech. fig. 4, table 1) indicates that lead white and iron oxide (earth pigments) were used throughout the painting. Lead white, iron oxide, vermilion, and umber were used for the skin tones. Azurite was used in the blues of the shirt. Significant amounts of old retouching are also present, which accounts for the detection of titanium, zinc, and chromium that suggest the use of titanium white, zinc white, and possibly chrome yellow. The background, in particular, has significant amounts of retouching covering previous damages.

Technical Figure 4: Locations of XRF readings. Attributed to Leandro Bassano, *Portrait of a Man*, about 1590–1600, Indianapolis Museum of Art at Newfields, The Clowes Collection, 2016.163.

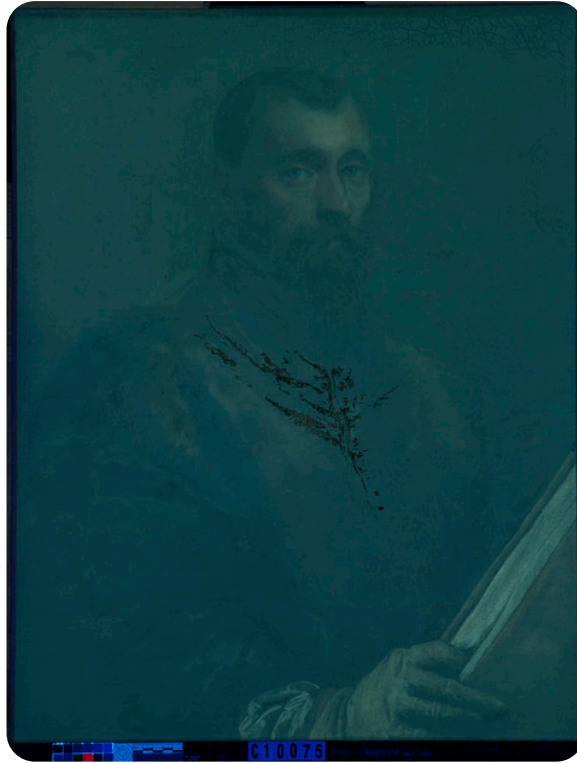
Technical Figure 5: *Portrait of a Man* under ultraviolet-induced visible fluorescence, revealing fluorescence of a natural resin varnish and the most recent campaign of inpainting. Attributed to Leandro Bassano, *Portrait of a Man*, about 1590–1600, Indianapolis Museum of Art at Newfields, The Clowes Collection, 2016.163.

Ultraviolet-induced visible fluorescence reveals that there is a coating of natural resin varnish present over the entire surface of the painting (tech. fig. 5). The varnish appears to be slightly yellowed. There are several campaigns of retouching from an older restoration and inpainting from a more recent campaign. The older campaigns are obscured by the natural resin varnish, and the more recent campaign can be seen in ultraviolet-induced visible fluorescence. A spritzing technique (tech. fig. 6) was used for some of the retouching around the edges and extends into the composition. Paraloid B-72 was applied in 1989 to saturate the colors, even out the previous coating, correct some blooming, and provide protection to the painting. According to the report on file at the IMA, the natural resin varnish is slightly soluble in isopropanol, and readily soluble in acetone.

The natural resin varnish is discolored, imparting a yellowed look to the painting. The varnish no longer saturates the painting adequately.

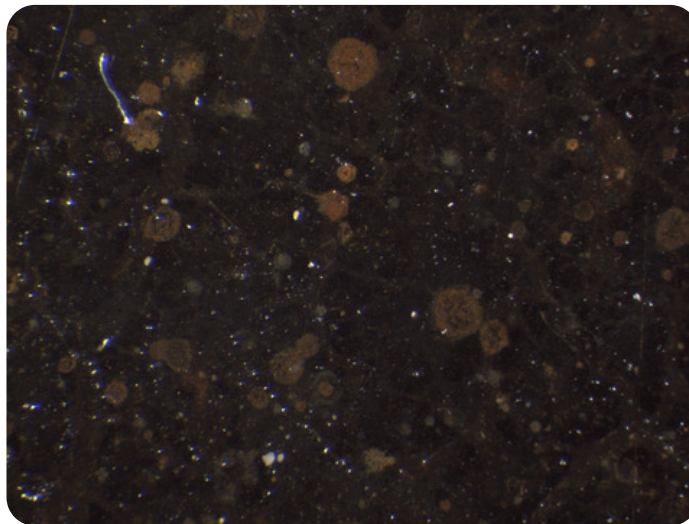
Technical Figure 6: Photomicrograph of retouching applied by spritzing in part of the background. Attributed to Leandro Bassano, *Portrait of a Man*, about 1590–1600, Indianapolis Museum of Art at Newfields, The Clowes Collection, 2016.163.

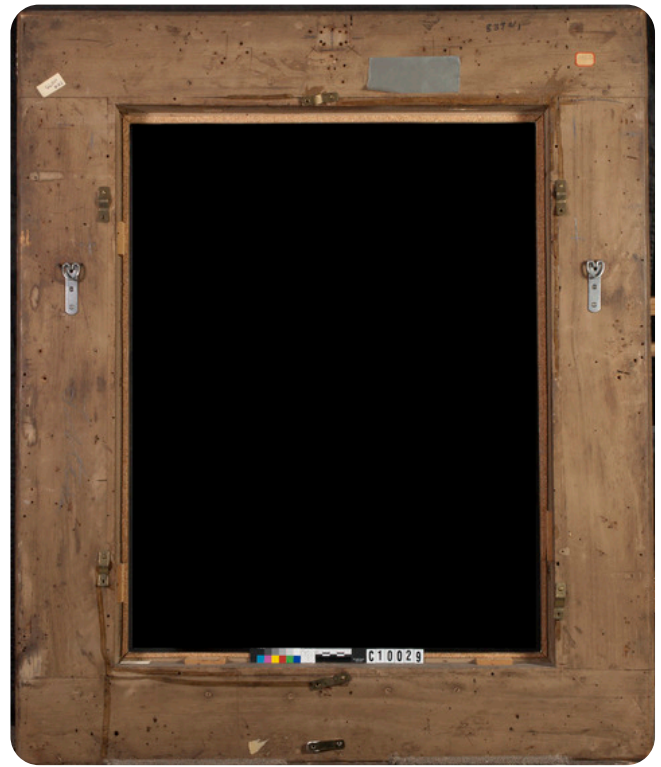
Item 1. White rectangular label with red trim, back, top right corner: "2429/1" (tech. fig. 8).

Item 2. Black marker, back, top right: "839#1"(tech. fig. 8).

Item 3. White rectangular label, back, top left corner: "TR#10075"(tech. fig. 8).

Item 4. Writing in pencil, back, left member, illegible (tech. fig. 8).

Some adjustments were made to the frame, including the trimming of the sight edge and the addition of a small, hollow molding. The red background of the frieze was painted over with a gray-brown paint. An oak backing with butt joined planks was applied to reinforce the structure of the frame (tech. fig. 8).

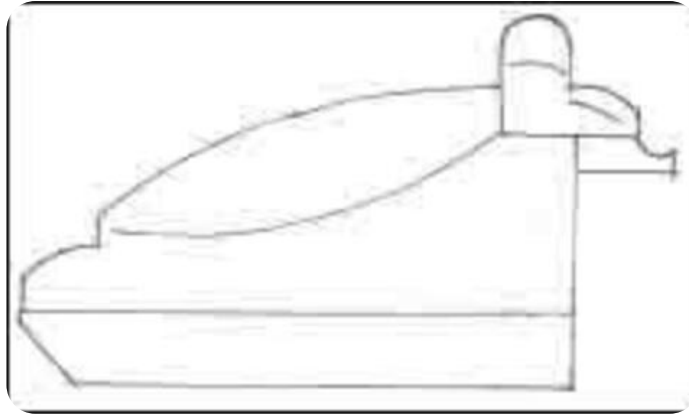
According to frame specialist Timothy Newbery, the frame is from the eighteenth century and originates in northern Spain. The frame is miter-lapped, carved, and gilded. The sight edge is decorated with egg-and-dart trim, while the outside edge portrays fluted leaves from the center (tech. fig. 9). The frieze is sloped. At the center of each member are patera, which are surrounded by cauliculi extending to the corners (tech. fig. 7). The ornamentation has raking leaves with rocaille-style decorations.² The original gilding, the rocaille, and the manner of frieze carving indicate the frame is of the Rococo period.

Technical Figure 9: Frame profile, as drawn by Timothy Newbery. Attributed to Leandro Bassano, *Portrait of a Man*, about 1590–1600, Indianapolis Museum of Art at Newfields, The Clowes Collection, 2016.163.
