#### TECHNICAL EXAMINATION REPORT

### **Adoration of the Christ Child**

#### **Workshop of Bastiano Mainardi**

2015.30

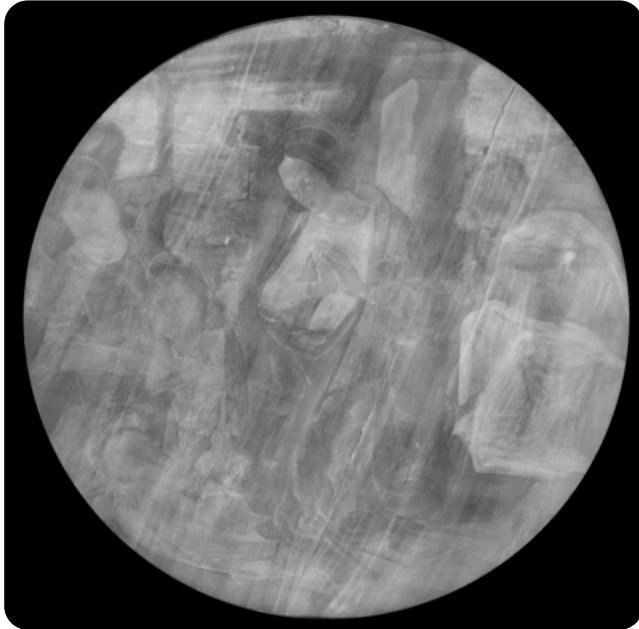
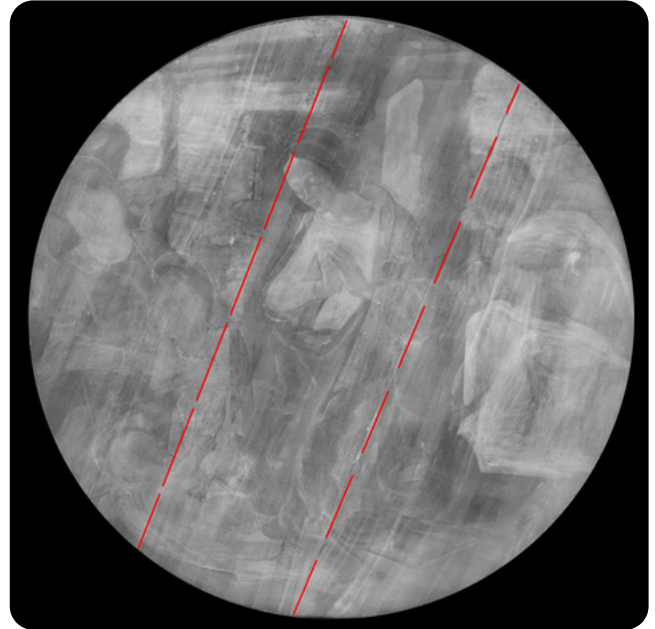
**Technical Figure. 1:** Overlay of X-radiograph with diagram showing red lines along the panel joins. Workshop of Bastiano Mainardi, *Adoration of the Christ Child*, 1490–1500, Indianapolis Museum of Art at Newfields, The Clowes Collection, 2015.30.

The painting is a circular (tondo) panel composed of three wood planks with the grain on a diagonal in relation to the orientation of the painting composition (tech. fig. 1). All three members of the panel are cut in slightly varying tangential orientations. It is impossible to see the joins from the back of the panel due to a large cradle that is covered with a thick wax coating. A layer of canvas is visible at the edges of the painting, suggesting the canvas is present over the seams, which is consistent with fifteenth-century Italian panel-preparation techniques. The wood was identified as *Salicaceae*, willow/poplar type, which was common in Italian painting materials of the period.<sup>5</sup>

The panel is constructed from three members, joined by glue (likely casein or animal glue) (tech. fig. 1). The panel would have been sized, and a layer of fabric added to the seams—some of the thin fabric can be seen along the painting's edges, with layers of gesso applied on top.

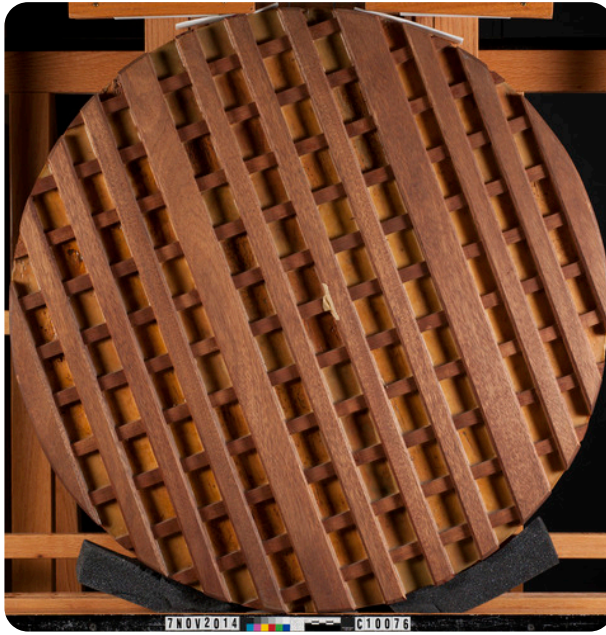
**Technical Figure 2:** Back showing the auxiliary support. Workshop of Bastiano Mainardi, *Adoration of the Christ Child*, 1490–1500, Indianapolis Museum of Art at Newfields, The Clowes Collection, 2015.30.

The cradle has 12 fixed members and 11 movable members, which were immobilized by the application of a thick coating of a waxy substance (~0.3 cm) (tech. fig. 2). The cradle is fitted to the panel in the same orientation as the wood grain, resulting in a diagonal orientation when the painting is viewed upright. On the areas of the joins, larger cradle battens are used than those in the rest of the cradle, likely to provide more support in these areas.

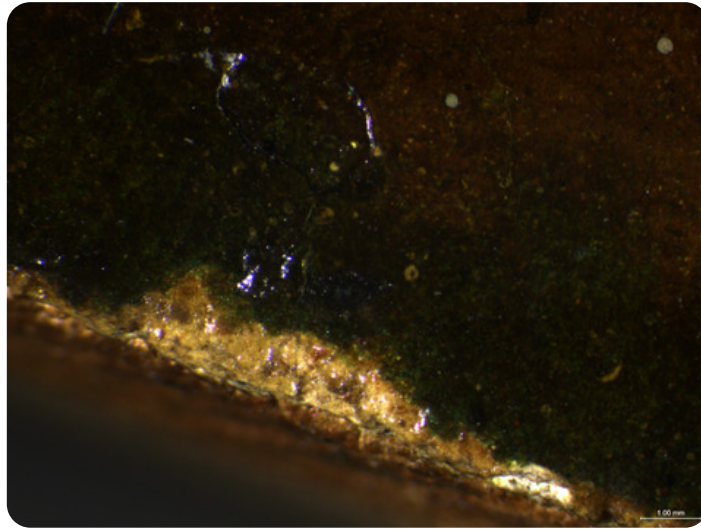
**Technical Figure 7:** Photomicrograph showing the original ground layer. Workshop of Bastiano Mainardi, *Adoration of the Christ Child*, 1490–1500, Indianapolis Museum of Art at Newfields, The Clowes Collection, 2015.30.

The ground is an off-white color where visible in the cracks and edges of the panel and seems to have slightly yellowed over time (tech. fig. 7).

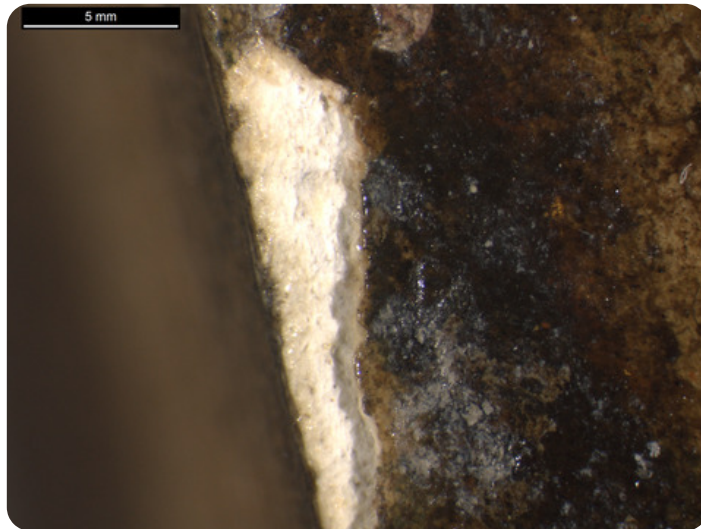
**Technical Figure 8:** Photomicrograph of white fill in ground layer. Workshop of Bastiano Mainardi, *Adoration of the Christ Child*, 1490–1500, Indianapolis Museum of Art at Newfields, The Clowes Collection, 2015.30.

In fills that were added to areas of loss around the panel edges, the ground appears to be bright white (tech. fig. 8).

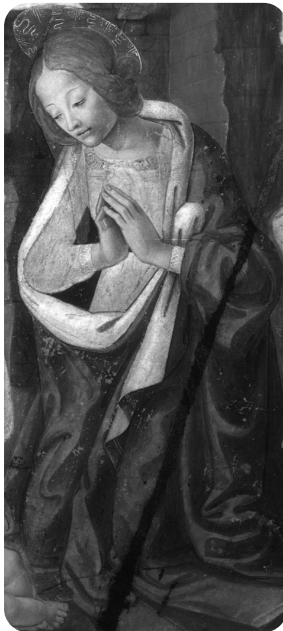
**Technical Figure 13:** Detail of the Madonna's robe in infrared reflectography showing extensive details in the robe that are no longer visible. Workshop of Bastiano Mainardi, *Adoration of the Christ Child*, 1490–1500, Indianapolis Museum of Art at Newfields, The Clowes Collection, 2015.30.

The compromised condition of the painting and heavily retouched surface make it difficult to determine details of the original painting technique. For instance, complex folds of drapery in the Madonna's robe are visible in the infrared reflectogram (tech. fig. 13), but have been completely obscured by layers of varnish, overpaint, and retouching (tech. fig. 14).

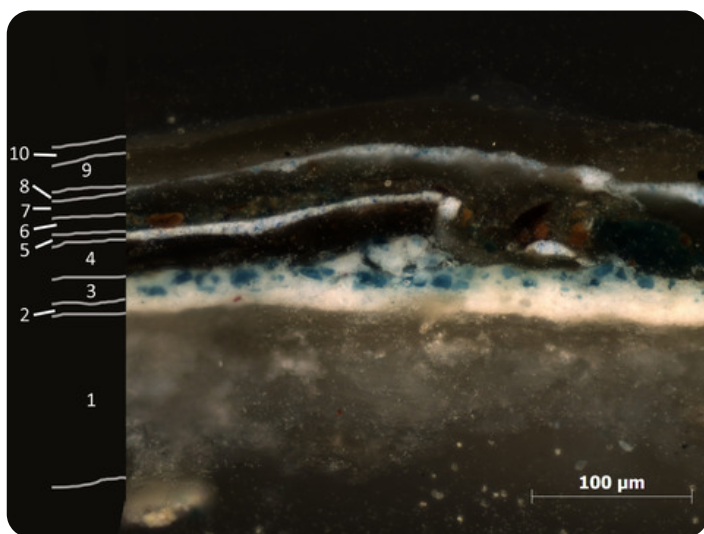
**Technical Figure 19:** Cross section 2, visible light showing original paint layer with layers of overpaint. Workshop of Bastiano Mainardi, *Adoration of the Christ Child*, 1490–1500, Indianapolis Museum of Art at Newfields, The Clowes Collection, 2015.30.

The sky has been repainted several times (see [Condition of Paint](#)). Cross section 2 (tech. fig. 19) shows the original paint layer composed of a lead *imprimatura* (layer 2) followed by a mixture of azurite and lead white (layer 3, tech. fig. 20). Larger passages of red appear to have been painted with red lead or red lake pigments. Umber was also used throughout the painting and particularly in the brown foreground.

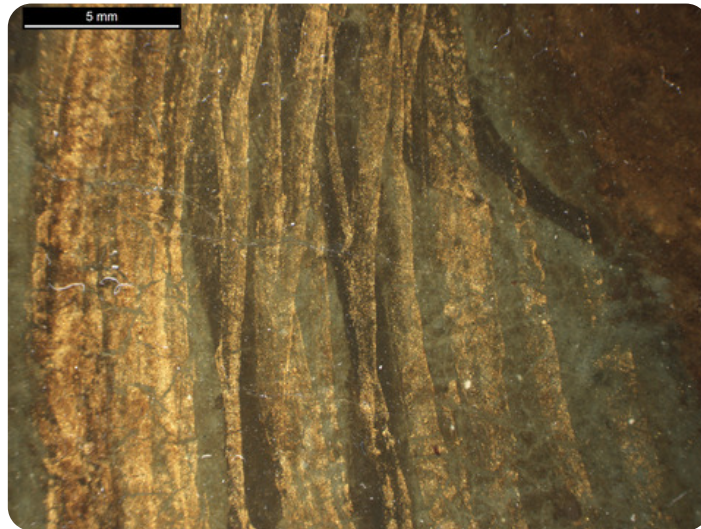
**Technical Figure 22:** Photomicrograph of gold overpaint in halo of the Joseph figure. Workshop of Bastiano Mainardi, *Adoration of the Christ Child*, 1490–1500, Indianapolis Museum of Art at Newfields, The Clowes Collection, 2015.30.

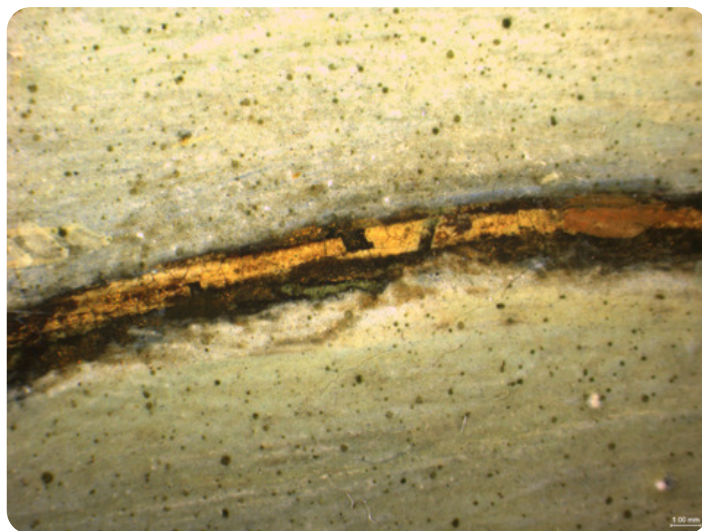
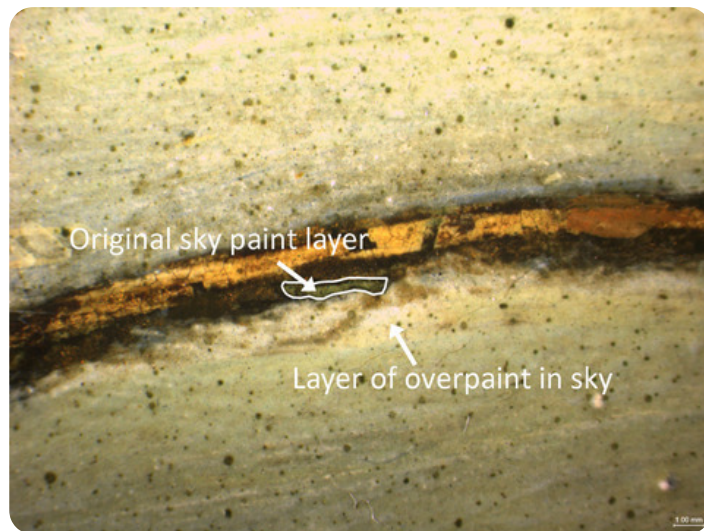
The layers of overpaint were applied using a brushy technique around elements of the foreground and figures, such as Joseph's halo (tech. fig. 27). The light blue overpaint obscures the original sky layer, which can be seen peeking through (tech. fig. 28). It is unclear why this large-scale overpainting was carried out. The X-radiograph suggests there are several damages in the sky (tech. fig. 1), such as along the panel join, that may have prompted an overly aggressive repainting rather than carefully matching the color of the original layer of aged azurite.

**Technical Figure 27:** Overlay of photomicrograph showing the overpaint in the sky applied around Joseph's halo with annotations (right-hand part of slider). Workshop of Bastiano Mainardi, *Adoration of the Christ Child*, 1490–1500, Indianapolis Museum of Art at Newfields, The Clowes Collection, 2015.30.

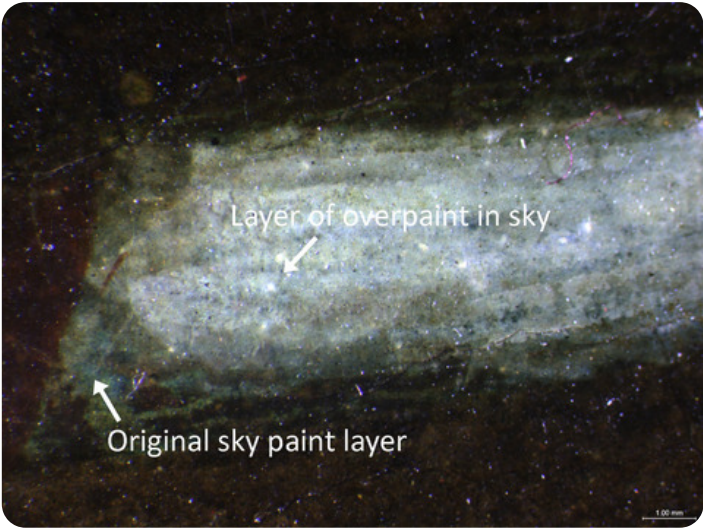
**Technical Figure 28:** Photomicrograph showing the cool overpaint in the sky with the greenish-blue original sky beneath. Workshop of Bastiano Mainardi, *Adoration of the Christ Child*, 1490–1500, Indianapolis Museum of Art at Newfields, The Clowes Collection, 2015.30.

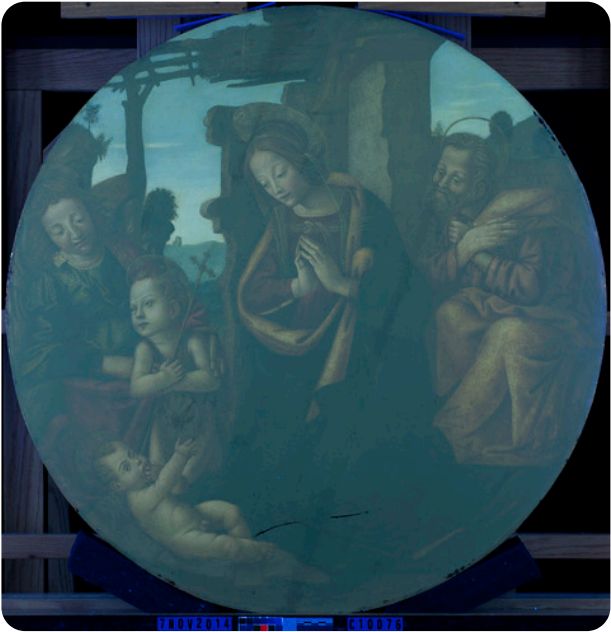
**Technical Figure 29:** Ultraviolet-induced visible fluorescence, depicting greenish fluorescence of a natural resin varnish. Workshop of Bastiano Mainardi, *Adoration of the Christ Child*, 1490–1500, Indianapolis Museum of Art at Newfields, The Clowes Collection, 2015.30.

Ultraviolet-induced visible fluorescence reveals a thick coating of discolored varnish present over the surface of the painting (tech. fig. 29). The varnish was analyzed using FTIR, and the upper layer of varnish (tech. fig. 30, layer 10) was found to be a synthetic acrylic resin varnish. The FTIR spectrum from the lower layer of varnish (tech. fig. 30, layer 9) identified [linseed oil](#) with the addition of small components of dammar varnish, suggesting the application of an earlier oleo-resinous varnish.

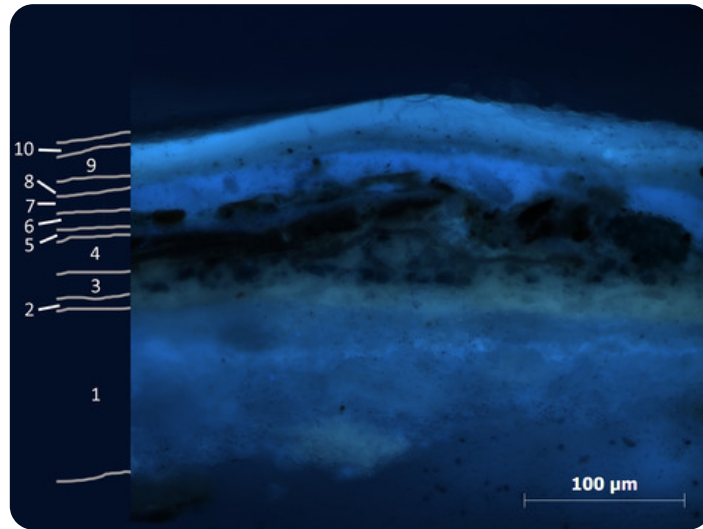
**Technical Figure 30:** Cross section 2, ultraviolet-induced visible fluorescence showing varnish and paint layers. Workshop of Bastiano Mainardi, *Adoration of the Christ Child*, 1490–1500, Indianapolis Museum of Art at Newfields, The Clowes Collection, 2015.30.

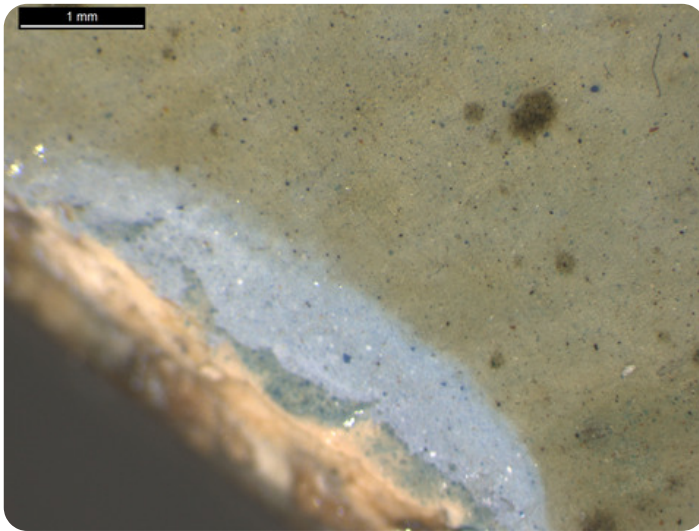
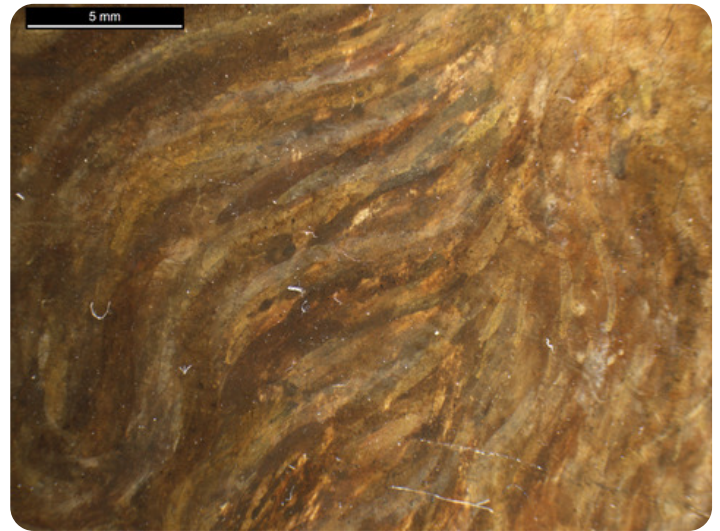
**Technical Figure 31:** Photomicrograph of yellowed varnish worn away at the painting's edge. Workshop of Bastiano Mainardi, *Adoration of the Christ Child*, 1490–1500, Indianapolis Museum of Art at Newfields, The Clowes Collection, 2015.30.
