TECHNICAL EXAMINATION REPORT

Landscape with Hermit

Circle of Jan Wellens de Cock

2017.84

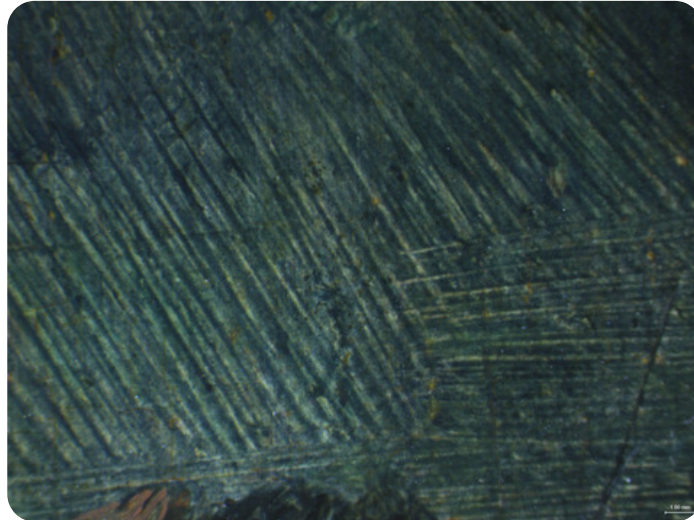
The composition was blocked in first with a dilute, washy application of paint using a wide, coarse brush. This is visible in the rock, sky, and water. The lines created from the coarse brush hairs are visible through the painting, especially in the sky. Technical figure 4 shows the hatched application of the thin, blue paint in the sky.

Technical Figure 4: Photomicrograph showing the brushy application of the paint in the sky. Circle of Jan Wellens de Cock, *Landscape with Hermit*, early 1500s, Indianapolis Museum of Art at Newfields, The Clowes Collection, 2017.84.

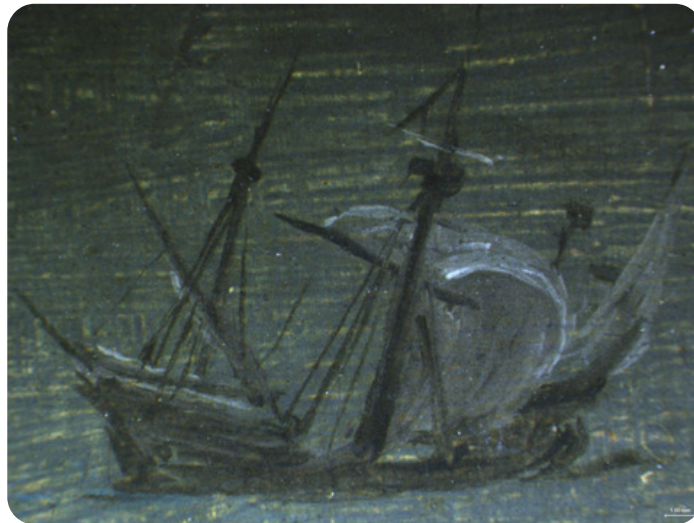
Over the quickly applied blocking-in layer, smaller brushes were used to create minute scenes with a higher level of detail. Technical figure 5 shows the careful depiction of a ship using tiny brushes applied over the thin, brushy application of the water. It is possible that the blocking in of the composition was carried out by one member of the workshop, and the finer details were applied by another hand entirely. The tree in the foreground extends over the mountainous rock suggesting the tree may have been added later by a different member of the workshop, perhaps the person responsible for painting the scene with the hermit.

Technical Figure 5: Photomicrograph of the ship. Circle of Jan Wellens de Cock, *Landscape with Hermit*, early 1500s, Indianapolis Museum of Art at Newfields, The Clowes Collection, 2017.84.

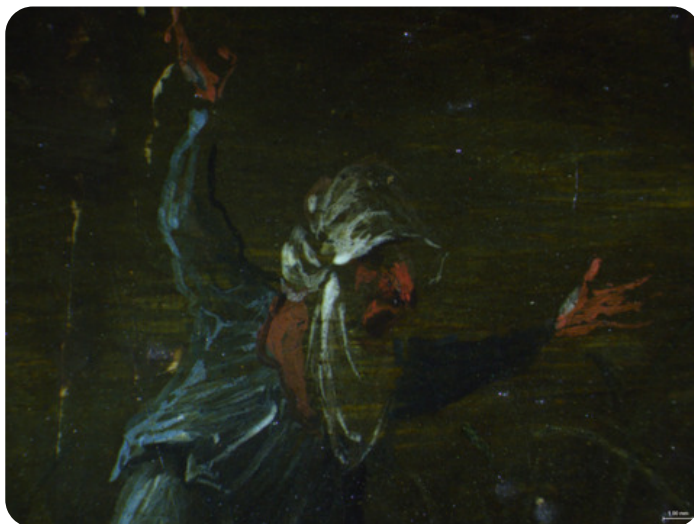
The figures are applied in thick dabs of paint in a loose, expressive style using small brushes (tech. fig. 6).

Technical Figure 6: Photomicrograph of the figure. Circle of Jan Wellens de Cock, *Landscape with Hermit*, early 1500s, Indianapolis Museum of Art at Newfields, The Clowes Collection, 2017.84.

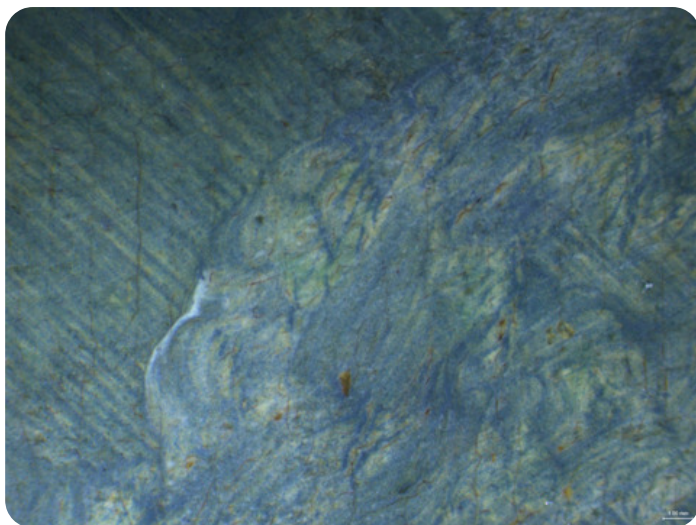
In some areas, such as the clouds and landscape, more texture is added by dragging the paint, possibly with a finger or another blunt instrument (tech. figs. 7, 8).

Technical Figure 7: Photomicrograph of clouds in the sky. Circle of Jan Wellens de Cock, *Landscape with Hermit*, early 1500s, Indianapolis Museum of Art at Newfields, The Clowes Collection, 2017.84.

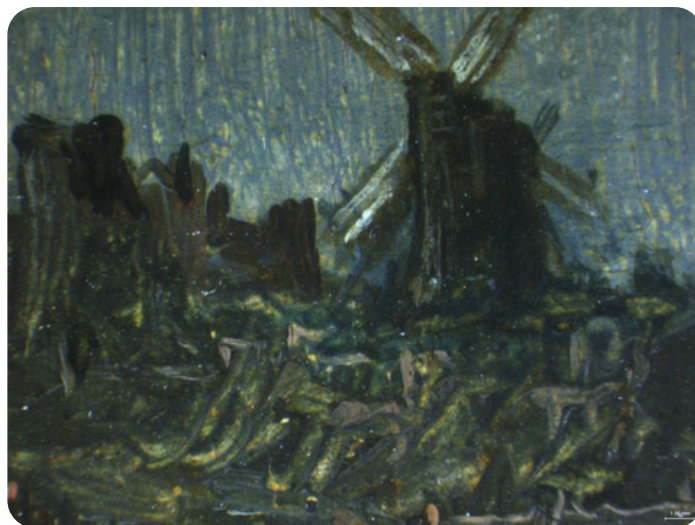
Technical Figure 8: Photomicrograph of the paint application using a blunt instrument. Circle of Jan Wellens de Cock, *Landscape with Hermit*, early 1500s, Indianapolis Museum of Art at Newfields, The Clowes Collection, 2017.84.

Numerous tools were used to create this small painting, including large coarse brushes, small detail brushes, and fingers or another blunt instrument for dabbing and scratching into the paint (tech. figs. 7, 8).

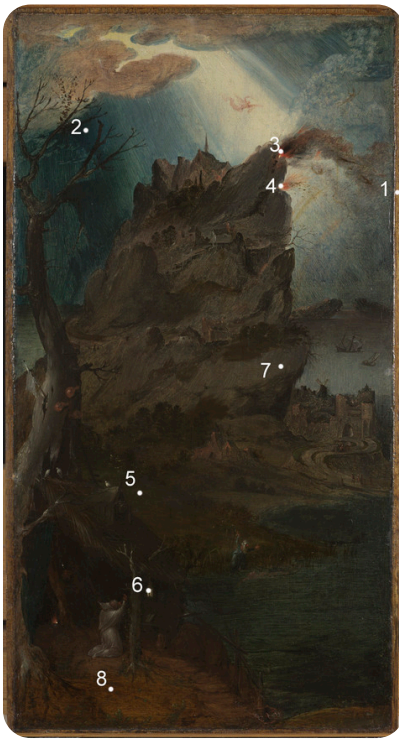
Technical Figure 9: XRF sample locations. Circle of Jan Wellens de Cock, *Landscape with Hermit*, early 1500s, Indianapolis Museum of Art at Newfields, The Clowes Collection, 2017.84.

Sample	Location	Elements	Possible Pigments
1	Ground	Major: Ca, Pb Minor: Trace: Fe	Calcium-containing ground, lead white, trace of iron oxide (earth pigments)
2	Blue sky	Major: Cu Minor: Pb Trace: Ca, Fe	Copper-containing blue pigment (azurite), lead white, trace of calcium-containing ground layer, trace of iron oxide (earth pigments)
3	Red fire	Major: Hg, Pb Minor: Cu Trace: Ca, Fe	Vermilion, copper-containing blue pigment (azurite), lead white, calcium-containing ground layer, trace of iron oxide (earth pigments including umber)
4	Yellow fire	Major: Pb, Hg Minor: Sn Trace: Ca, Cu	Lead white, vermilion, lead-tin yellow, trace of copper-containing green and/or blue pigment, trace of calcium from ground layer,
5	Green grass in the midground	Major: Pb, Cu Minor: Cu Trace: Hg, Fe, Sn	Lead white, copper-containing green and/or blue pigment, calcium from ground layer, trace of iron oxide (earth pigments), trace of vermilion, trace of lead-tin yellow.

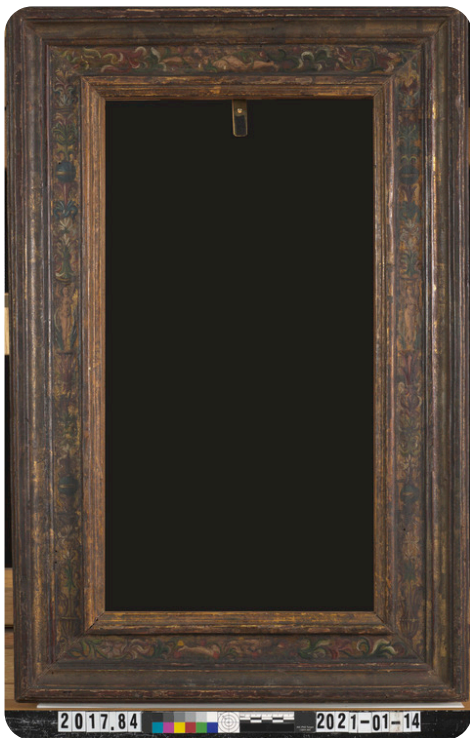
The frame is in acceptable condition. The structure is sound, but there are some losses to the gilding and abrasion to the painted surface.

Frame for *Landscape with Hermit*, 65.6 × 43 cm, front, visible light, Indianapolis Museum of Art at Newfields, The Clowes Collection, 2017.84.
