TECHNICAL EXAMINATION REPORT

Madonna and Child

Badia a Isola Master

2009.52

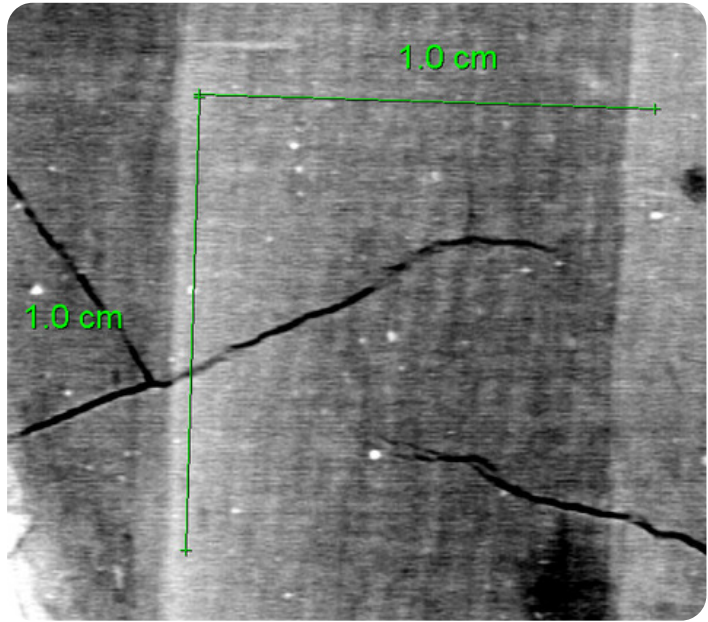
A finely woven, plain-weave canvas (approximately 18×17 threads/cm) (tech. fig. 6) covers the panel and frame. Examination of the top edge of the panel suggests the canvas extends under the carved component of the wooden frame and wraps around the top edge of the panel. The engaged component of the frame appears to have been separately covered with canvas. An additional section of canvas was added to the frame addition, in keeping with the Italian fabrication methods that would have been used when the panel was first created (see tech. fig. 2). This added section of canvas also wraps around the outer edges of the engaged frame and was clearly added during a conservation campaign. Along the edges, the canvas that was added later appears to have a white gesso layer and a brown layer of opaque, matte oil paint. This masks other indications of the frame's construction.

Technical Figure 6: Thread count of original canvas layer applied to the panel, as seen in the X-radiograph detail. Badia a Isola Master, *Madonna and Child*, about 1300–1310, Indianapolis Museum of Art at Newfields, The Clowes Collection, 2009.52.

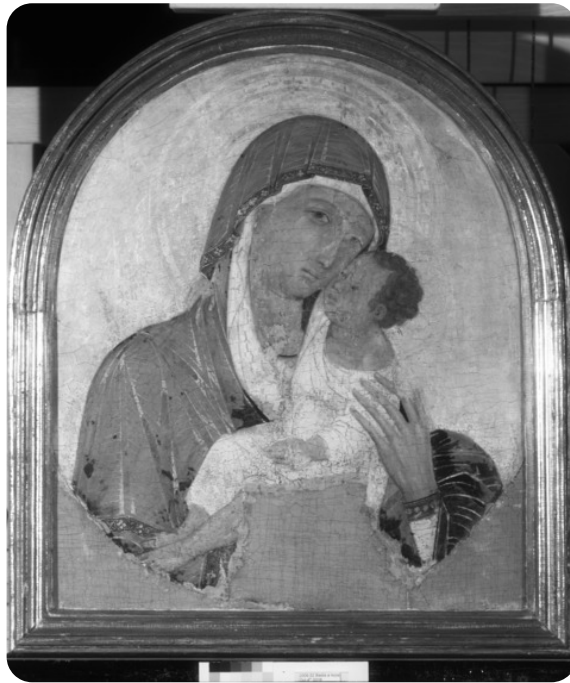
Technical Figure 12: Infrared reflectogram. Badia a Isola Master, *Madonna and Child*, about 1300–1310, Indianapolis Museum of Art at Newfields, The Clowes Collection, 2009.52.

There appears to be some outlining in a fluid carbon-containing medium around the Madonna's figure (tech. fig. 12). Some smaller dots are present along some of the clothing folds but not with enough consistency to indicate the use of pouncing from a cartoon transfer. The devotional Madonna and Child composition was a very common subject in thirteenth-century Italian artwork, and while there is no direct evidence of the artist working from a design, it is highly likely that this method was employed. It would have also been necessary to plan where the gold leaf would be applied, as these areas were typically covered initially with several layers of red bole. Notably, there are no visible incision lines delineating the edge of the water gilding and paint layer as are often found on paintings of this period.⁵

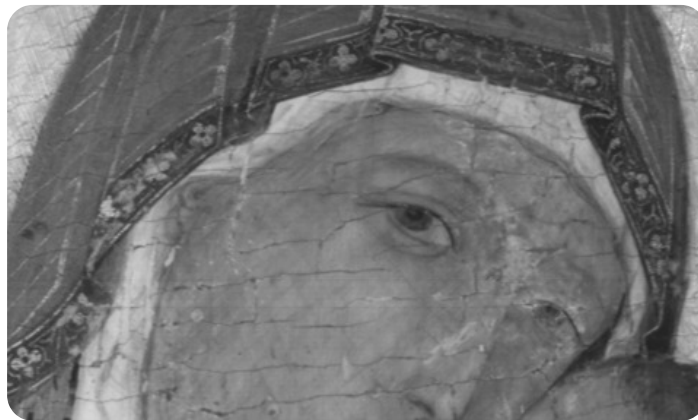
No pentimenti are visible in the painting using IRR; however, minor outlines and adjustments are visible along the contours of the Madonna's face and drapery (tech. fig. 13), as well as in the feet of the Christ child.

Technical Figure 13: Detail from the infrared reflectogram of minor outlines and adjustments in the contours of the Madonna's face. Badia a Isola Master, *Madonna and Child*, about 1300–1310, Indianapolis Museum of Art at Newfields, The Clowes Collection, 2009.52.

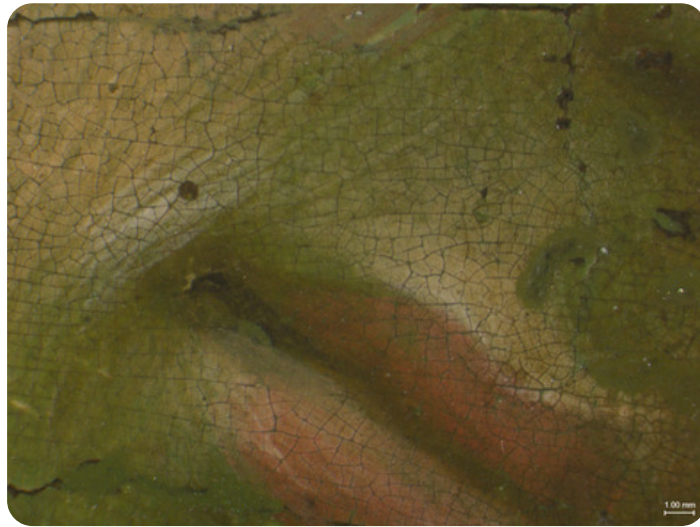
The paint for the skin was applied using small linear brushstrokes (tech. fig. 16), typical of egg tempera painting. Shades of pink were applied in thin, delicate brushstrokes to create form in the faces and hands. Bright white highlights are present at the corner of the Madonna's mouth and along the top of her lip (tech. fig. 17).

Technical Figure 17: Photomicrograph of the Madonna's lips showing the verdaccio layer and white highlights at the corner of her mouth. Badia a Isola Master, *Madonna and Child*, about 1300–1310, Indianapolis Museum of Art at Newfields, The Clowes Collection, 2009.52.

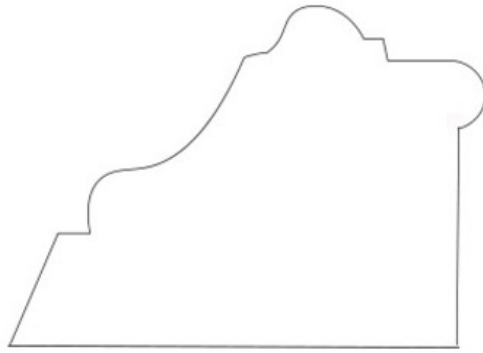
The painting has an engaged frame that appears to be partly original and partly a later addition (see the [Description of Support](#)). Examination of the back of the painting reveals the upper arch of the frame appears to be original; it is pictured in an early photograph of the painting before the additions were made (tech. fig. 1). The frame is carved wood that has been covered in gesso with red bole and water gilding. The additions closely match the profile of the original frame (tech. fig. 25).

Technical Figure 25: Diagram showing the profile of the frame. Badia a Isola Master, *Madonna and Child*, about 1300–1310, Indianapolis Museum of Art at Newfields, The Clowes Collection, 2009.52.
