TECHNICAL EXAMINATION REPORT

Portrait of a Man

Attributed to Leandro Bassano

2016.163

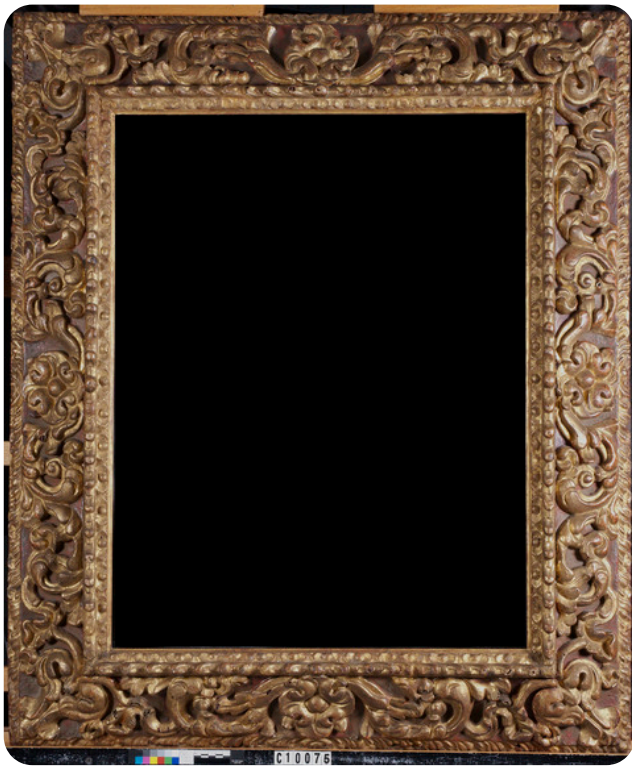
Technical Figure 7: Frame, front. Attributed to Leandro Bassano, *Portrait of a Man*, about 1590–1600, Indianapolis Museum of Art at Newfields, The Clowes Collection, 2016.163.

The frame is in stable condition; however, it has suffered from woodworm damage in the past, and many areas of the frame show woodworm holes. The top edge detached in the past, and the entire frame was built up with wood to strengthen it.

Newbery recommended repairing the break under the top edge molding and the integration of additional sight molding.

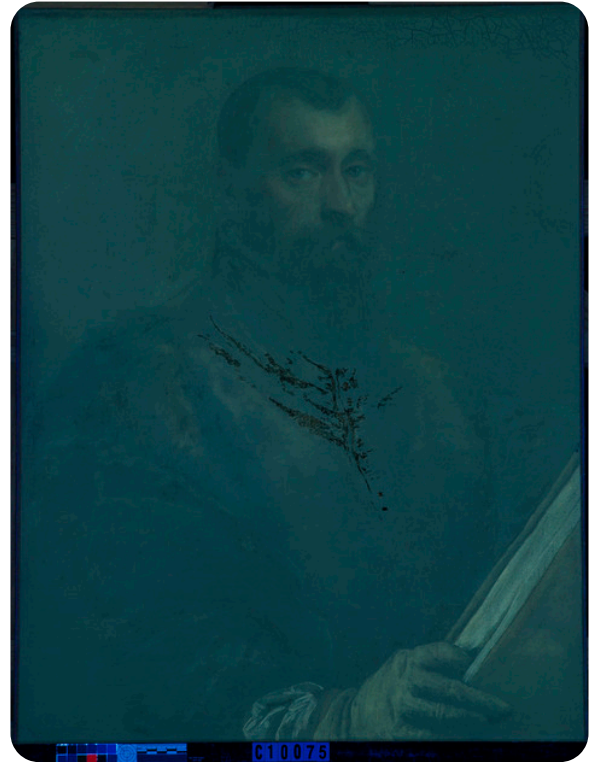
The painting was treated shortly after entering the possession of Dr. Clowes. Two early treatments took place in 1941 by Anthony Ripportella,¹ and letters between Dr. Clowes and William Suhr suggest that Suhr treated the painting in 1955–56.² The canvas has what appears to be a twentieth-century glue [lining](#), perhaps performed during one of these treatments, and evidence of [retouching](#) is visible in ultraviolet-induced visible fluorescence.

Attributed to Leandro Bassano (Italian, 1557–1622), *Portrait of a Man*, about 1590–1600, oil on canvas, 75.5 × 58.2 cm, front, ultraviolet-induced visible fluorescence, Indianapolis Museum of Art at Newfields, The Clowes Collection, 2016.163.

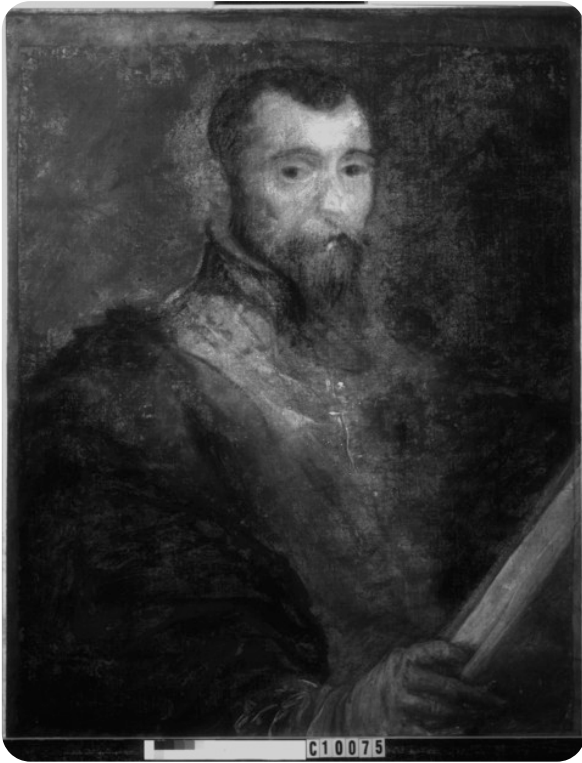
No pentimenti are discernible (tech. fig. 3). Some slight adjustments and reinforcements of the figure using paint are present, for example in the folds of the coat around the neck and in the facial hair. Numerous damages are also visible in the infrared reflectogram, particularly in the background and around the head of the figure. Additionally, there are some wavy lines visible in the X-radiograph that appear to be painted with lead white on the proper right near the figure's head. These do not correspond to the composition, and the reason for their presence is unclear. The original edge of the canvas is visible in the reflected infrared image, and it is apparent that the canvas was quite damaged, especially at the top edge where holes and tears are present.

Attributed to Leandro Bassano (Italian, 1557–1622), *Portrait of a Man*, about 1590–1600, oil on canvas, 75.5 × 58.2 cm, front, infrared reflectography, Indianapolis Museum of Art at Newfields, The Clowes Collection, 2016.163.

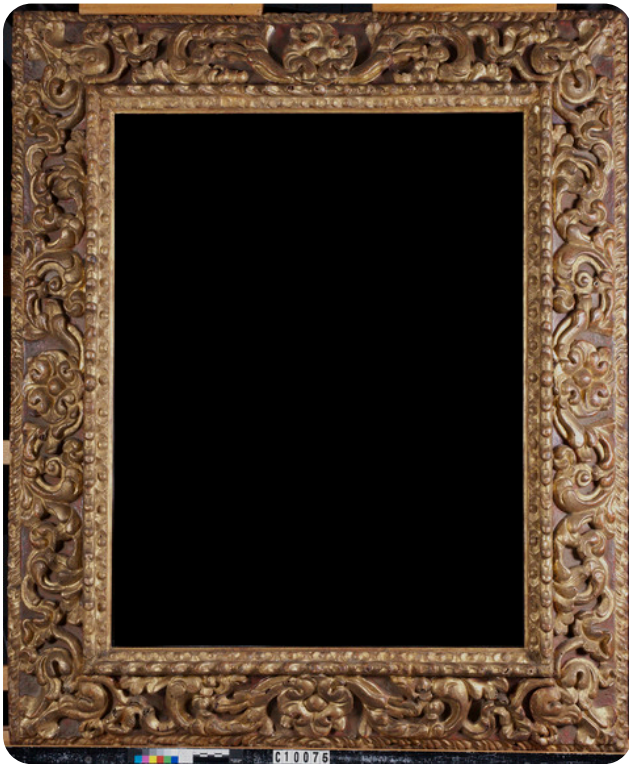
Frame for *Portrait of a Man*, 104 × 87.5 cm, front, visible light, Indianapolis Museum of Art at Newfields, The Clowes Collection, 2016.163.
