#### TECHNICAL EXAMINATION REPORT

### **Adoration of the Christ Child**

#### **Workshop of Bastiano Mainardi**

2015.30

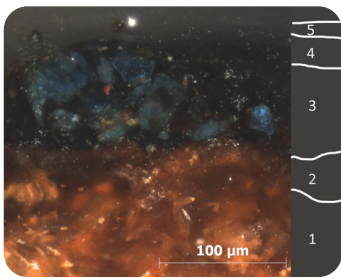
A [cross section](#) of the ground (tech. fig. 3) was analyzed using SEM-EDS. The composition of the ground was confirmed to be calcium sulfate (tech. figs. 5, 6). The use of calcium sulfate (gesso) is consistent with Italian paintings of this period.

**Technical Figure 3:** Cross section 1, visible light. Workshop of Bastiano Mainardi, *Adoration of the Christ Child*, 1490–1500, Indianapolis Museum of Art at Newfields, The Clowes Collection, 2015.30.

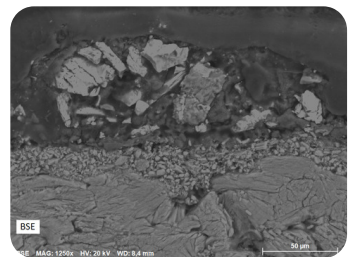
**Technical Figure 6:** Cross section 1, BSE with the elemental distribution of sulfur in green. Workshop of Bastiano Mainardi, *Adoration of the Christ Child*, 1490–1500, Indianapolis Museum of Art at Newfields, The Clowes Collection, 2015.30.

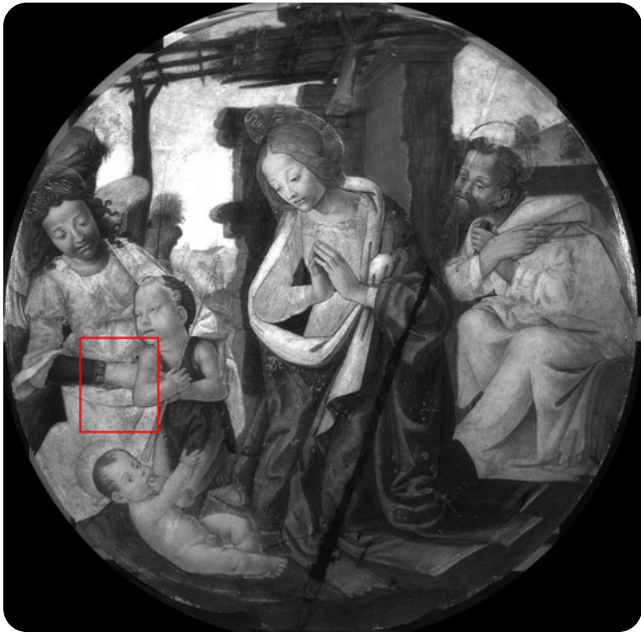
Underdrawing is present throughout the painting and indicates that the composition was planned deliberately (tech. fig. 9). Small hatching lines executed in a dry medium can be seen in the robes of the figures to indicate the location of the fabric folds, while more defined, denser lines are present around the limbs and contours of the figures (tech. fig. 10).

**Technical Figure 9:** Infrared reflectogram showing the location of the detail (tech. fig. 10). Workshop of Bastiano Mainardi, *Adoration of the Christ Child*, 1490–1500, Indianapolis Museum of Art at Newfields, The Clowes Collection, 2015.30.

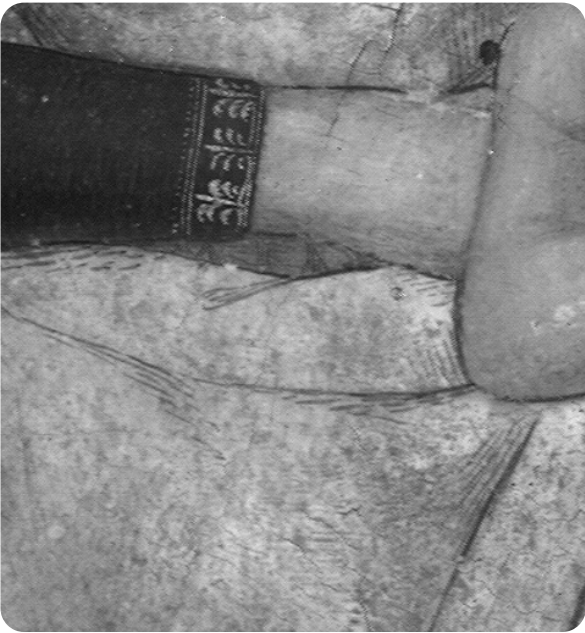
**Technical Figure 10:** Infrared reflectogram detail showing underdrawing executed in a dry medium. Workshop of Bastiano Mainardi, *Adoration of the Christ Child*, 1490–1500, Indianapolis Museum of Art at Newfields, The Clowes Collection, 2015.30.

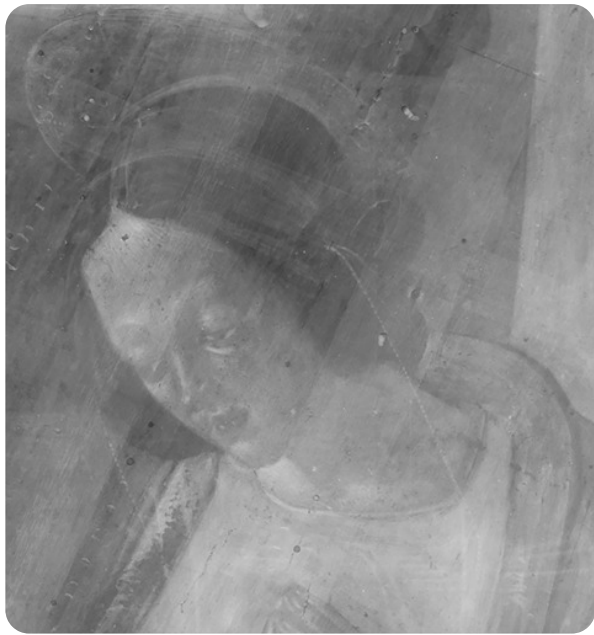
There appears to have been a stylistic change in the Madonna's face during the painting stage. The X-radiograph shows the Madonna's face with full, rosebud lips and round, downturned eyes with heavy eyelids (tech. fig. 11). Her eyes appear to have been slightly lower on her face as well. This style is more consistent with that of the angel on the left side of the panel. The current paint layer does not appear to have been overpainted (although retouching is present) but rather reworked by the artist. This version has upturned eyelids, a wider mouth with thin lips and a square chin (tech. fig. 12).

**Technical Figure 11:** Detail of the Madonna's face in X-radiography. Workshop of Bastiano Mainardi, *Adoration of the Christ Child*, 1490–1500, Indianapolis Museum of Art at Newfields, The Clowes Collection, 2015.30.

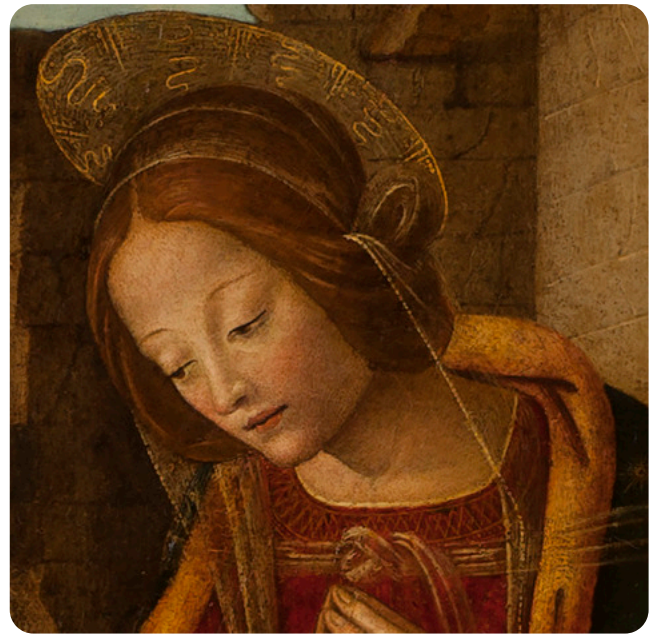
**Technical Figure 12:** Detail of the Madonna's face in visible light. Workshop of Bastiano Mainardi, *Adoration of the Christ Child*, 1490–1500, Indianapolis Museum of Art at Newfields, The Clowes Collection, 2015.30.

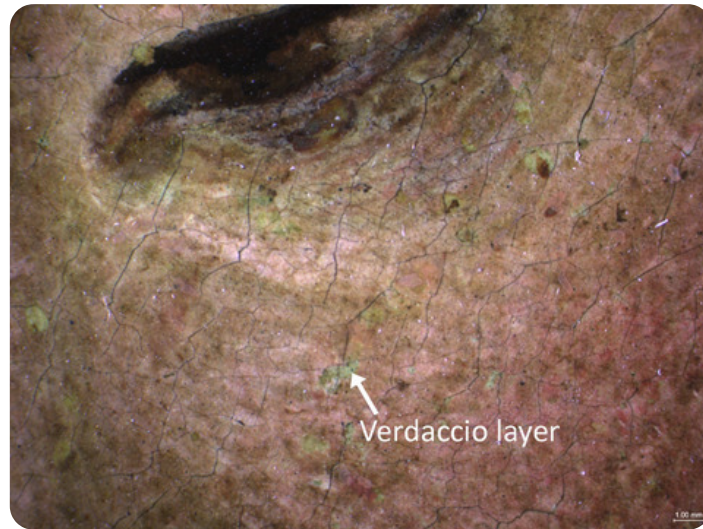
What can be observed of the original painting technique reveals a carefully planned and confidently executed painting, an example of a work that bridges the transition from egg tempera to oil painting. The shadows of the faces are built up over a layer of green verdaccio (tech. fig. 15), typical of early Italian painting technique. The skin tones likely incorporated lake pigments that have faded and become more transparent over time, revealing more of the greenish layer.

**Technical Figure 15:** Photomicrograph of the Madonna's eye showing the *verdaccio* layer under the skin paint. Workshop of Bastiano Mainardi, *Adoration of the Christ Child*, 1490–1500, Indianapolis Museum of Art at Newfields, The Clowes Collection, 2015.30.

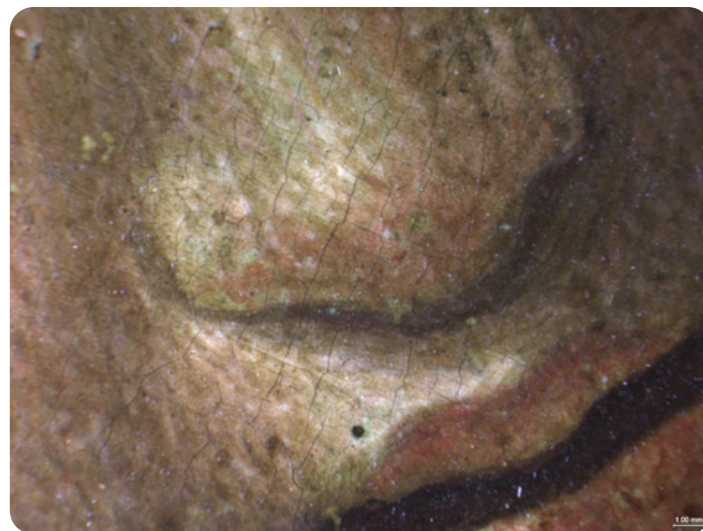
Short, linear brushstrokes, typical of an egg tempera technique, were used to delicately detail the contours of the faces (tech. fig. 16). While most of the faces have endured significant abrasion, the angel's face shows evidence of the original technique where careful manipulation of small strokes of paint applied highlights, midtones, and shadows over a *verdaccio* layer to create form. Less restrained brushwork was used in the drapery, suggesting the possible use of oil paint in these areas. Medium analysis would be necessary to confirm this hypothesis, however the current condition of the work, with layers of later paint, makes such analysis difficult.

**Technical Figure 16:** Photomicrograph of the short brush strokes in the angel's face. Workshop of Bastiano Mainardi, *Adoration of the Christ Child*, 1490–1500, Indianapolis Museum of Art at Newfields, The Clowes Collection, 2015.30.

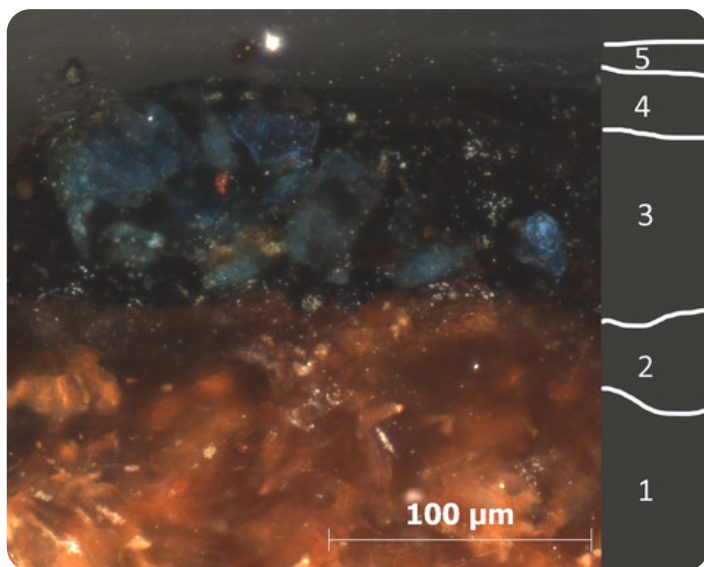
Lead white was used widely throughout the entire painting. For the skin tones, a mixture of lead white, iron oxide (earth pigments likely including yellow ochre and umber), and vermilion were used likely in addition to organic pigments such as red lake that are not detected by XRF. Azurite was used for the blue tones. SEM-EDS analysis of a cross section from the robe of the Madonna (tech. fig. 17) confirms the presence of copper-containing azurite in this area (tech. fig. 18).

**Technical Figure 17:** Cross section 1, visible light. Workshop of Bastiano Mainardi, *Adoration of the Christ Child*, 1490–1500, Indianapolis Museum of Art at Newfields, The Clowes Collection, 2015.30.

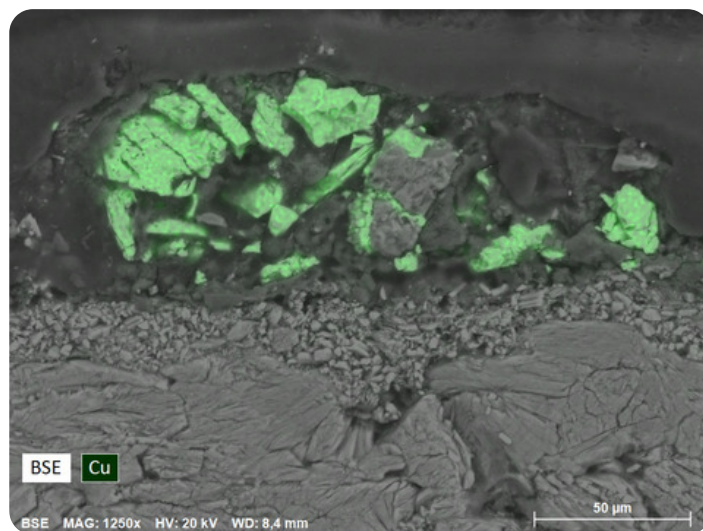
**Technical Figure 18:** Cross section 1, BSE showing the elemental distribution of copper (green) in layer 3. Workshop of Bastiano Mainardi, *Adoration of the Christ Child*, 1490–1500, Indianapolis Museum of Art at Newfields, The Clowes Collection, 2015.30.

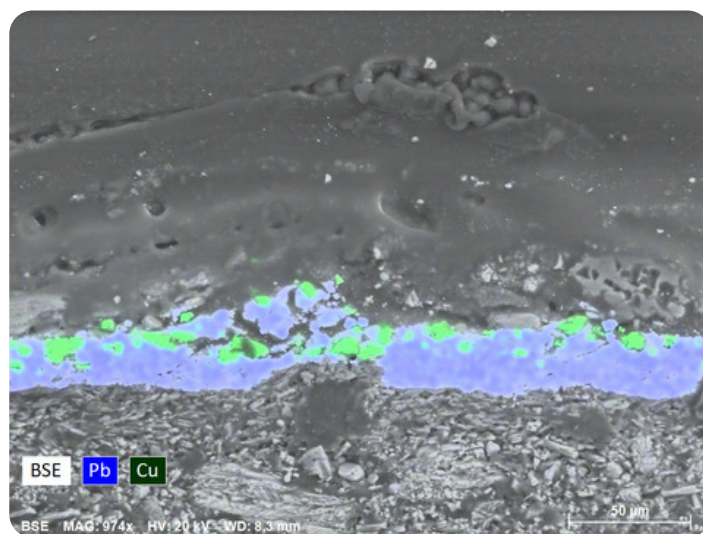
The sky has been repainted several times (see [Condition of Paint](#)). Cross section 2 (tech. fig. 19) shows the original paint layer composed of a lead *imprimatura* (layer 2) followed by a mixture of azurite and lead white (layer 3, tech. fig. 20). Larger passages of red appear to have been painted with red lead or red lake pigments. Umber was also used throughout the painting and particularly in the brown foreground.

**Technical Figure 20:** Cross section 2, BSE showing the elemental distribution of lead (light blue) and copper (green) in layer 3. Workshop of Bastiano Mainardi, *Adoration of the Christ Child*, 1490–1500, Indianapolis Museum of Art at Newfields, The Clowes Collection, 2015.30.

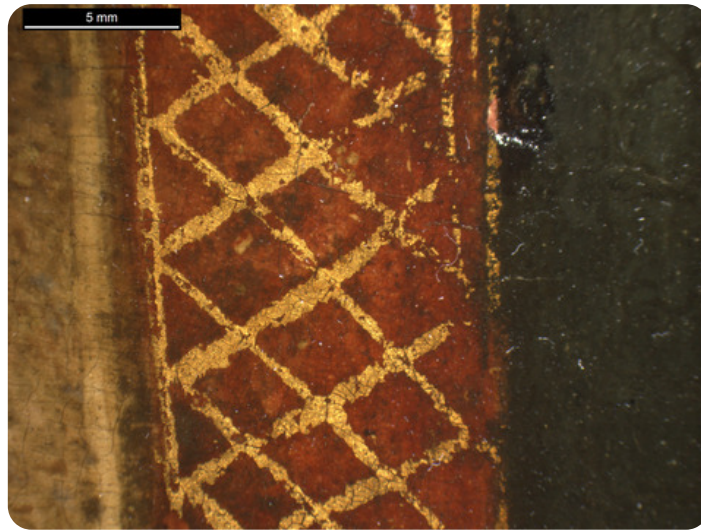
Shell gold was applied in several areas, specifically the halos and decorative elements on the clothes of the Madonna (tech. fig. 21).

**Technical Figure 21:** Photomicrograph of gilding in the Madonna figure's sleeve. Workshop of Bastiano Mainardi, *Adoration of the Christ Child*, 1490–1500, Indianapolis Museum of Art at Newfields, The Clowes Collection, 2015.30.

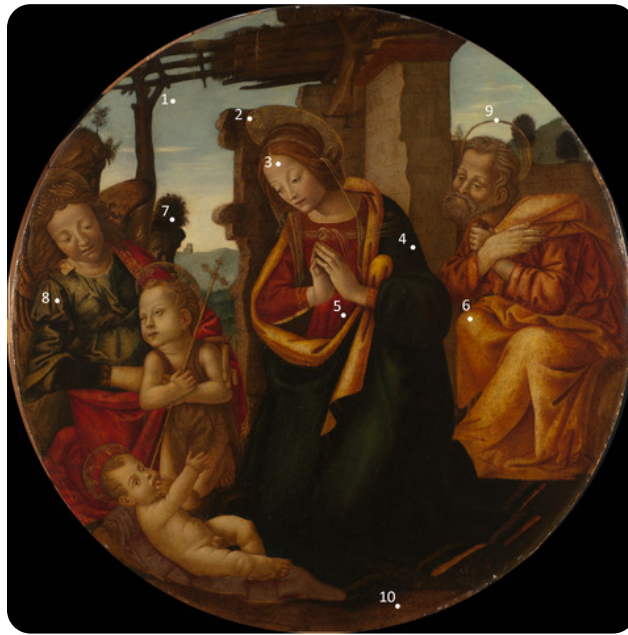
**Technical Figure 23:** XRF sample locations. Workshop of Bastiano Mainardi, *Adoration of the Christ Child*, 1490–1500, Indianapolis Museum of Art at Newfields, The Clowes Collection, 2015.30.

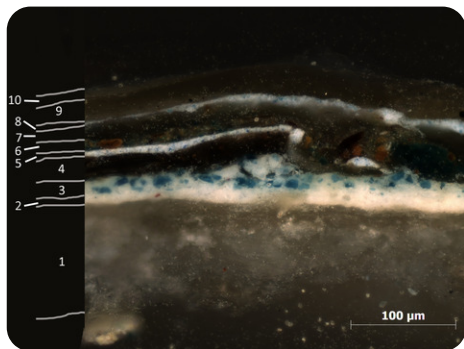
Cross section 2 shows that the sky has been largely repainted several times (tech. fig. 24). Over the original paint layer is a dark layer containing a blue-green particle that is rich in chromium, likely viridian (tech. fig. 25). This suggests the first repainting was applied as early as the second half of the nineteenth century. Two more layers of light blue paint (layers 5, 8) that are rich in titanium (tech. fig. 26) have been applied over this layer, perhaps to “correct” the darker sky with a lighter blue. Titanium white, available by the 1920s, appears to be present in both layers. It is unclear if these layers are from the same overpainting campaign or different campaigns.

**Technical Figure 24:** Cross section 2, visible light showing original paint layer with layers of overpaint, Workshop of Bastiano Mainardi, *Adoration of the Christ Child*, 1490–1500, Indianapolis Museum of Art at Newfields, The Clowes Collection, 2015.30.

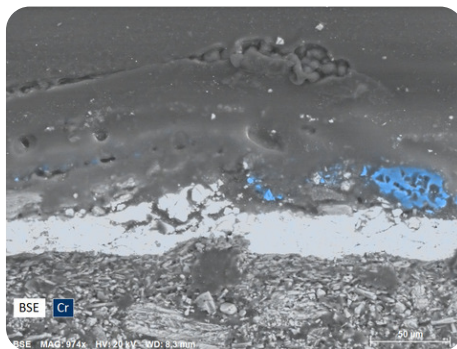
**Technical Figure 25:** Cross section 2, BSE showing the elemental distribution of chromium (dark blue) in layer 4. Workshop of Bastiano Mainardi, *Adoration of the Christ Child*, 1490–1500, Indianapolis Museum of Art at Newfields, The Clowes Collection, 2015.30.

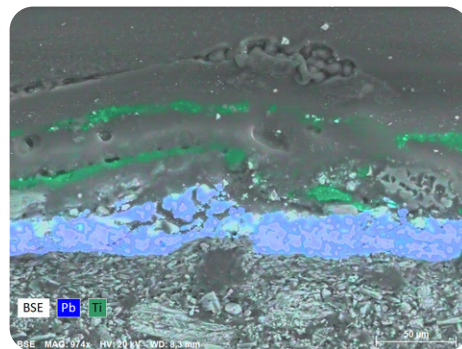
**Technical Figure 26:** Cross section 2, BSE showing the elemental distribution of lead (light blue) in layer 3 and titanium (teal) in layers 5 and 8. Workshop of Bastiano Mainardi, *Adoration of the Christ Child*, 1490–1500, Indianapolis Museum of Art at Newfields, The Clowes Collection, 2015.30.

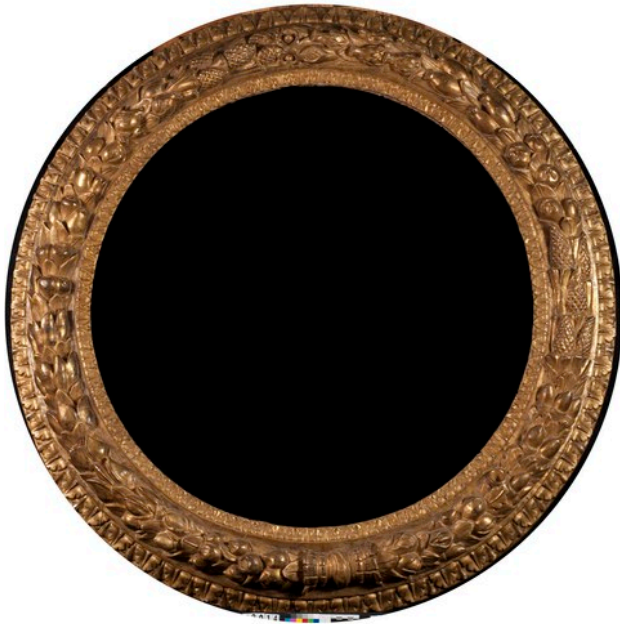
**Technical Figure 33:** Frame, front. Workshop of Bastiano Mainardi, *Adoration of the Christ Child*, Indianapolis Museum of Art at Newfields, The Clowes Collection, 2015.30.

The frame was examined at the IMA by frame specialist Timothy Newbery on 18 January 2012. Newbery suggested that the frame is of Venetian origin and dates from between 1590 and 1600 (tech. fig. 33). It is constructed from poplar and is half-lapped, carved, and gilt. A reddish-orange bole layer is present over the gesso (tech. fig. 33). The top edge has laurel leaves from cross ribbon center to ribbon corners (tech. fig. 40). Star punching is also present on the hollow. The bottom edge portrays a double-twisted ribbon. The frame has been adjusted in the past, including a reduction at the center, and has been backed with a secondary supportive layer of wood (tech. fig. 34).<sup>8</sup>

The frame is in relatively good condition. It was damaged in the past and restored with some areas of bronze paint visible. The frame needs consolidation since some areas of flaking gesso are present. There is significant woodworm damage, and the channeling is particularly noticeable on the back of the frame, which has since been coated and painted with an orange tone.

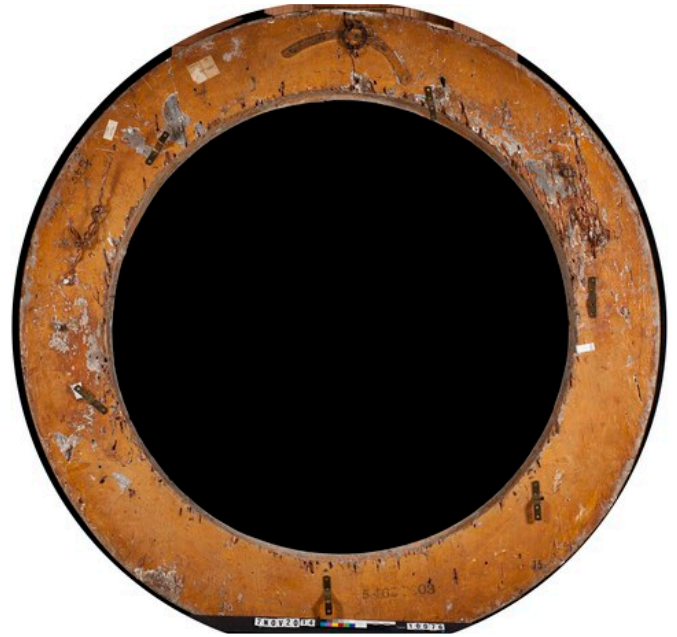
**Technical Figure 34:** Frame, back. Workshop of Bastiano Mainardi, *Adoration of the Christ Child*, Indianapolis Museum of Art at Newfields, The Clowes Collection, 2015.30.

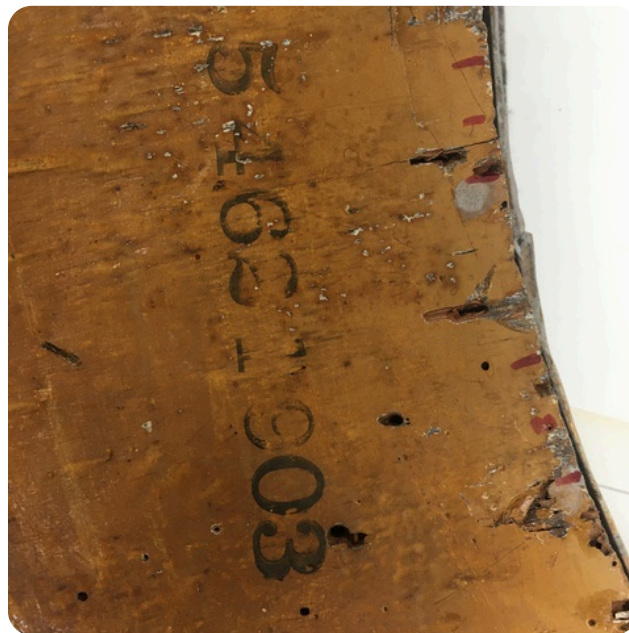
Item 1. Black stamp (tech. fig. 35).

**Technical Figure 35:** Inscription reading "5462 1903," back, bottom right. Workshop of Bastiano Mainardi, *Adoration of the Christ Child*, Indianapolis Museum of Art at Newfields, The Clowes Collection, 2015.30.

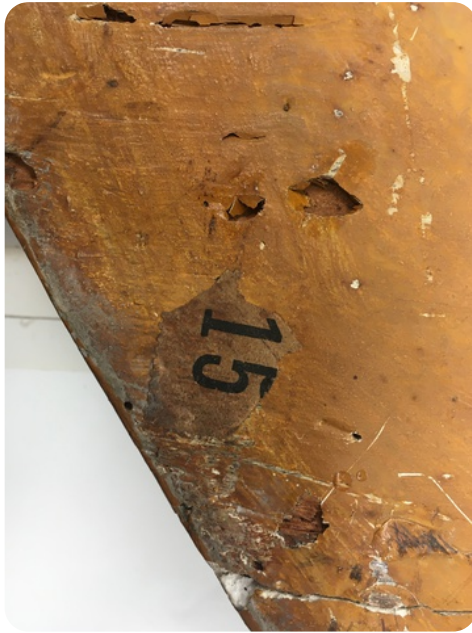
Item 2. Black stamp on brown paper (tech. fig. 36).

**Technical Figure 36:** Inscription "15," back, bottom right. Workshop of Bastiano Mainardi, *Adoration of the Christ Child*, Indianapolis Museum of Art at Newfields, The Clowes Collection, 2015.30.

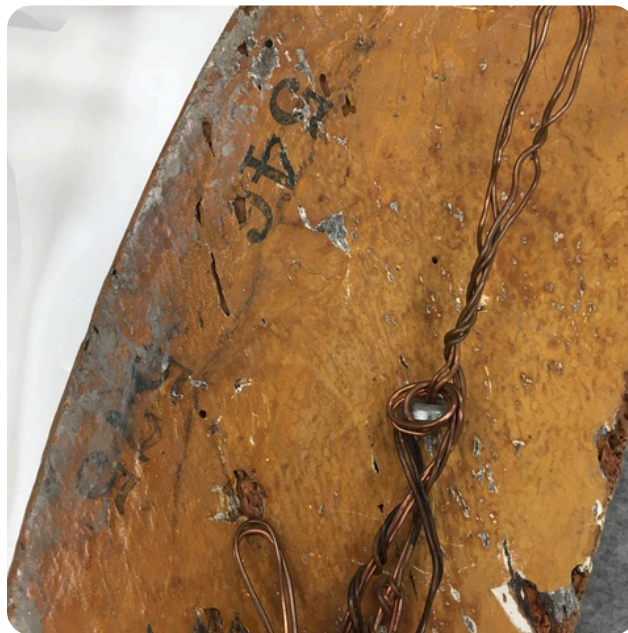
Item 3. Black stamp (tech. fig. 37).

**Technical Figure 37:** Inscription "546 575," back, top left. Workshop of Bastiano Mainardi, *Adoration of the Christ Child*, Indianapolis Museum of Art at Newfields, The Clowes Collection, 2015.30.

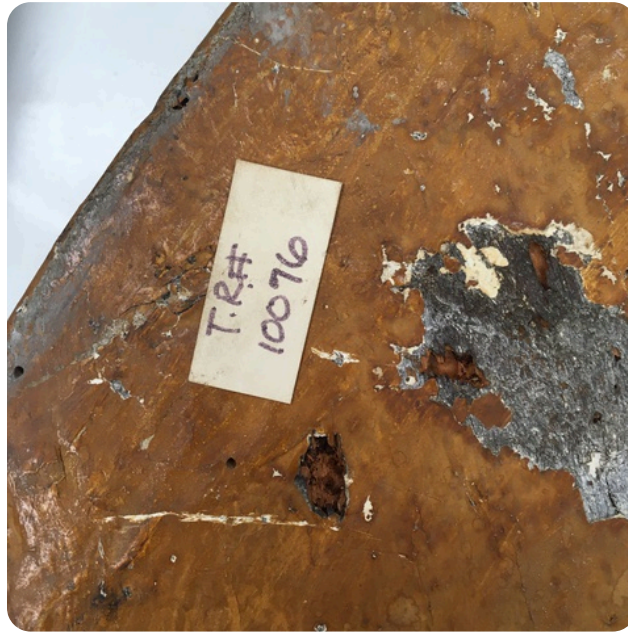
Item 4. White label (tech. fig. 38).

**Technical Figure 38:** Inscription "TR 10076," back, top left. Workshop of Bastiano Mainardi, *Adoration of the Christ Child*, Indianapolis Museum of Art at Newfields, The Clowes Collection, 2015.30.

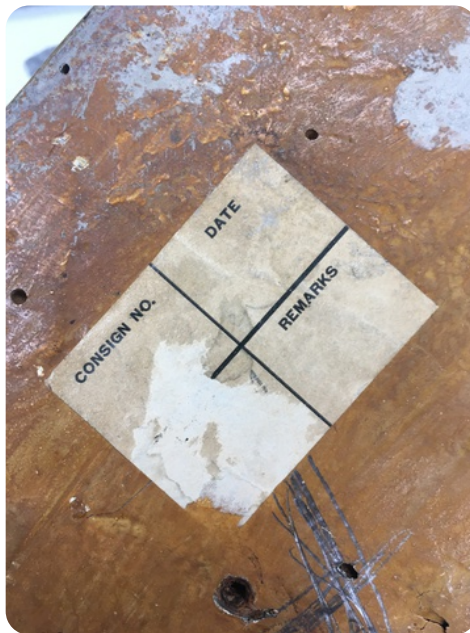
Item 5. White label (tech. fig. 39).

**Technical Figure 39:** Printed words in grid "consign no.," "date," "remarks," back, top left. Workshop of Bastiano Mainardi, *Adoration of the Christ Child*, Indianapolis Museum of Art at Newfields, The Clowes Collection, 2015.30.

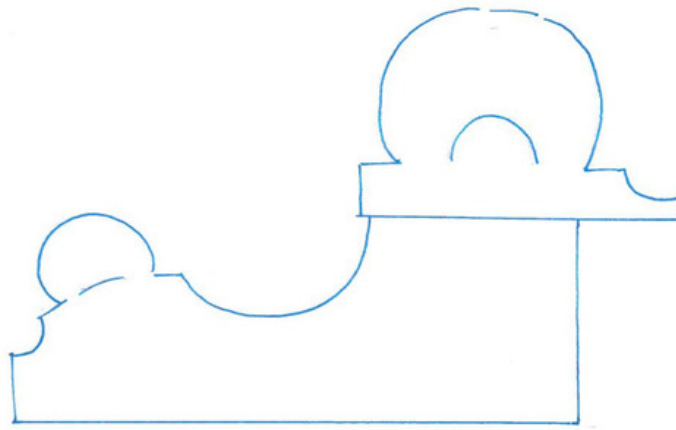
**Technical Figure 40:** Frame profile as drawn by Timothy Newbery, 2012. Workshop of Bastiano Mainardi, *Adoration of the Christ Child*, Indianapolis Museum of Art at Newfields, The Clowes Collection, 2015.30.

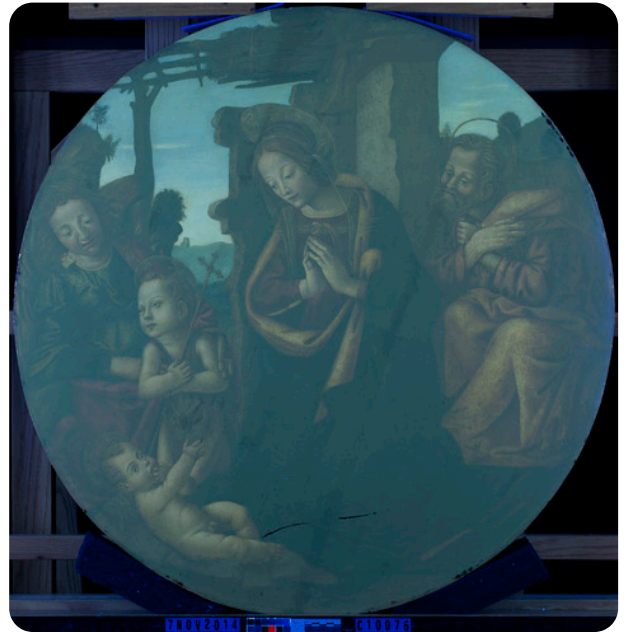
Ultraviolet-induced visible fluorescence reveals a thick coating of discolored varnish present over the surface of the painting (tech. fig. 29). The varnish was analyzed using FTIR, and the upper layer of varnish (tech. fig. 30, layer 10) was found to be a synthetic acrylic resin varnish. The FTIR spectrum from the lower layer of varnish (tech. fig. 30, layer 9) identified [linseed oil](#) with the addition of small components of dammar varnish, suggesting the application of an earlier oleo-resinous varnish.

Workshop of Bastiano Mainardi (Italian, 1466–1513), *Adoration of the Christ Child*, 1490–1500, egg tempera and oil on poplar panel, 84.7 × 83.8 cm, front, ultraviolet-induced visible fluorescence, Indianapolis Museum of Art at Newfields, The Clowes Collection, 2015.30.

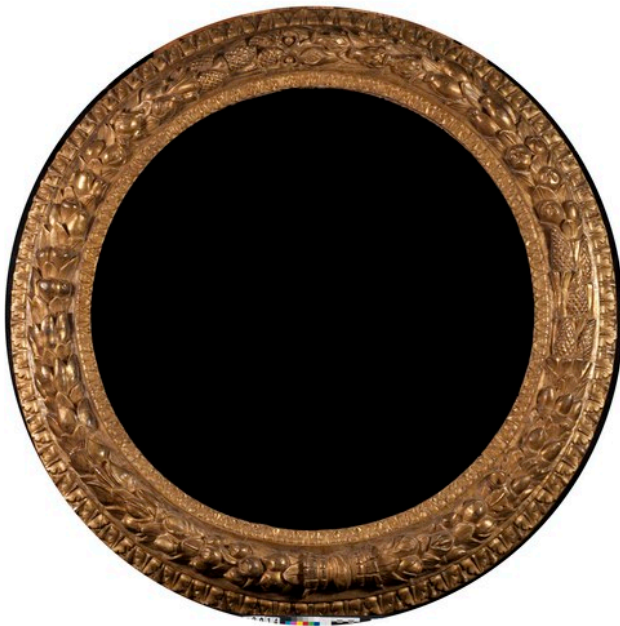
Frame for *Adoration of the Christ Child*, 1490–1500, 115 cm (diameter), front, visible light, Indianapolis Museum of Art at Newfields, The Clowes Collection, 2015.30.
