Temptation of St. Anthony after 1531

Follower of Hieronymus Bosch Netherlandish

Overview:

Conservator/examiner: Erica Schuler with contributions from Roxane Sperber

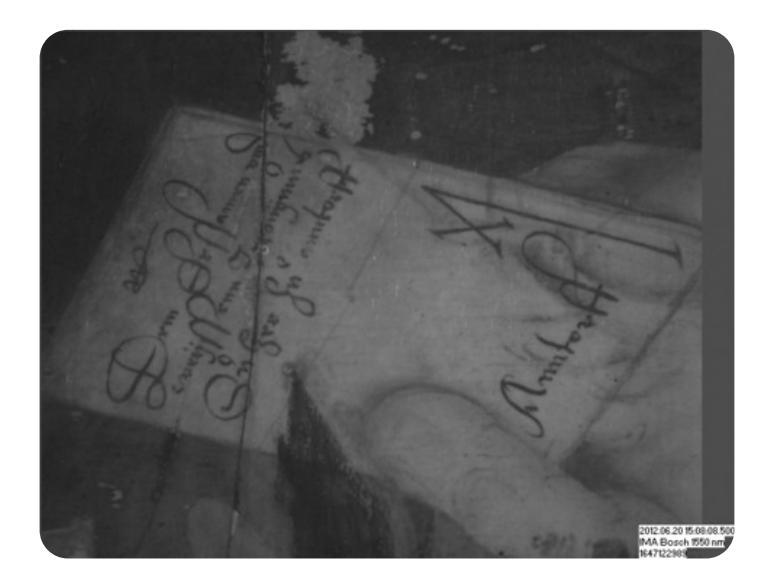
Item I. Underlying portrait of a male sitter made visible through infrared reflectography. A legible inscription written on a card held by the sitter reads, "Dem Erssamen und/ weijssenn Heronymus/ Sulzer zu anntorff/ Antorff," which translates as "To the honorable and wise Heronymus Sulzer at Antwerp."

Technical Figure 1: Infrared reflectogram of inscription. Follower of Hieronymus Bosch, *Temptation of St. Anthony*, after 1531, Indianapolis Museum of Art at Newfields, The Clowes Collection, 2020.1.

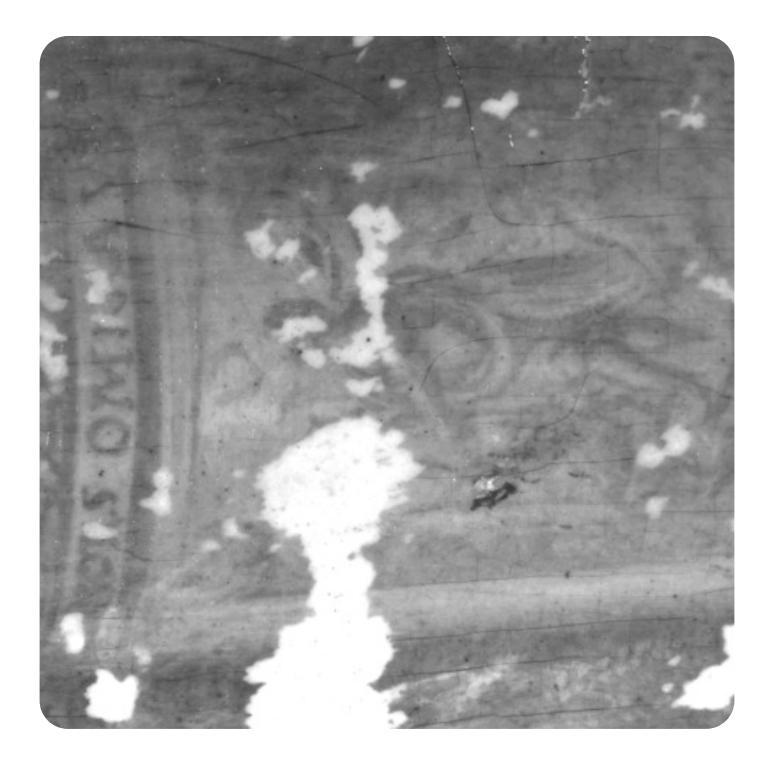
Item 2. A figural motif with script, likely "MORS OMNIA V[ICIT]," visible on what appears to be a book spine.

Technical Figure 2: Infrared reflectogram of script. Follower of Hieronymus Bosch, Temptation of St. Anthony, after 1531, Indianapolis Museum of Art at Newfields, The Clowes Collection, 2020.1.

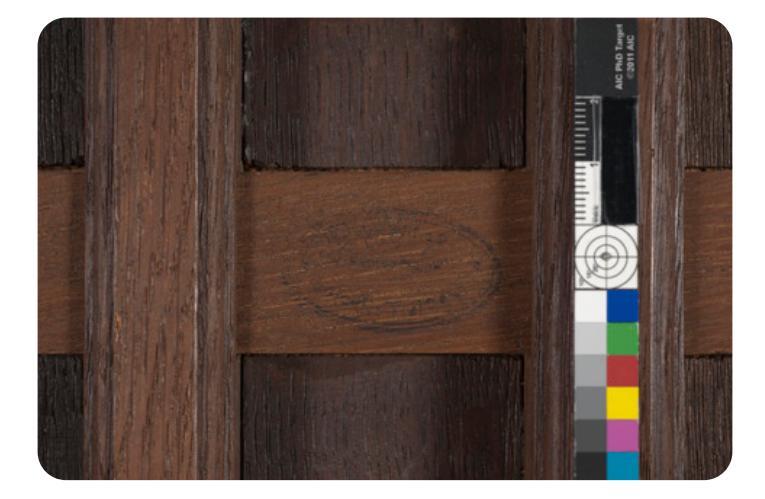
Technical Figure 3: Detail of oval stamp on <u>cradle</u> member. Follower of Hieronymus Bosch, *Temptation of St. Anthony*, after 1531, Indianapolis Museum of Art at Newfields, The Clowes Collection, 2020.1.

An illegible oval stamp is present on the sixth (from top) horizontal cradle member (tech. fig. 3).

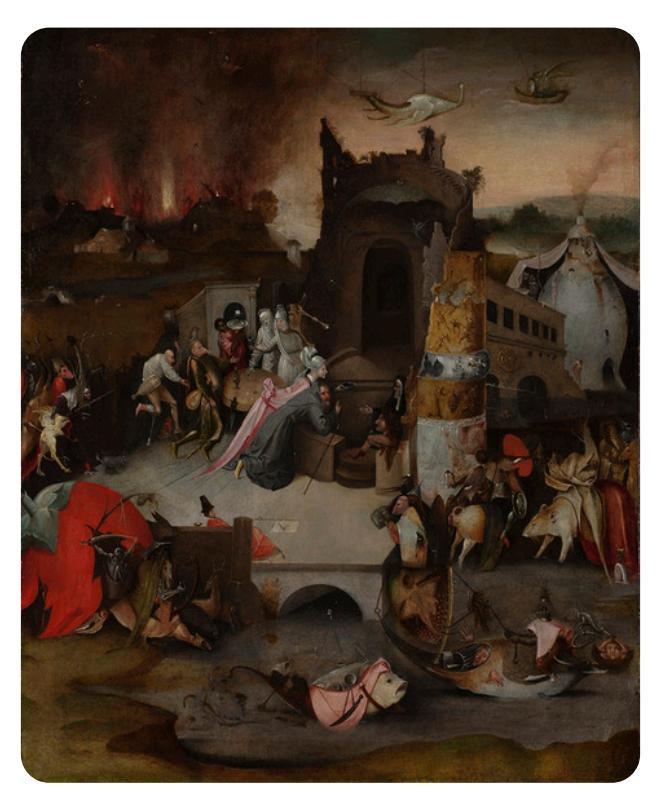
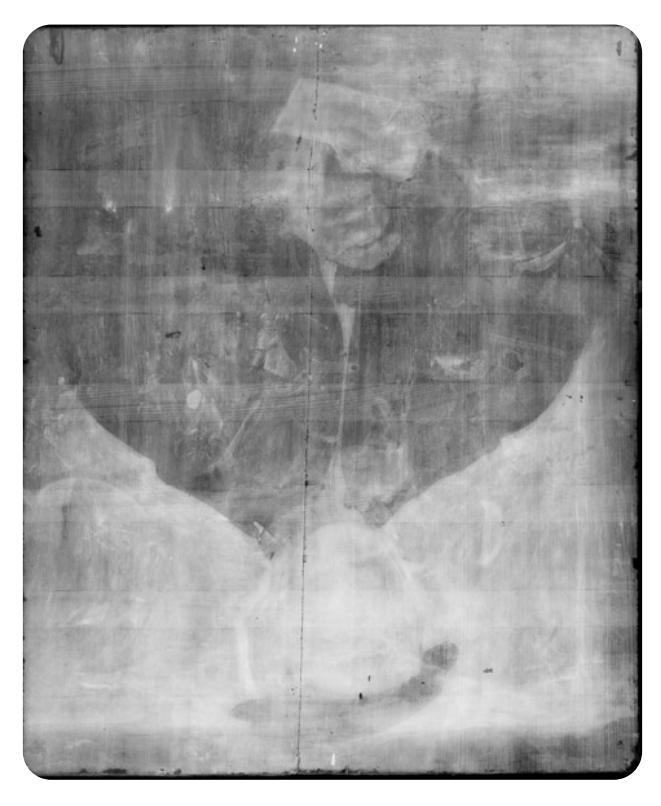
Technical Figure 4: Overlay of the visible light image (left) and the X-radiograph (right) illustrates the approximate location of the underlying portrait relative to the visible picture layer. Follower of Hieronymus Bosch, *Temptation of St. Anthony*, after 1531, Indianapolis Museum of Art at Newfields, The Clowes Collection, 2020.1.

The X-radiograph reveals that minor loss has occurred within the ground layer (see tech. fig. 4); however, such damage appears negligible and adhesion between the ground and support remains secure and in very good condition overall. With the exception of a relatively large rectangular loss measuring approximately 3×1.2 cm in the bottom left corner, the remaining damage noted in the X-radiograph appears to relate to minor insect infestation and mechanically induced stresses incurred through handling and display. In addition to nail holes, each corner has sustained loss measuring ≤ 1 cm from handling. Additional nail holes are present around the painting's perimeter, as are numerous pinpoint losses and minor insect damage associated with the tunneling visible on the back (29.5 \times 8.5 cm, from the bottom-left corner; see **Condition of Support**).

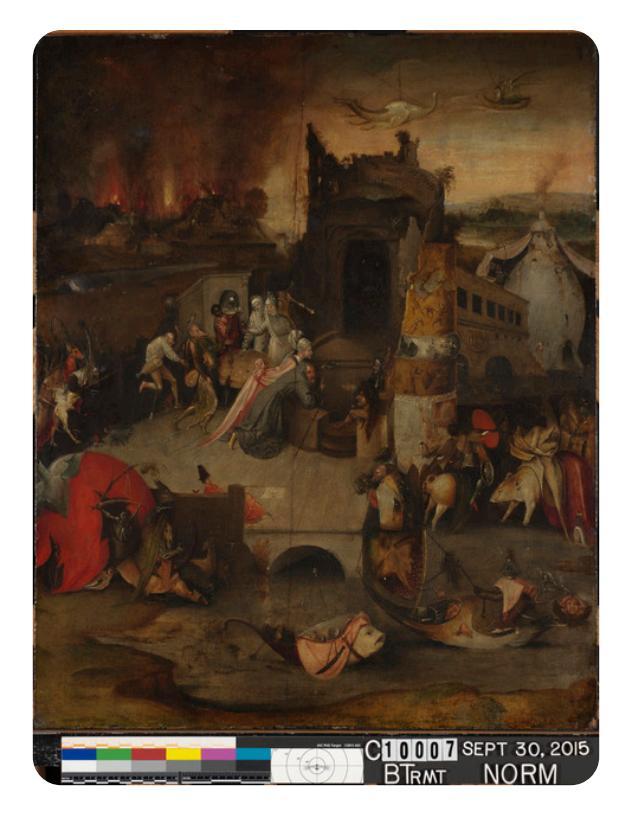
Technical figure 5: The Clowes *Temptation* as it appeared prior to the 2016 examination and treatment campaign. Follower of Hieronymus Bosch, *Temptation of St. Anthony*, after 1531, Indianapolis Museum of Art at Newfields, The Clowes Collection, 2020.1.

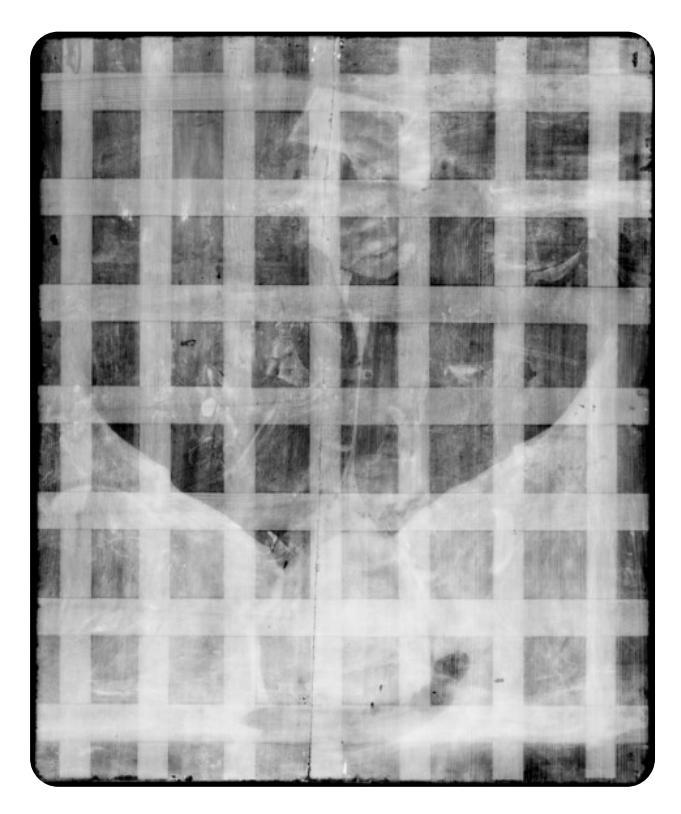
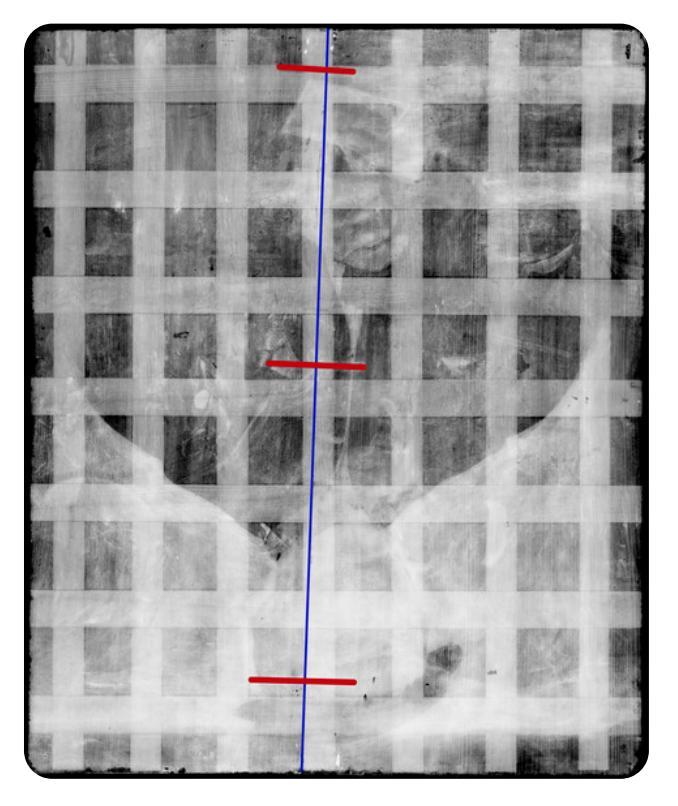
The X-radiograph shows vertically oriented grain on the two quarter-sawn oak planks that constitute the panel.⁸ The planks are somewhat uneven in dimension, aligned at a slight oblique angle with three wooden dowels, and secured with glue (tech. fig. 6). Although visible characteristics of construction are obscured by a 14-member auxiliary cradle, evidence of tool marks (possibly saw and plane) can be detected within the interstices of the latticed members. It is entirely plausible, however, that the noted tool marks are a hallmark of a later structural treatment and are not original to its construction, as the back was likely sanded overall in preparation for the cradle attachment. Shallow channels are cut directly into the support's back to accommodate both the fixed (vertical) and mobile (horizontal) cradle members.

Technical Figure 6: Annotated overlay of X-radiograph shows the location of the join between the planks (blue line), the general location of each of the three dowels used to align the boards (red lines), and the full cradle attached to the painting's back. The table lists the dimensions of the two planks that constitute the support. Follower of Hieronymus Bosch, *Temptation of St. Anthony*, after 1531, Indianapolis Museum of Art at Newfields, The Clowes Collection, 2020.1.

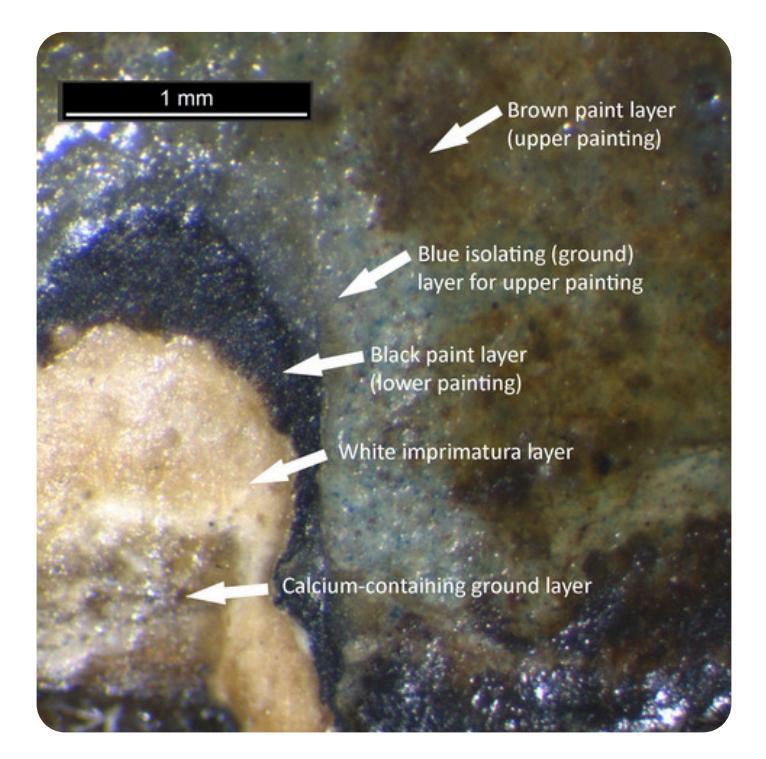
The primary glue-based ground is off-white, and the thin finishing paint layer is white in color (tech. fig. 7). Examination of exposed strata within losses around the periphery suggests that the artist of the *Temptation* concealed the majority of the underlying portrait with white paint (approximate bottom five-sixths of

the composition—see tech. fig. 12, layer 6) then switched to light blue paint to mask the figure's black costume in the sky (approximate top one-sixth of the composition). This is the case in a loss imaged in technical figure 7.

Technical Figure 7: Photomicrograph showing the original preparatory layers and the isolating layer for the upper paint layers. Follower of Hieronymus Bosch, *Temptation of St. Anthony*, after 1531, Indianapolis Museum of Art at Newfields, The Clowes Collection, 2020.1.

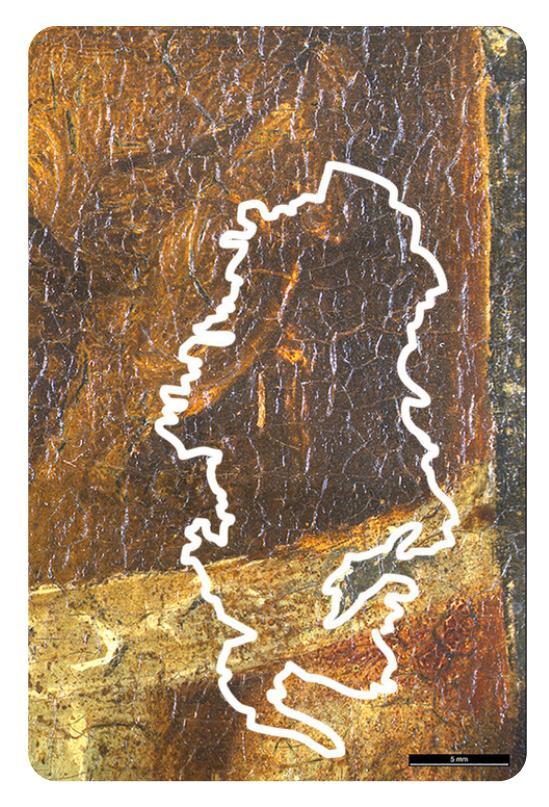
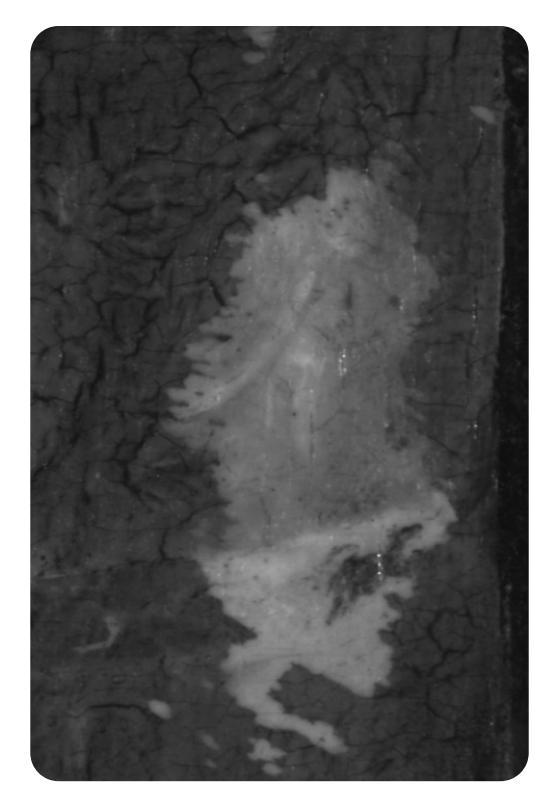
Technical Figure 8: Overlay of visible light photomicrograph (left) and an IRR detail (right) showing a loss within the picture layer of the underlying portrait. The size of the loss measures approximately 30 × 17 mm. Follower of Hieronymus Bosch, *Temptation of St. Anthony*, after 1531, Indianapolis Museum of Art at Newfields, The Clowes Collection, 2020.1.

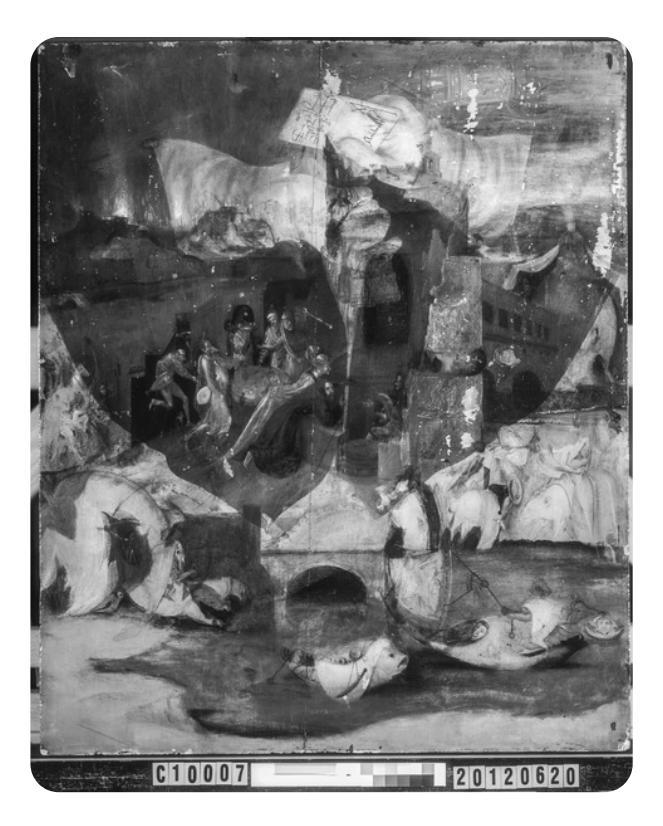
Technical Figure 9: Infrared reflectogram. Follower of Hieronymus Bosch, *Temptation of St. Anthony*, after 1531, Indianapolis Museum of Art at Newfields, The Clowes Collection, 2020.1.

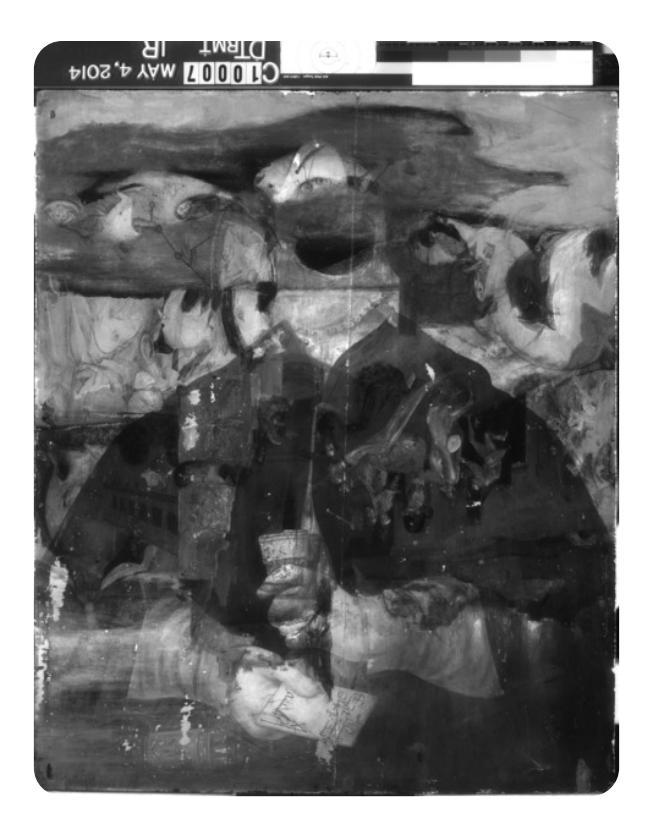
Technical Figure 10: Infrared reflectogram rotated 180°. Follower of Hieronymus Bosch, *Temptation of St. Anthony*, after 1531, Indianapolis Museum of Art at Newfields, The Clowes Collection, 2020.1.

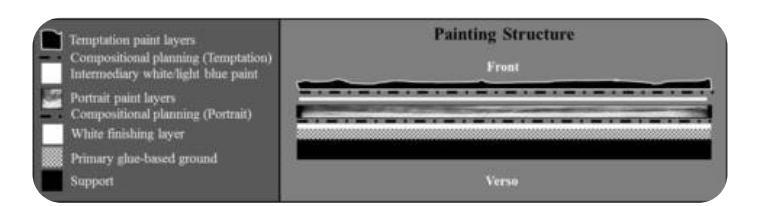
Technical Figure 11: Illustration showing the layered structure observed throughout the painting. Follower of Hieronymus Bosch, *Temptation of St. Anthony*, after 1531, Indianapolis Museum of Art at Newfields, The Clowes Collection, 2020.1.

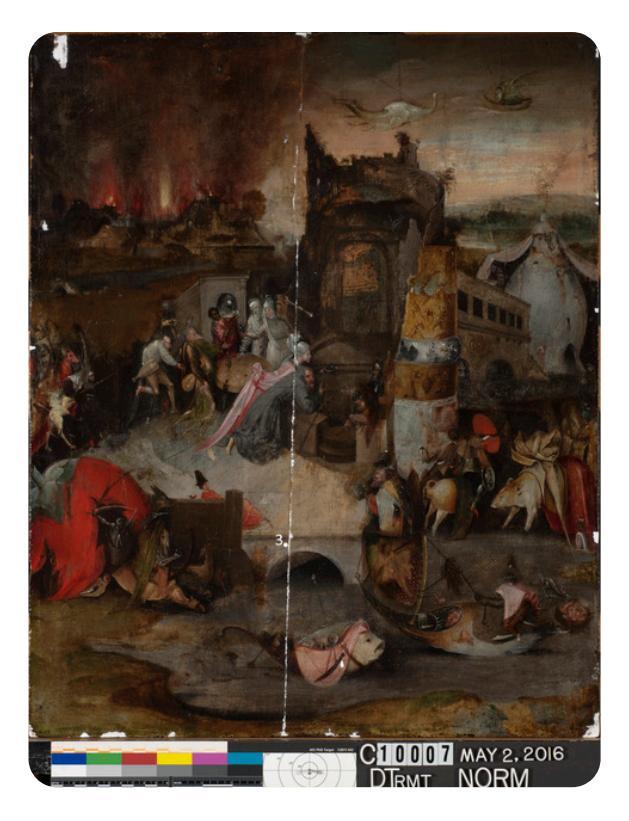
Technical Figure 12: Cross-section sample location map. Follower of Hieronymus Bosch, *Temptation of St. Anthony*, after 1531, Indianapolis Museum of Art at Newfields, The Clowes Collection, 2020.1.

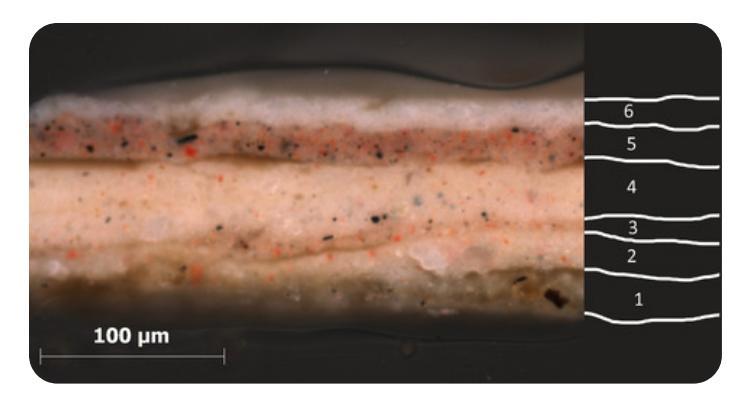
Technical Figure 13: Cross-section 3 from area of face showing the calcium-containing ground (layer 1), the imprimatura (layer 2), layers of pale pink skin paint (layers 3-5), and the white isolating layer (layer 6). Upper paint layers were no long present in this area and are therefore not included in this sample. Follower of Hieronymus Bosch, *Temptation of St. Anthony*, after 1531, Indianapolis Museum of Art at Newfields, The Clowes Collection, 2020.1.

As mentioned previously, the portrait was likely drawn on the prepared panel in preparation for paint application. The X-radiograph reveals thick paint surrounding the sitter's head and shoulders, as well as a defined band of <u>radiopaque</u> paint defining the edge of the hair, ear, and neck along the proper-left side of the sitter's head (tech. fig. 14). The artist likely blocked in the colors of his composition with relatively broad brushwork following the previously established contours of the underdrawing. Examination of the painting's edges and surface under magnification showed that the sitter is surrounded by a blue-green background, wears a black cloak, and wears a red jeweled gold ring. Although the sitter's head and shoulders are obscured by a thick layer of radiopaque paint applied in broad, irregular brushwork, a cross section taken from an area of the sitter's face revealed layers of pale pink paint, suggesting that skin tones were initially blocked in with color (tech. fig. 13, layers 3-5).

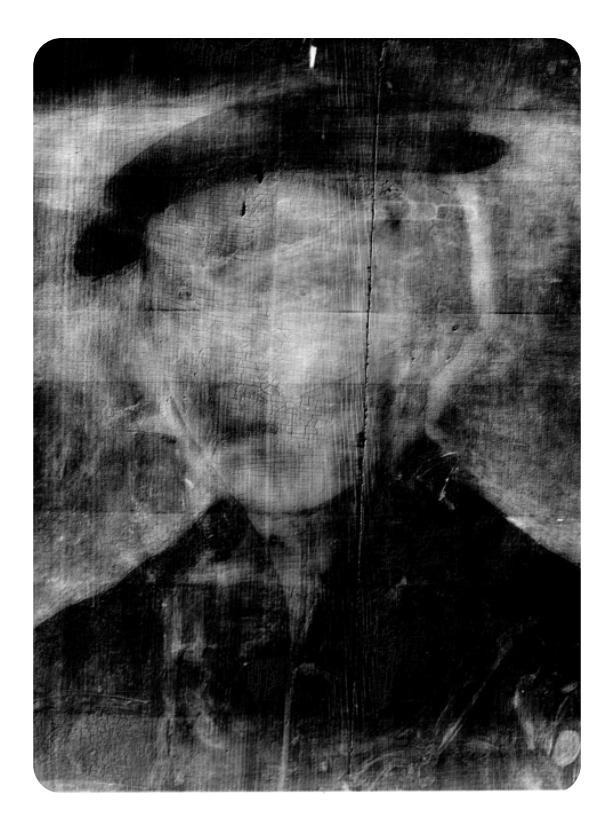
Technical Figure 14: Enhanced radiograph details the sitter's face. Follower of Hieronymus Bosch, *Temptation of St. Anthony*, after 1531, Indianapolis Museum of Art at Newfields, The Clowes Collection, 2020.1.

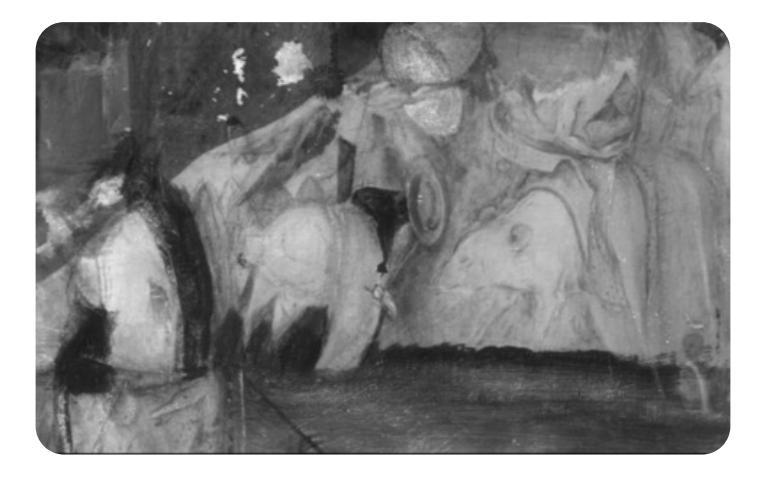
Technical Figure 15: Infrared reflectogram showing an area of underdrawing in the *Temptation*. Follower of Hieronymus Bosch, *Temptation of St. Anthony*, after 1531, Indianapolis Museum of Art at Newfields, The Clowes Collection, 2020.1.

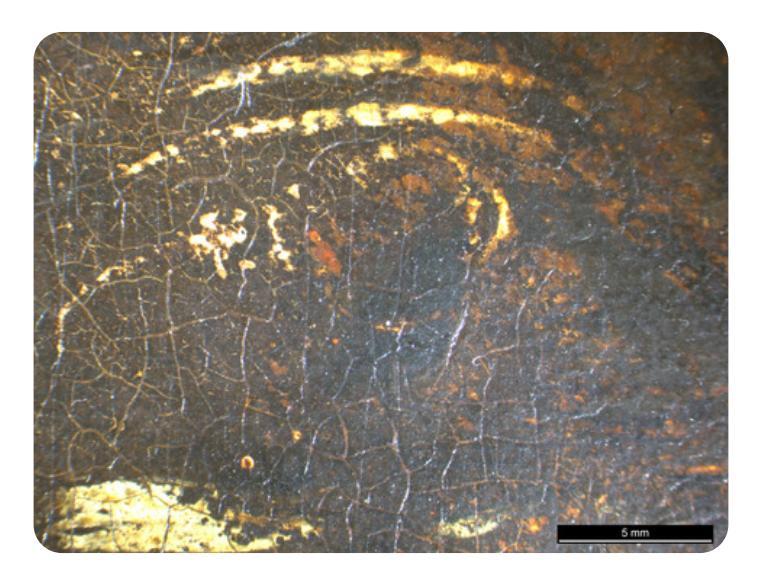
Technical Figure 16: Photomicrograph details the ring adorning the sitter's proper-right pinky, as it appeared through the abraded brown paint of the *Temptation*'s central tower prior to the 2016 treatment campaign. Location: 47.0 × 26.0 cm from the bottom-left corner. Follower of Hieronymus Bosch, *Temptation of St. Anthony*, after 1531, Indianapolis Museum of Art at Newfields, The Clowes Collection, 2020.1.

Prior to the 2016 treatment campaign, a few elements of the underlying portrait were visible through the *Temptation*'s picture layer, including the three gold bands and red jewel of the sitter's ring (tech. fig. 16), creases of the shirt sleeve within the top-right corner, and the border of the sitter's proper-left shoulder. The visibility of these elements was corrected through inpainting. At present, the sitter's proper-left shoulder remains visible through the translucent light gray paint of the center platform, as are localized passages of the portrait's green background within the painted bluffs of the foreground. Although past speculation has theorized that some of the visual artifacts mentioned above result from artistic intent, the 2016 examination and treatment campaign revealed a paint surface damaged by extreme chemical and mechanical abrasion and, as such, any observed <u>pentimenti</u> are likely a product of past human intervention and not artist technique.

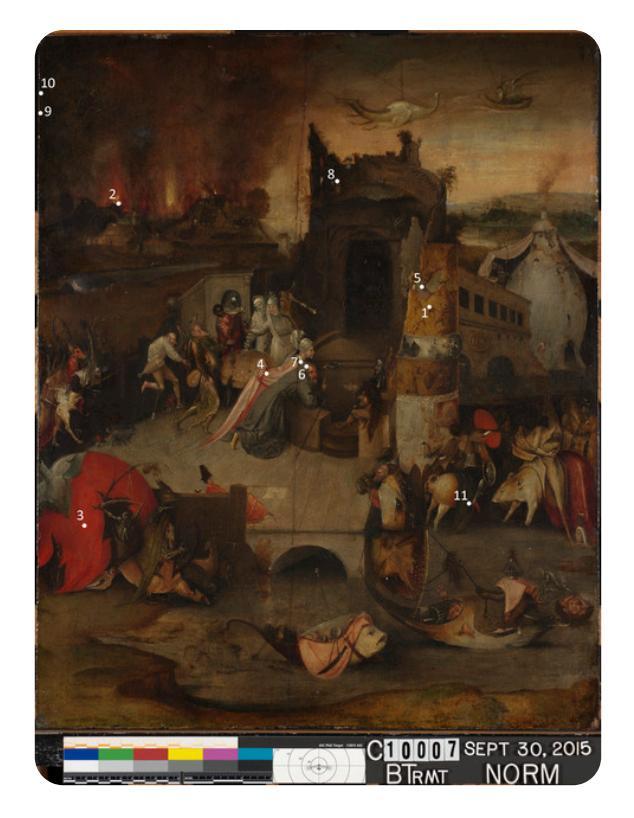
Technical Figure 17: XRF sample locations. Follower of Hieronymus Bosch, *Temptation of St. Anthony*, after 1531, Indianapolis Museum of Art at Newfields, The Clowes Collection, 2020.1.

Sample	Location	Elements	Possible Pigments
1	Pale yellow highlight on figure on tower	Major: Pb Minor: Fe, Sn, Ca Trace: Cu	Lead white, lead-tin yellow, iron oxide (earth pigments), calcium (likely from ground layer), trace of copper-containing green and/or blue pigment.
2	Light yellow flame in the background village	Major: Pb Minor: Sn, Ca Trace: Fe	Lead white, lead-tin yellow, vermilion, calcium (likely from ground layer), trace of iron oxide (earth pigments).
3	Red fruit	Major: Pb, Hg, Cu Minor: Fe, Ca Trace:	Lead white, vermilion, iron oxide (earth pigments), copper-containing green and/or blue pigment (likely from the lower layer), calcium (likely from ground layer).
4	Red drapery on central female figure	Major: Pb Minor: Cu, Fe, Ca Trace: Hg	Lead white, iron oxide (earth pigments including), calcium (likely from ground layer and possible red lake), copper-containing green and/or blue pigment, trace of vermilion.

5	Blue passage on tower	Major: Cu, Pb Minor: Fe, Ca Trace: Mn, K	Lead white, copper-containing blue (likely azurite), iron oxide (earth pigments including umber), calcium (likely from ground layer).
6	Gray robe of St. Anthony	Major: Pb, Cu, Fe Minor: Trace: Ca, Hg	Lead white, iron oxide (earth pigments), copper-containing green and/or blue pigment, trace of calcium (likely from ground layer), trace of vermilion.
7	White highlight on central female figure's collar	Major: Pb Minor: Trace: Fe, Ca	Lead white, trace of calcium (likely from ground layer), trace of iron oxide (earth pigments).
8	Area of yellow ring from lower painting with black upper paint	Major: Pb Minor: Fe, Cu Trace: Ca, Sn	Lead white, lead-tin yellow, iron oxide (earth pigments), copper-containing green and/or blue pigment.
9	Green background of underlying portrait	Major: Cu Minor: Pb Trace: Fe, Ca, K	Copper-containing green pigment, lead white, trace of iron oxide (earth pigment), trace of calcium (likely from ground).

10	Ground layer under portrait	Major: Ca Minor: Trace: Pb	Calcium containing material (likely calcium carbonate), trace of lead white.
11	Blue-green blanket on knight's mount	Major: Cu, Pb Minor: Fe Trace: Mn, Ca, K	Lead white, copper-containing green and/or blue pigment, iron oxide (earth pigment including umber), trace of calcium (likely from ground).

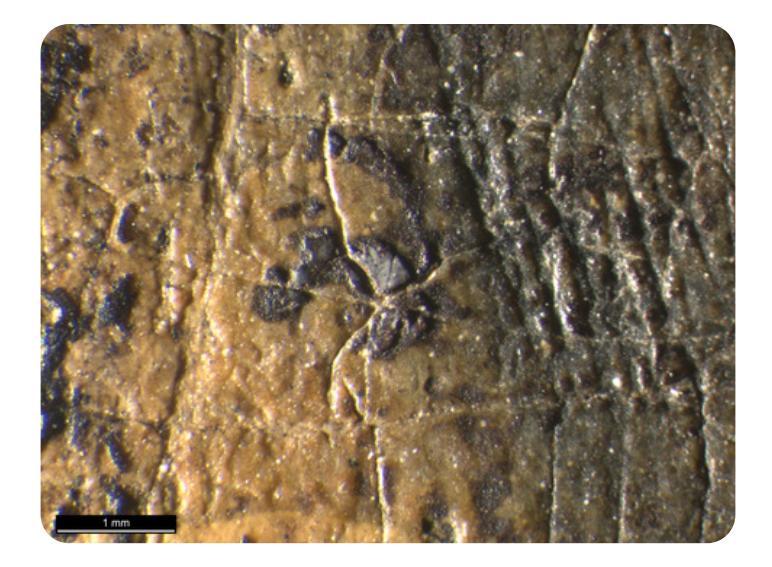
Technical Figure 18: Photomicrographs detail the painting's mechanically abraded surface as it appeared within the arched passage of the chapel before compensation during the 2016 treatment campaign. Follower of Hieronymus Bosch, *Temptation of St. Anthony*, after 1531, Indianapolis Museum of Art at Newfields, The Clowes Collection, 2020.1.

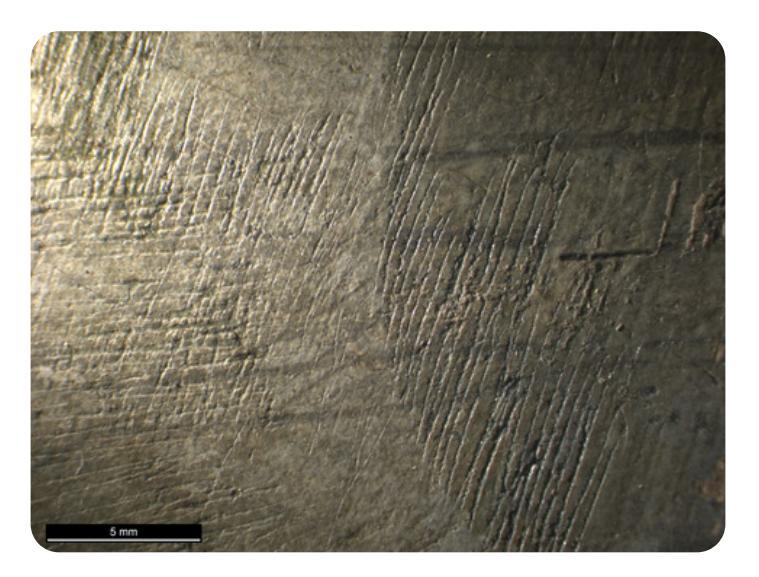
The paint layer exhibits very good adhesion to the support and cohesion throughout the strata, but inherent aging of original materials combined with chemically and mechanically induced damage from past treatment and handling have contributed to an abraded aesthetic condition. Technical figure 18 illustrates extreme mechanical abrasion noted within the center of the arched passage of the chapel and similar linear abrasion noted on the left side of the central platform (tech. fig. 19). The cause of such damage is not yet clear.

Technical Figure 19: Photomicrographs detail the painting's mechanically abraded surface as it appeared within the white platform before compensation during the 2016 treatment campaign. Follower of Hieronymus Bosch, *Temptation of St. Anthony*, after 1531, Indianapolis Museum of Art at Newfields, The Clowes Collection, 2020.1.

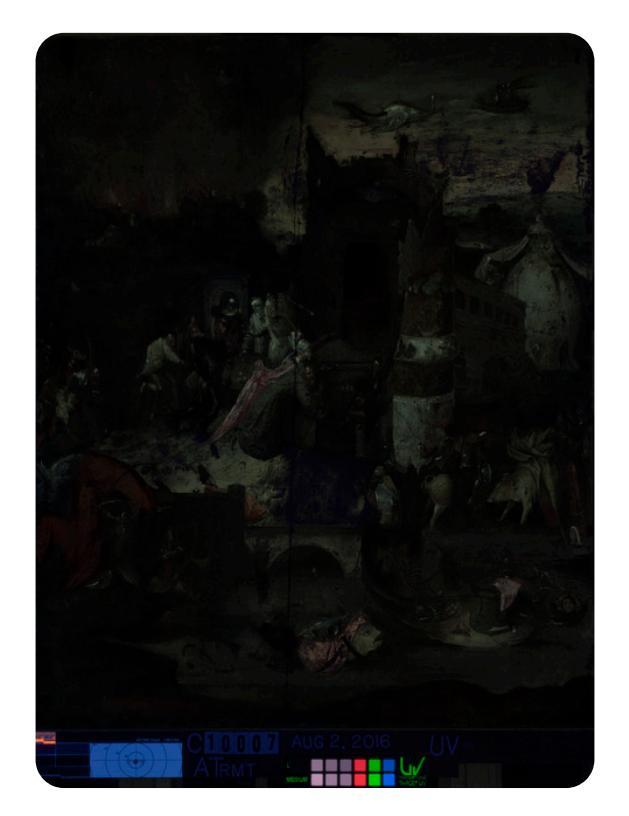
Technical Figure 20: Ultraviolet-induced visible fluorescence. Follower of Hieronymus Bosch, *Temptation of St. Anthony*, after 1531, Indianapolis Museum of Art at Newfields, The Clowes Collection, 2020.1.

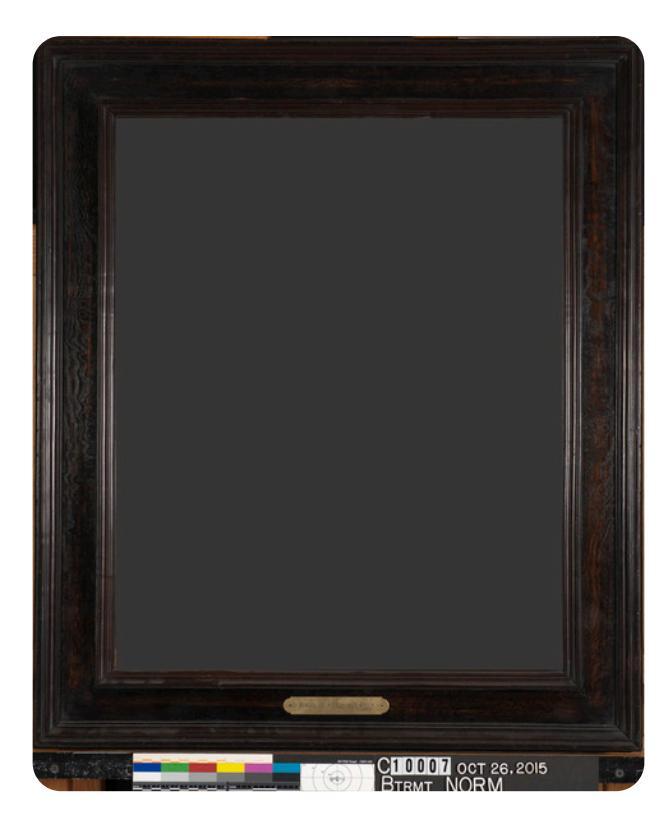
Technical Figure 21: Frame, front. *The Temptation of St. Anthony*, normal illumination. Follower of Hieronymus Bosch, *Temptation of St. Anthony*, after 1531, Indianapolis Museum of Art at Newfields, The Clowes Collection, 2020.1.

The cassetta-style frame (tech. fig. 21) is constructed of wood and joined at each corner with half-lapped joints (tech. fig. 22). The frame's features show a shallow profile that exhibits a predominant wood-veneered flat section flanked by raised molding around the outer perimeter and the sight edge. The sides and front are stained dark brown, and the reverse appears to have a thin coating.

Past damage and delamination of the <u>veneer</u> wood occurred at the frame's corners but was addressed during the 2016 treatment campaign. Some scuffs, nicks, and abrasion remain on the front overall, and the back shows marked abrasion, scuffs, and nail/screw holes around hanging hardware. However, the frame is stable and adequately supports and houses the painting.

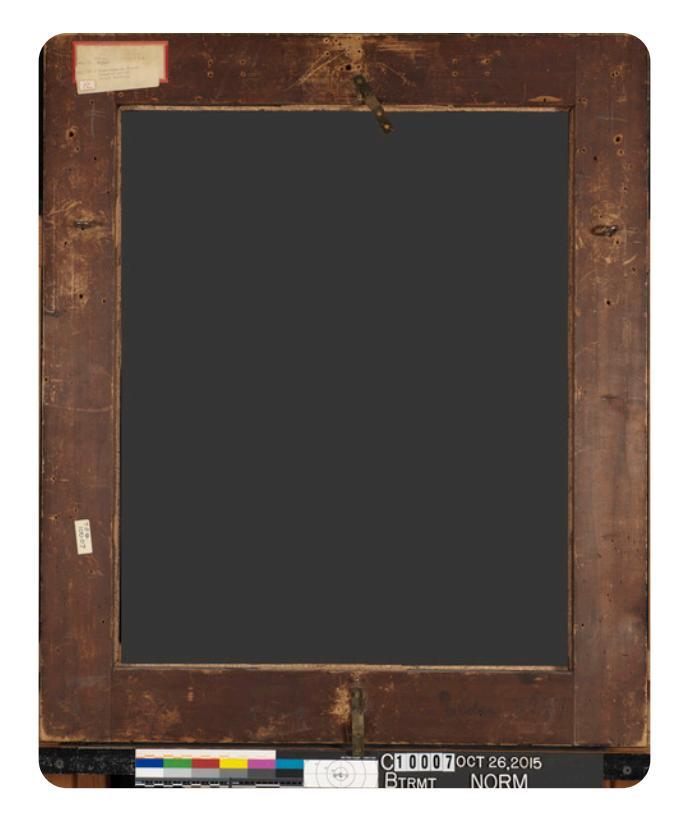
Technical Figure 22: Frame, back. *The Temptation of St. Anthony*, normal illumination. Follower of Hieronymus Bosch, *Temptation of St. Anthony*, after 1531, Indianapolis Museum of Art at Newfields, The Clowes Collection, 2020.1.
