1 TECHNICAL EXAMINATION REPORT

# Portrait of René du Puy du Fou about 1550

**Corneille de Lyon** Netherlandish, active in France, 1500/1510—1575

oil on wood panel, transferred to canvas  $6\text{-}11/16 \times 5\text{-}7/16 \text{ in.}$   $(17 \times 13.8 \text{ cm})$  The Clowes Collection 2014.86

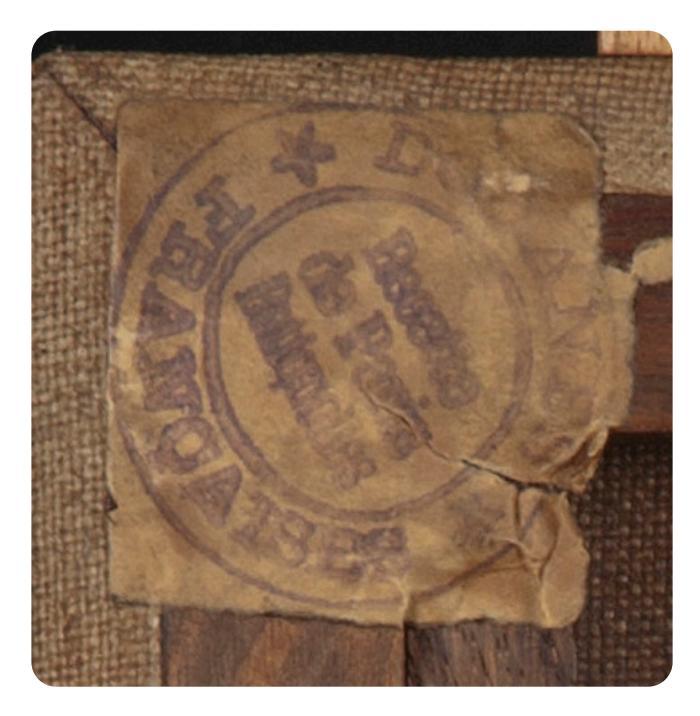
Item I. Round purple stamp on square brown paper label, top left: "DOUANES FRANCAISES Recette de Paris Batignolles" (tech. fig. 1).

Technical Figure 1: Paper label with stamp. Corneille de Lyon, *Portrait of René du Puy du Fou*, about 1550, Indianapolis Museum of Art at Newfields, The Clowes Collection, 2014.86.

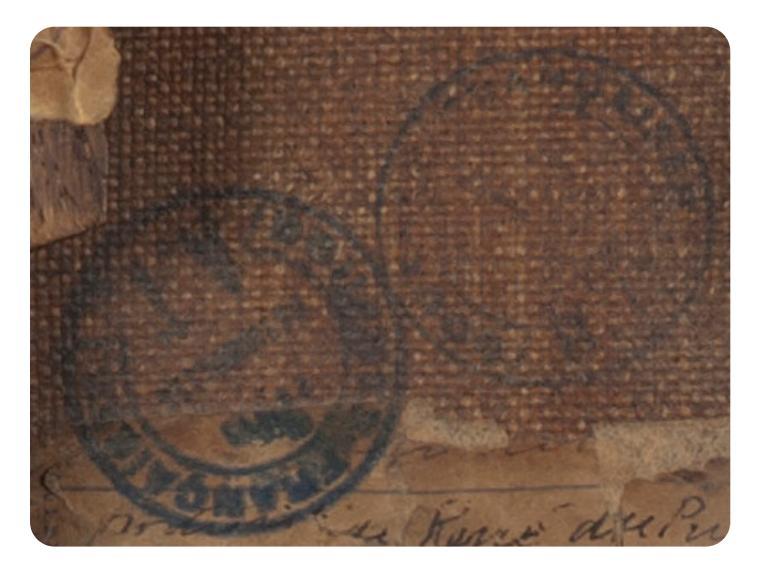
Item 2. Round blue stamp, upper portion of canvas: " DOUANES FRANCAISES.....AT" (tech. fig. 2).

Item 3. Round blue stamp, similar to item 2 but illegible, upper portion of canvas (tech. fig. 2).

Technical Figure 2: Stamps. Corneille de Lyon, *Portrait of René du Puy du Fou*, about 1550, Indianapolis Museum of Art at Newfields, The Clowes Collection, 2014.86.

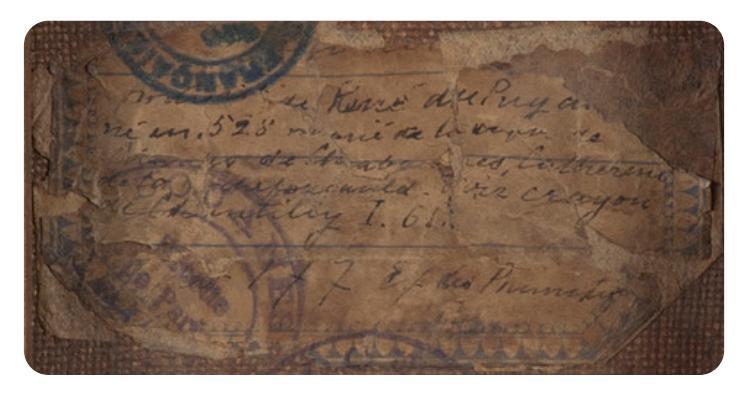
Item 4. Octagonal label with decorative blue ribbon, center of canvas on top of another label: "Portrait de Réné du Puy du ...né en 1528 marié Portrait de Réné du Puy du ...né en 1528, marié á la veuve de Charles de Chabannes, Catherine de la Rochefoucauld. Voir crayon de Chantilly 1.61. – no. 177 Ex des primitifs" (tech. fig. 3).

Item 5. Partial round purple stamp, on top of item 4: "DOUANES....Recette de Paris" (tech. fig. 3).

Technical Figure 3: Paper label with writing and stamps. Corneille de Lyon, *Portrait of René du Puy du Fou*, about 1550, Indianapolis Museum of Art at Newfields, The Clowes Collection, 2014.86.

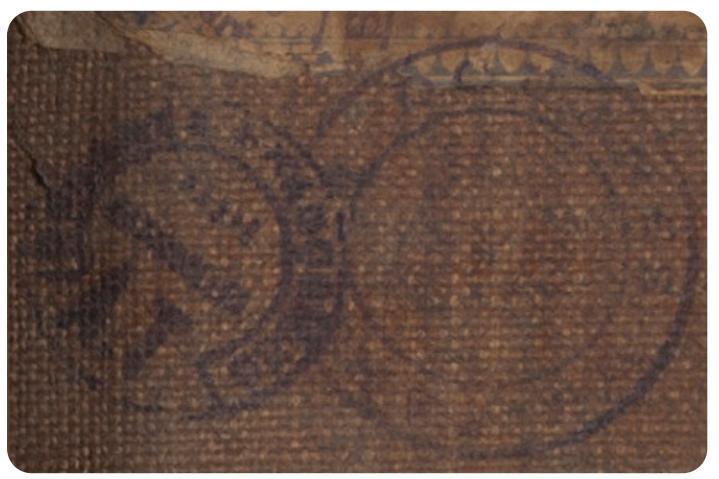
Item 6. Round purple stamp, lower portion of canvas: "DOUANES FRANCAISES...AT" (tech. fig. 4).

Item 7. Round purple stamp, lower portion of canvas: "DOUANES ..." (tech. fig. 4).

Technical Figure 4: Stamps. Corneille de Lyon, *Portrait of René du Puy du Fou,* about 1550, Indianapolis Museum of Art at Newfields, The Clowes Collection, 2014.86.

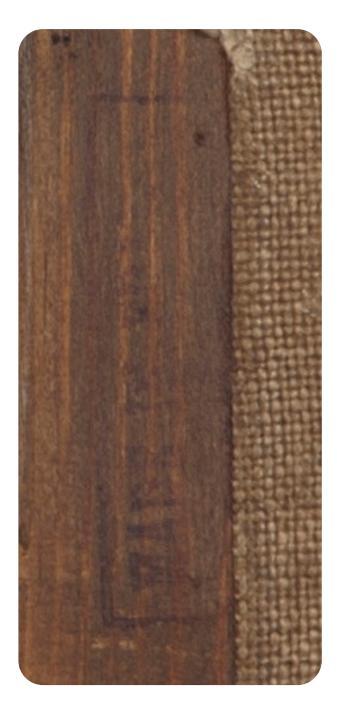
Item 8. Partial rectangular purple stamp, lower portion of right stretcher: "MADE IN..." (tech. fig. 5).

Technical Figure 5: Stamps. Corneille de Lyon, *Portrait of René du Puy du Fou*, about 1550, Indianapolis Museum of Art at Newfields, The Clowes Collection, 2014.86.

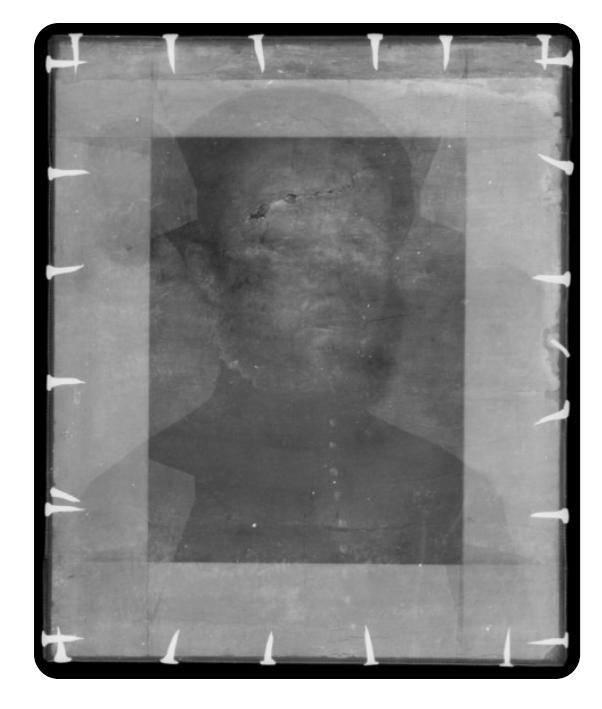
Technical Figure 7: X-radiograph showing damage to the head and reconstruction of the top edge of the painting. Corneille de Lyon, Portrait of René du Puy du Fou, about 1550, Indianapolis Museum of Art at Newfields, The Clowes Collection, 2014.86.

The painting is currently on a canvas support, but it was originally on a horizontally oriented wood panel. At some point in its history, the painting was transferred to the fabric support. During the transfer process the original panel was thinned, leaving only the ground and paint layer. Possible residue of the wood panel remains visible in the X-radiography along the top edge (tech. fig. 7).

The top portion of the painting (~2cm) was lost or damaged, and additional ground and paint layers along this edge were applied when the painting was transferred to canvas.

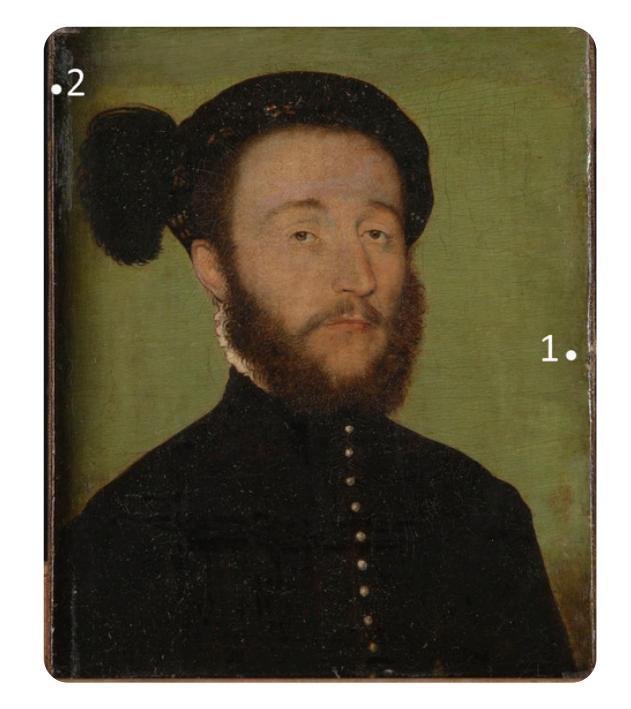
Technical Figure 8: Locations of <u>cross section</u> samples taken before 2019 treatment. Corneille de Lyon, *Portrait of René du Puy du Fou*, about 1550, Indianapolis Museum of Art at Newfields, The Clowes Collection, 2014.86.

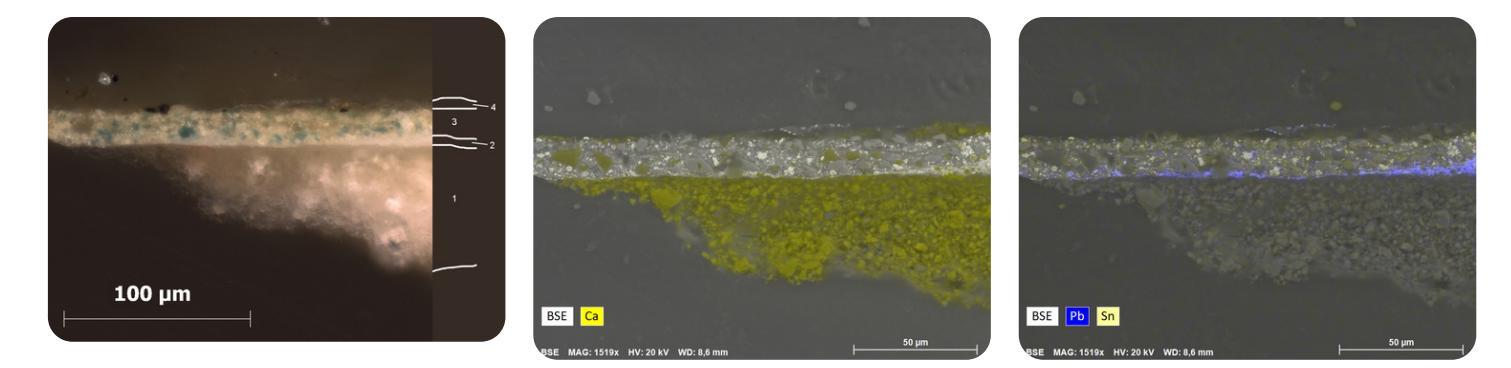
Cross section 1A shows the preparation layers in an area of light green paint (tech. fig. 9). The painting has a calcium carbonate ground (tech. fig. 10) followed by a thin layer of lead white <u>imprimaturg</u> (tech. fig. 11). This ground structure is consistent with Northern European painting of this period.

Technical figures 9–11: Cross section 1A in visible light showing a layer of calcium carbonate (layer 1) followed by a thin layer of lead white imprimatura (layer 2). BSE images show the elemental distribution of calcium (yellow) and lead (blue). Corneille de Lyon, Portrait of René du Puy du Fou, about 1550, Indianapolis Museum of Art at Newfields, The Clowes Collection, 2014.86.

The ground, where seen along the edges and in cross section, is off-white. The imprimatura is bright white (tech. fig. 9).

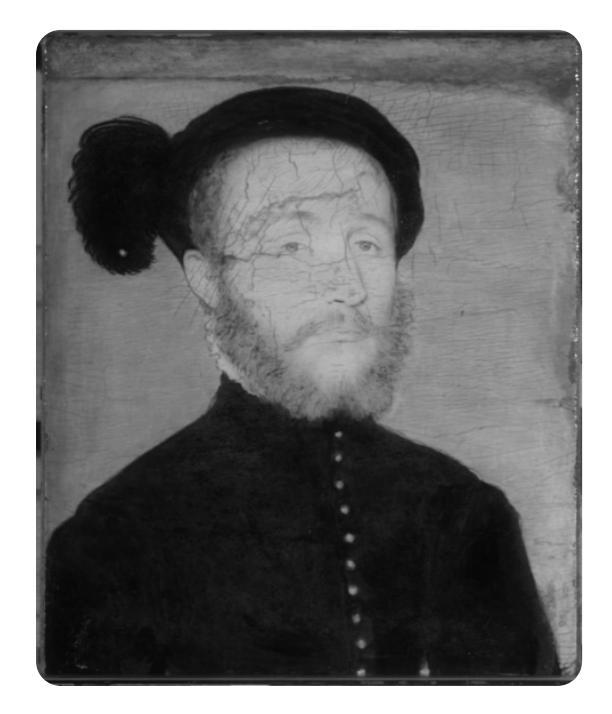
Technical Figure 12: Infrared reflectogram showing some thin lines of the <u>underdrawing</u>, particularly in the face. The larger area of loss is visible along the upper edge of the painting. Corneille de Lyon, *Portrait of René du Puy du Fou*, about 1550, Indianapolis Museum of Art at Newfields, The Clowes Collection, 2014.86.

The infrared reflectogram reveals some minimal underdrawing, particularly in the man's face (tech. fig. 12). The artist likely used a dry carbon-containing medium (possibly charcoal or black chalk) to create these fine outlines. The underdrawing is almost entirely observable in visible lighting due to the thin application of the paint.

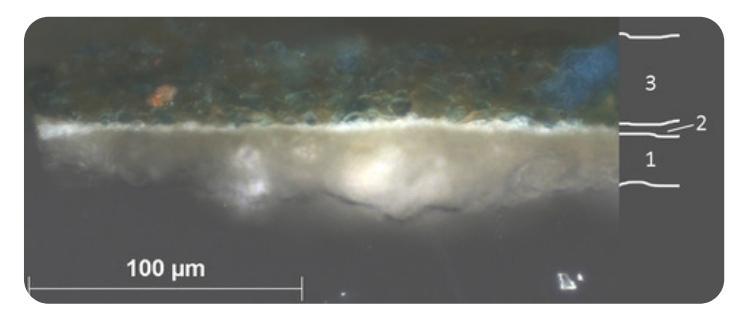
Technical Figure 13: Cross section 2A showing the dark green paint layer (layer 3) applied directly over the imprimatura layer (layer 2). Corneille de Lyon, *Portrait of René du Puy du Fou*, about 1550, Indianapolis Museum of Art at Newfields, The Clowes Collection, 2014.86.

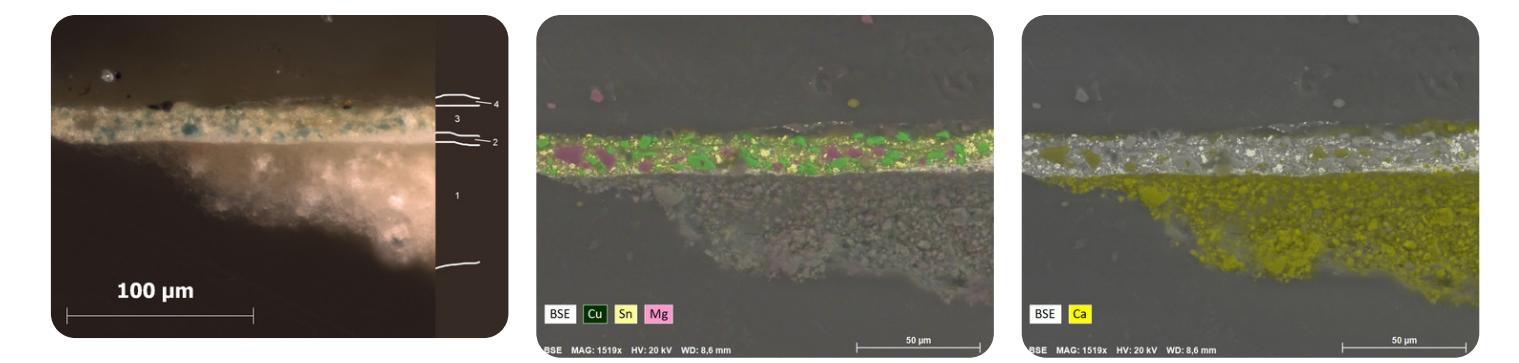
Cross sections were taken from light and dark areas of the background. Cross section 1A shows the composition of the light green paint in the background (tech. fig. 14; for cross section location, see tech. fig. 8). The layer is composed of a copper-containing green pigment, likely copper resinate or oleate, mixed with lead-tin yellow (tech. fig. 15). Lead white does not appear to be in the mixture, as all areas of lead in the paint layer correspond to areas of tin. There are also large, transparent particles rich in calcium and magnesium (tech. fig. 15, 16). This mixture is identical to that found in cross section 2 of *Portrait of Marie de Lorraine*. Raman microspectroscopy on that painting confirmed the magnesium- and calcium-rich particles are dolomite, suggesting that marble dust may have been added to the paint, possibly as a filler.

Technical Figures 14-16: Cross section IA with a BSE, showing the elemental distribution of copper (green), tin (light yellow), magnesium (pink), and calcium (dark yellow) in the light green paint layer. Corneille de Lyon, *Portrait of René du Puy du Fou*, about 1550, Indianapolis Museum of Art at Newfields, The Clowes Collection, 2014.86.

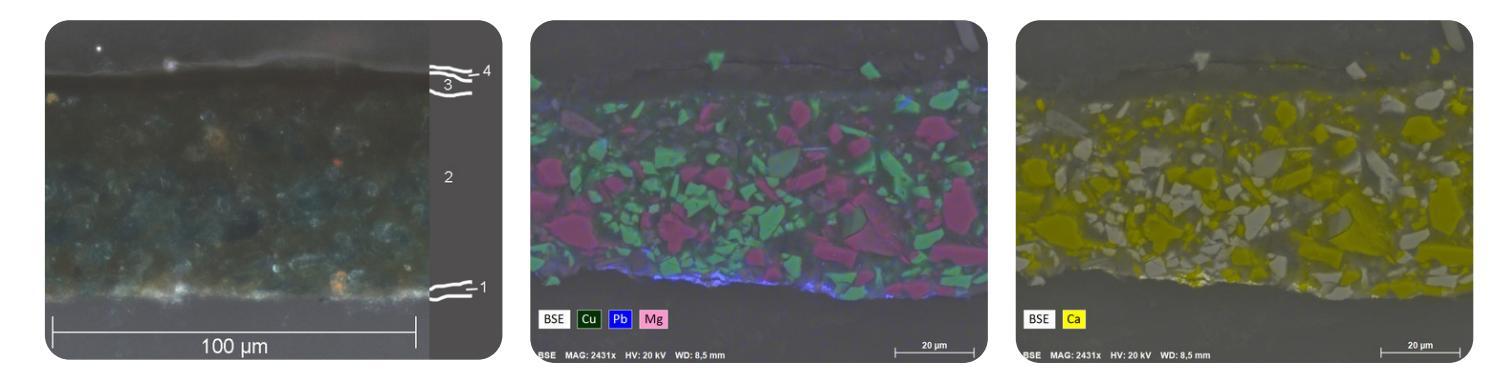
Cross section 2B is taken from an area of the dark green edge (see tech. fig. 8). No ground is present on the sample, and layer 3 and layer 4 are composed of retouching and varnish (tech. fig. 17). EDS analysis of layer 2 reveals a matrix of copper-containing pigment (green), likely copper resinate or oleate, mixed with a large proportion of particles rich in calcium (yellow) and magnesium (pink), and a small proportion of aluminosilicates (tech. figs. 18, 19). No lead (blue) or tin (light yellow) is present in the dark green matrix, although lead white is present in the imprimatura (layer 1) (tech. fig. 18).

Technical Figures 17–19: Cross section 2B with a BSE showing the elemental distribution of copper (green), magnesium (pink), lead (blue), and calcium (dark yellow) in the dark green paint layer. Corneille de Lyon, Portrait of René du Puy du Fou, about 1550, Indianapolis Museum of Art at Newfields, The Clowes Collection, 2014.86.

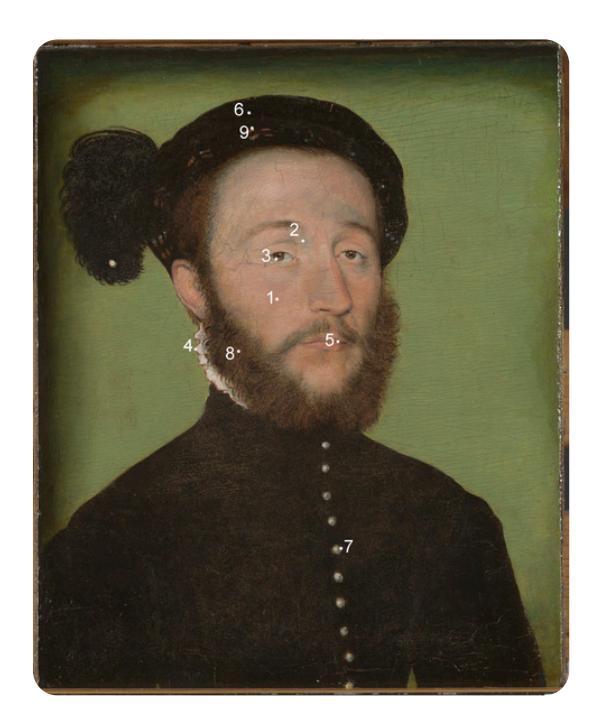
Technical Figure 20: XRF sample locations. Corneille de Lyon, *Portrait of René du Puy du Fou*, about 1550, Indianapolis Museum of Art at Newfields, The Clowes Collection, 2014.86.

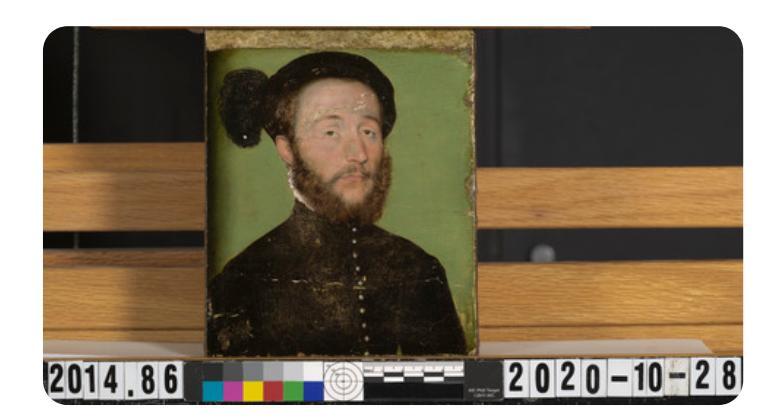
Following the 2019 treatment, the paint layer is in good condition. A craquelure pattern consistent with that of horizontal wood grain is present in both the ground and paint layers. A large loss in the forehead of the figure can be observed in the X-radiograph and the photograph of the painting during treatment (tech. fig. 21). This loss affects both the paint layer

Technical Figure 21: Painting during 2019 treatment, after varnish removal and before inpainting. Corneille de Lyon, *Portrait of René du Puy du Fou*, about 1550, Indianapolis Museum of Art at Newfields, The Clowes Collection, 2014.86.

and ground. The 2019 treatment addressed this area of loss and integrated severely <u>abraded</u> areas of the figure's jacket. The gradient along the upper edge of the painting was reconstructed to more accurately reflect the appearance of the original composition.

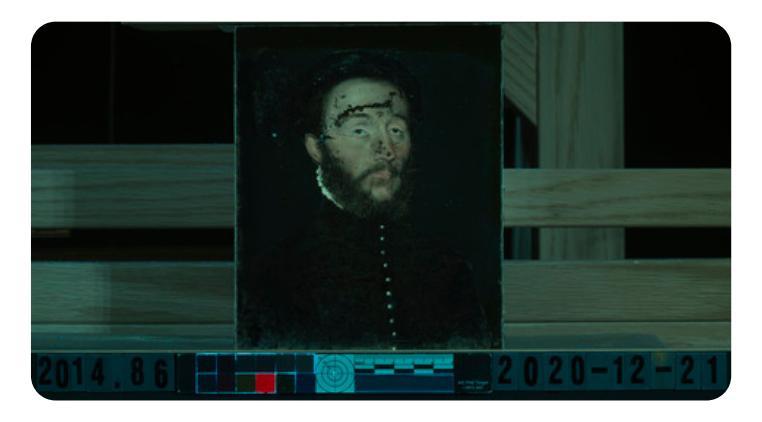
Technical Figure 22: Ultraviolet-induced visible fluoresce showing a greenish fluorescence characteristic of a natural resin varnish. Additionally, abrasion and retouching are visible. Corneille de Lyon, *Portrait of René du Puy du Fou*, about 1550, Indianapolis Museum of Art at Newfields, The Clowes Collection, 2014.86.

The varnish and inpainting are in good condition following the 2019 treatment. The varnish is clear and well saturating, and the inpainting now matches the surrounding paint layer. Furthermore, the reconstruction of the upper portion restored the intended framing of the man's face, in keeping with other works from the Corneille studio (tech. fig. 22).

A synthetic varnish composed of 30% 1:4 <u>Paraloid B-72</u>: Larapol A81 in Shellsol A100 was applied during the 2019 treatment. The painting was inpainted using <u>Gamblin Conservation</u> <u>Colors</u> in Larapol A81. Removal of the overpaint across the top edge during the 2019 treatment revealed the edge of a gradient that would have originally created a transition to a dark green top edge, similar to that of the left edge. Therefore, the decision was taken to recreate this gradient using inpainting. Further inpainting was applied in the figure's coat, forehead, and face.

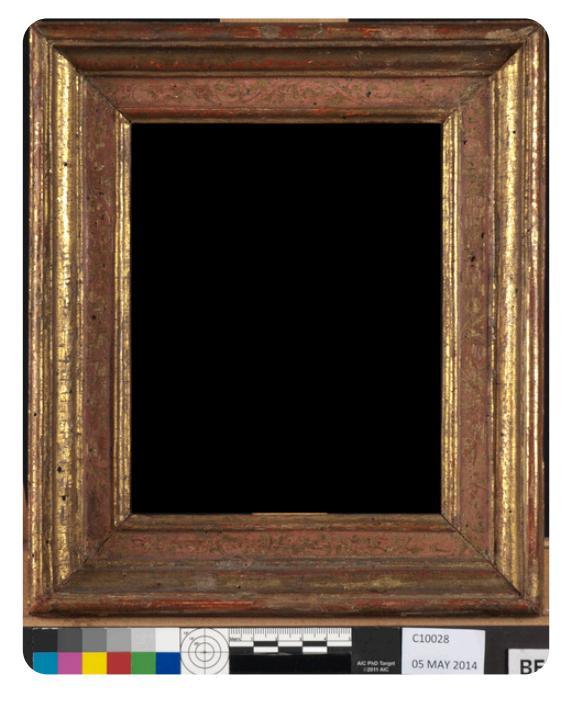
Technical Figure 23: Frame, front. Corneille de Lyon, *Portrait of René du Puy du Fou*, about 1550, Indianapolis Museum of Art at Newfields, The Clowes Collection, 2014.86.

As per the observations of historian and frame specialist Timothy Newbery, the frame consists of gilt oak with imitation craquelure and pale red sgraffito on the frieze (tech. fig. 23).<sup>9</sup> The style of the frame is seventeenth-century French, but the frame was likely constructed in about 1970 in New York. The back joints are half-lapped (tech. fig. 24).

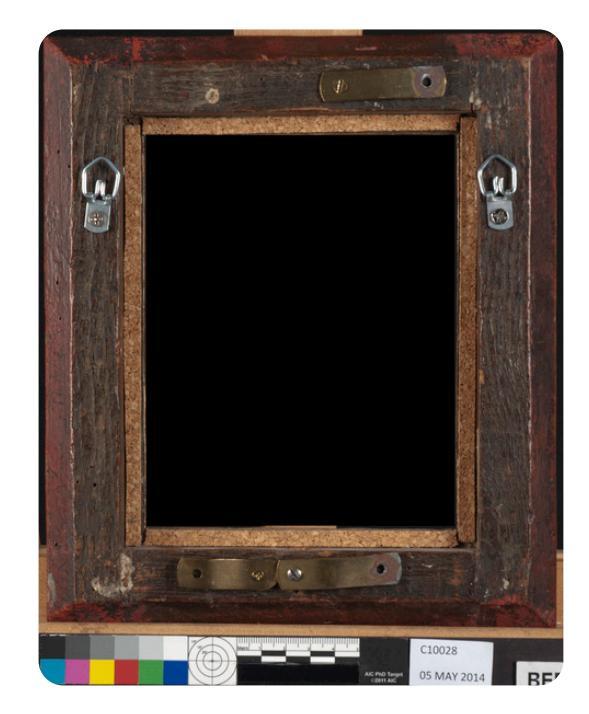
Technical Figure 24: Frame, back. Corneille de Lyon, *Portrait of René du Puy du Fou*, about 1550, Indianapolis Museum of Art at Newfields, The Clowes Collection, 2014.86.
